Best Practices in the Design and Construction of Airfield Asphalt Pavements

2010 CAPTG Workshop - September 12, 2010

Chris Stewart, P.Eng., A.A.E.
Manager, Airside & Infrastructure Engineering

Greater Toronto Airports Authority

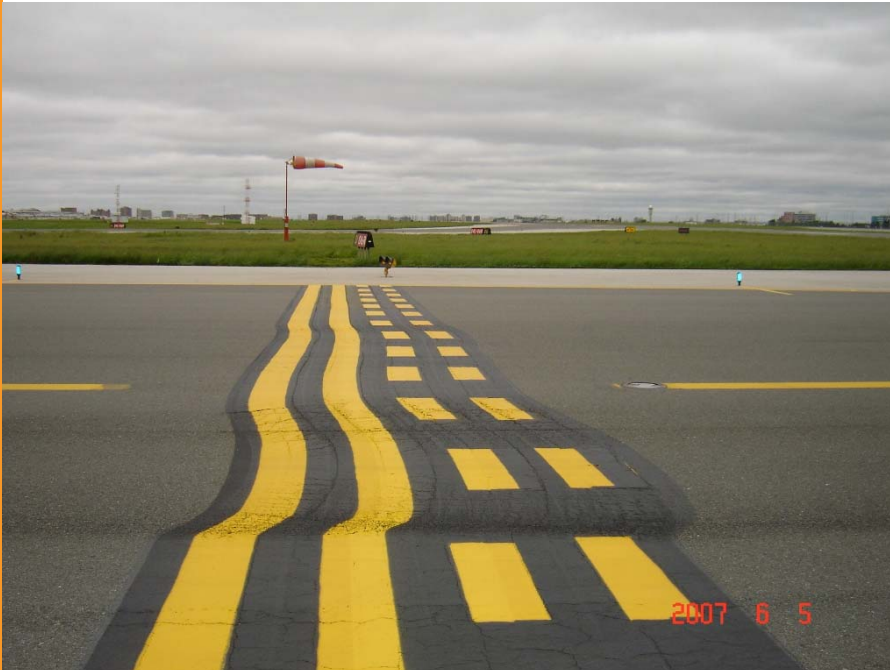
Pavement shoved at the holdline position

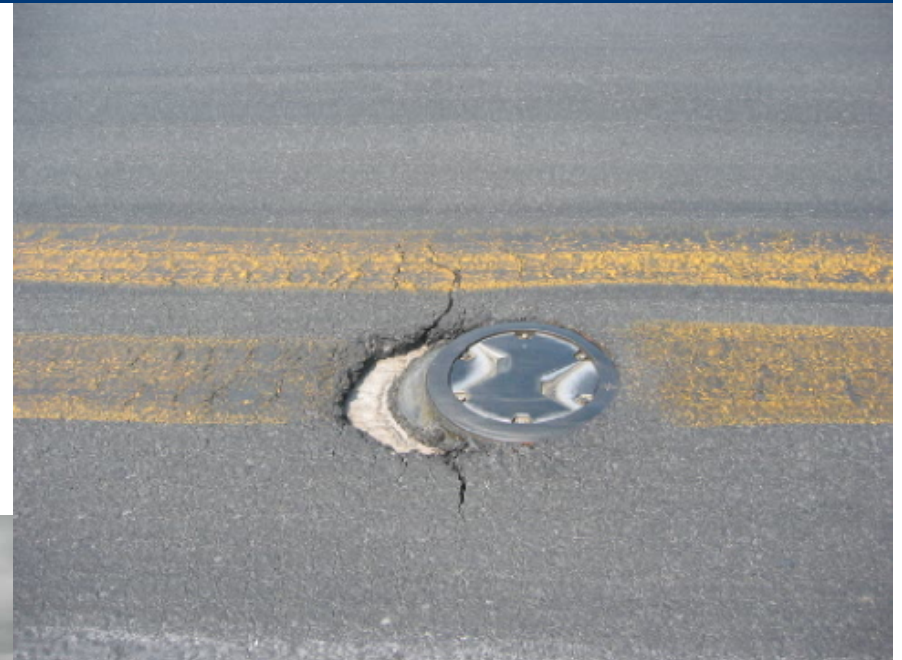
Slippage of asphalt away from the inset light

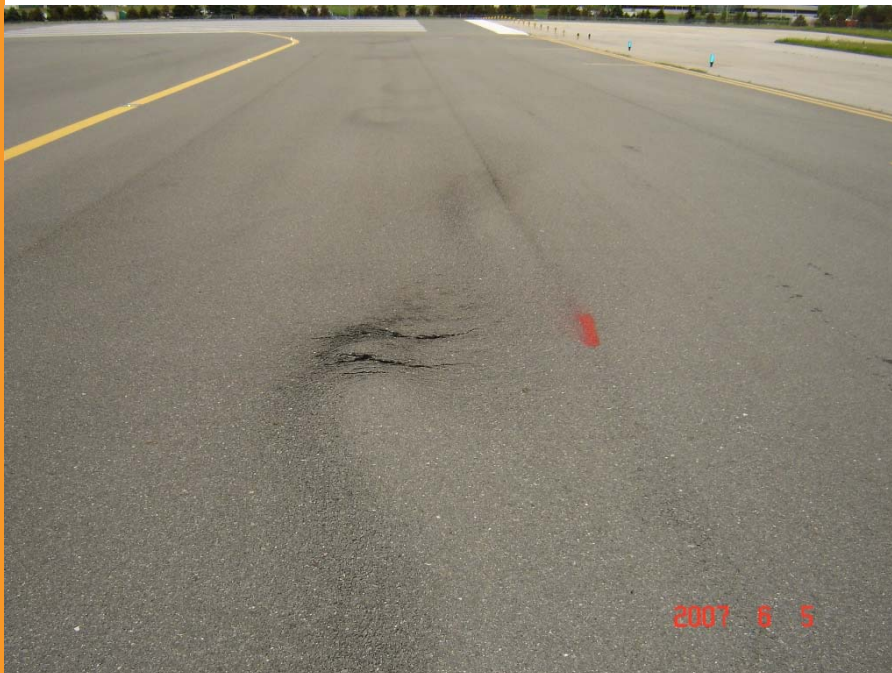
Shoving in asphalt

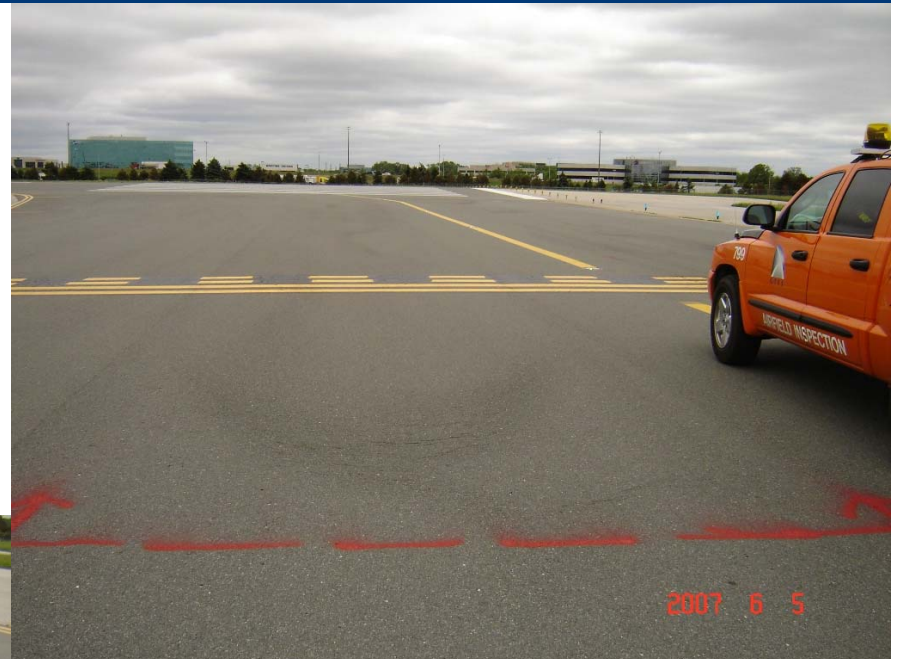
Shoving at locations of heavy braking of aircraft.

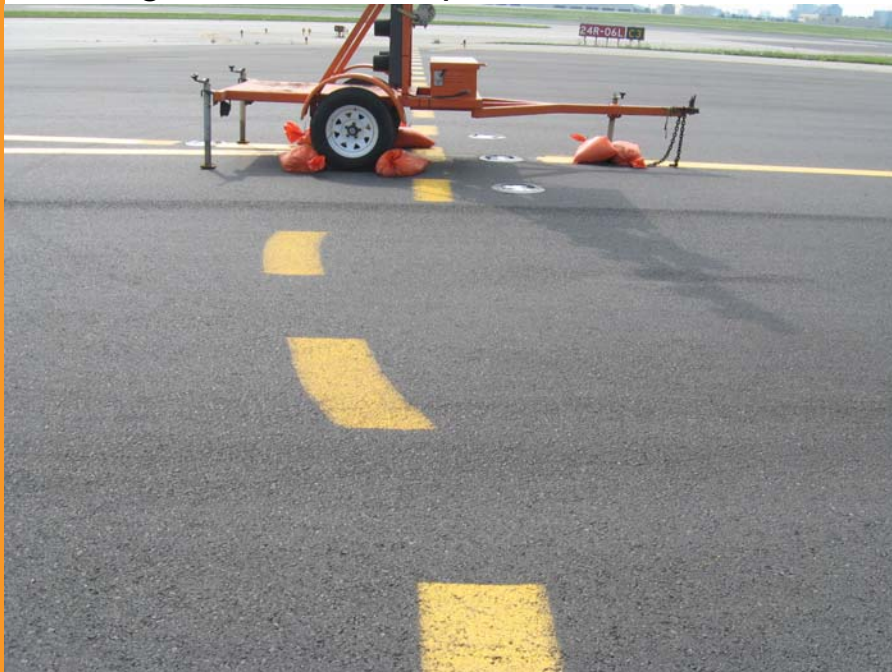
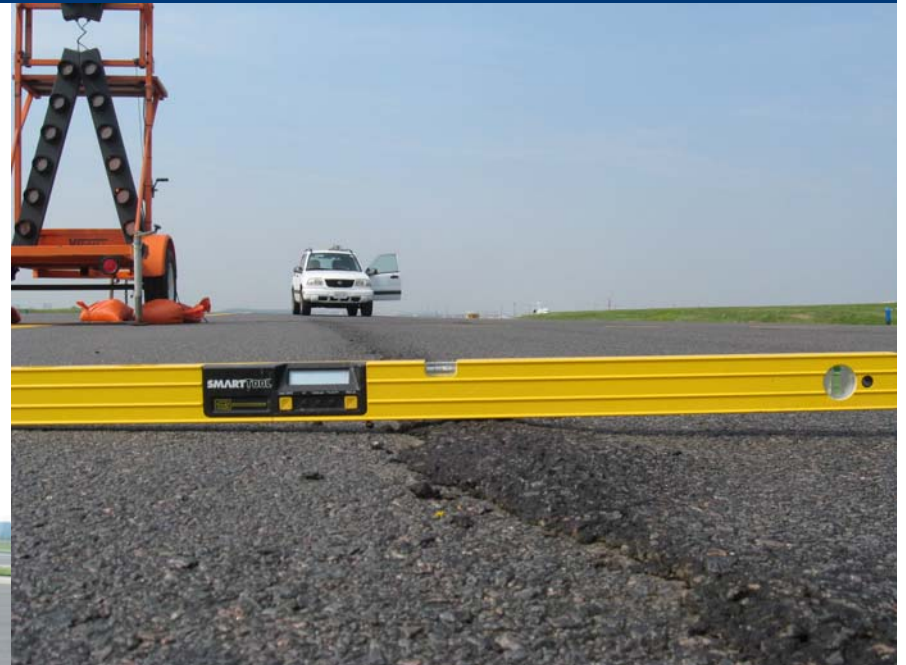
Shoving at the holdline position

Asphalt Sliding

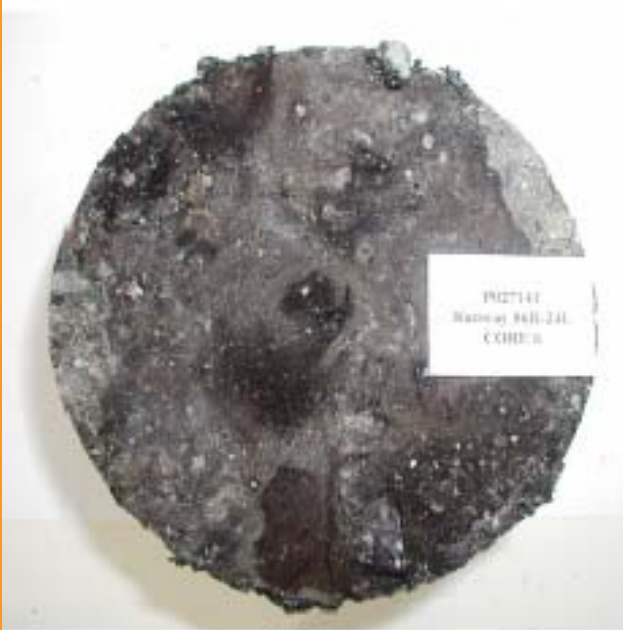
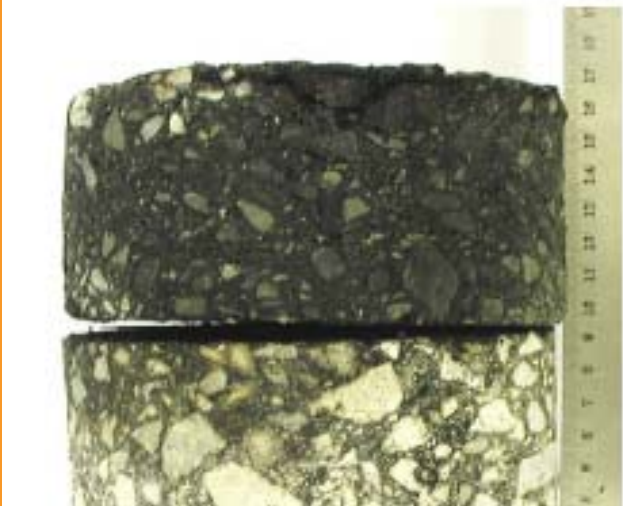
-Joint sealant was in poor conditions. It was only bonded to the top 2 to 3 mm of the joint reservoir and was easy to pull out.

-Rout configuration 11mm wide by 18mm deep.

-Surface and lower courses were separated during coring.

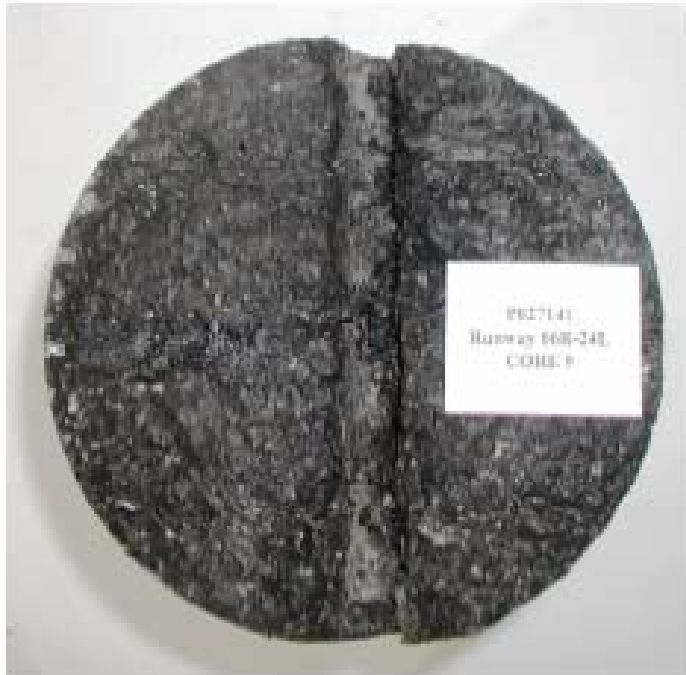
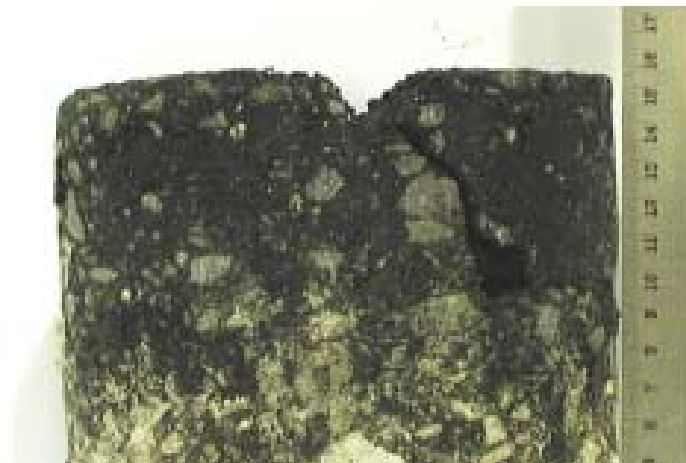
-Transverse joint sealant was completely lost with rough joint reservoir wall

-Rout configuration 13mm wide by 14mm deep

-Good asphalt bonding between surface and lower courses

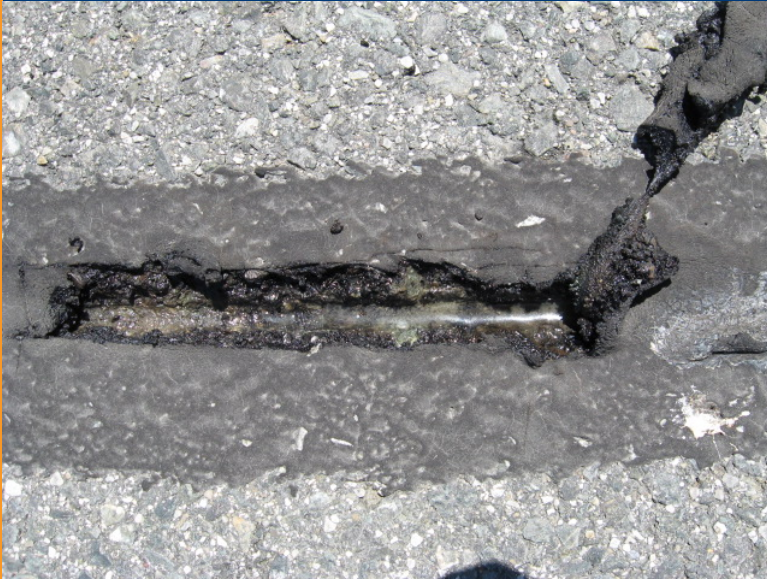
4. Particles of shattered aggregate were observed in the bottom of the joint reservoir which was likely caused by the use of rotary-impact router. This material was not cleaned out properly prior to the sealant installation.
5. Free standing water was observed at the bottom of the joint reservoir after blisters were opened up.

-After sealant was pulled out, free standing water was observed at the bottom of the joint reservoir.

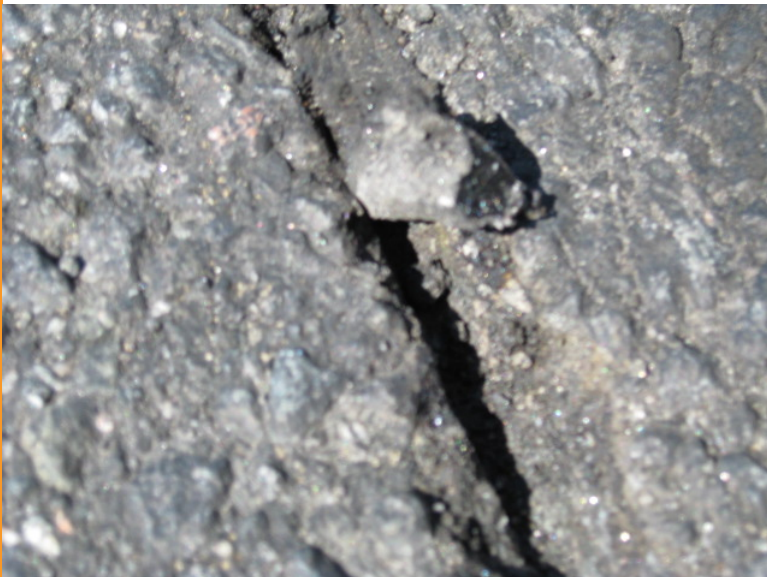
-Particles of shattered aggregate were observed in the bottom of the joint reservoir.

1. Random crack saw with diamond blades should be used to minimize fracture damage of trap rock aggregate.
2. Additional random crack saw should be considered to accommodate the lower production rate when comparing to the standard rotary-impact router.
3. Rout configuration with width/depth ratio ≥ 1 (20mm width by 20mm depth) is recommended.
4. Use of hot lance to clean and dry the joint reservoir should be continued.
5. Use of sealant such as Beram 195 should be continued.
