# **REHABILITATION OF RUNWAY 11/29 AT CFB BAGOTVILLE**

Presented by: Marla Hughesman  
CAPTG Sunday Workshop  
12 September 2010

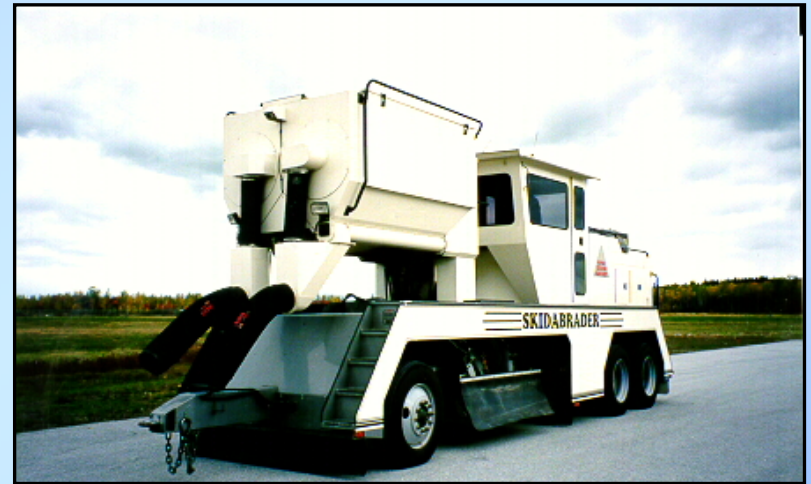
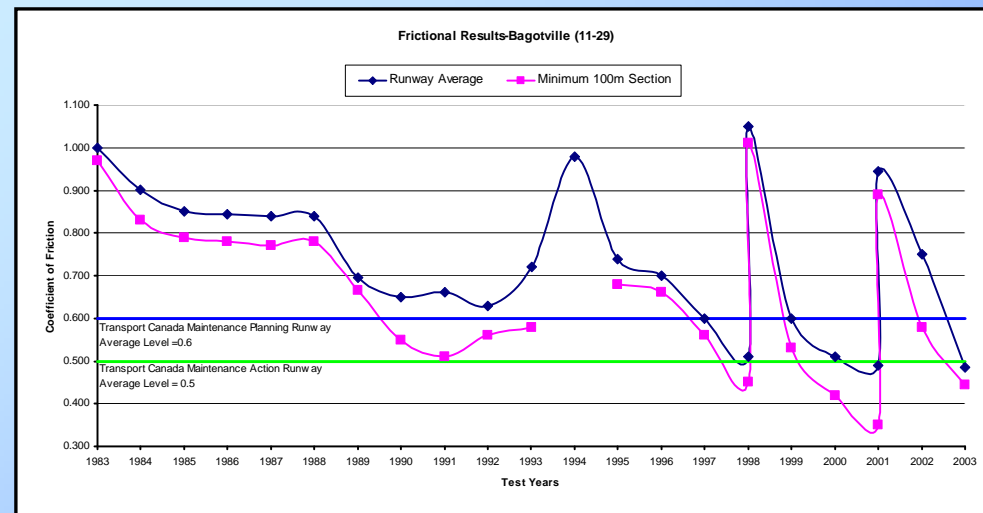
- 1994 was the first retexturing project on the runway.
- Following that the runway was redone:
  - 1998
  - 2001
  - 2004
  - 2005
- Losing friction levels in 6 months. Issuing NOTAMs for winter ops.

- Forensics investigation revealed that the Limestone aggregate used to construct the runway was extremely soft
- ATC & Heavy equipment was requiring daily brushing of the runway surface with steel brooms whose cartridges were allowed excessive wear
- Continual retexturing operations caused reduction of the cement matrix exposing more soft aggregate

- Realized we needed a more permanent solution
- Also needed a band-aid to carry us through until a rehabilitation project could be funded
- Fall 2005 decided to do a diamond grinding trial, 3 patches on the centre line, to see how it would withstand Winter OPS
- Saw only a 25 – 30 % decrease in friction
- Decided to proceed with a full scale project in Summer 2006

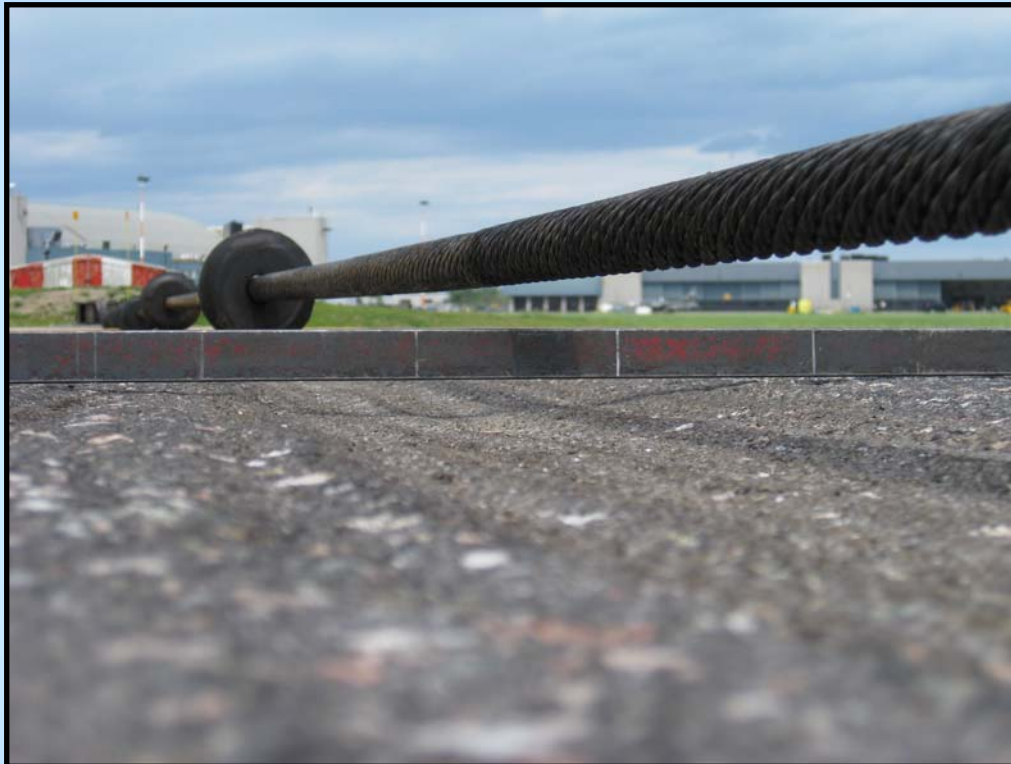
- August 2009 – 8 mths after construction
  - Advised that pavement under arrestor gear is wearing

- Advised the base to mill and repair the area with asphalt
- Issue is that the arrestor gear is employed 24 hrs
- Repair was completed
- Further repairs were required in Oct '09 and May '10 due to excessive wearing

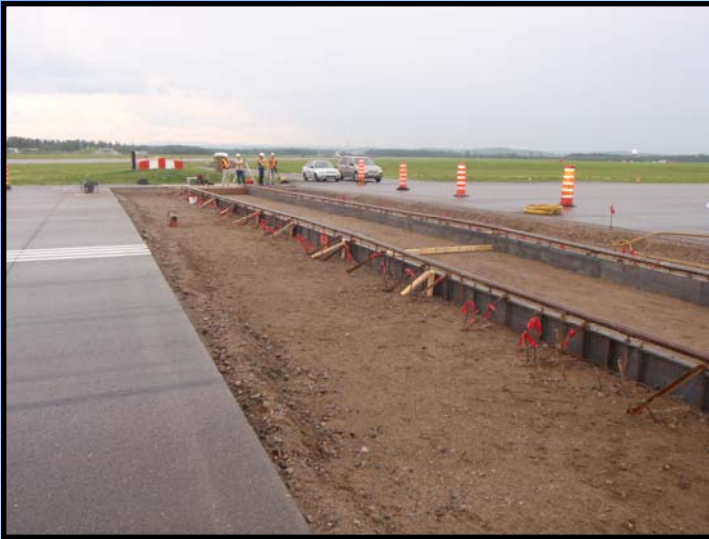
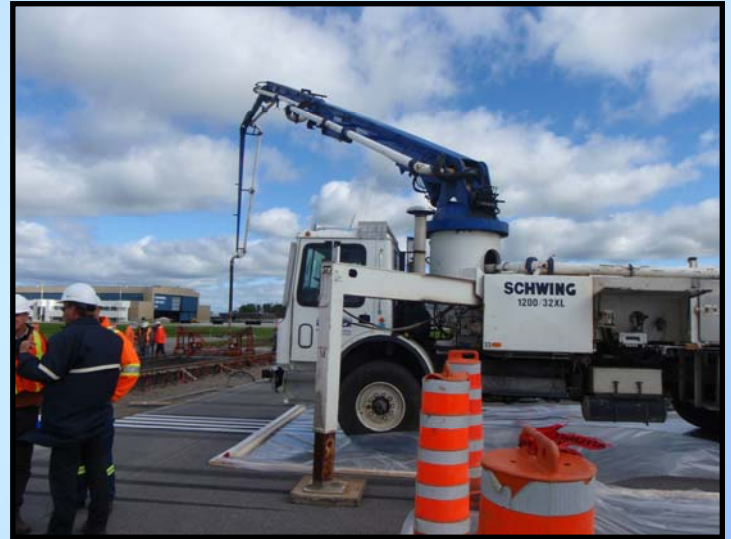
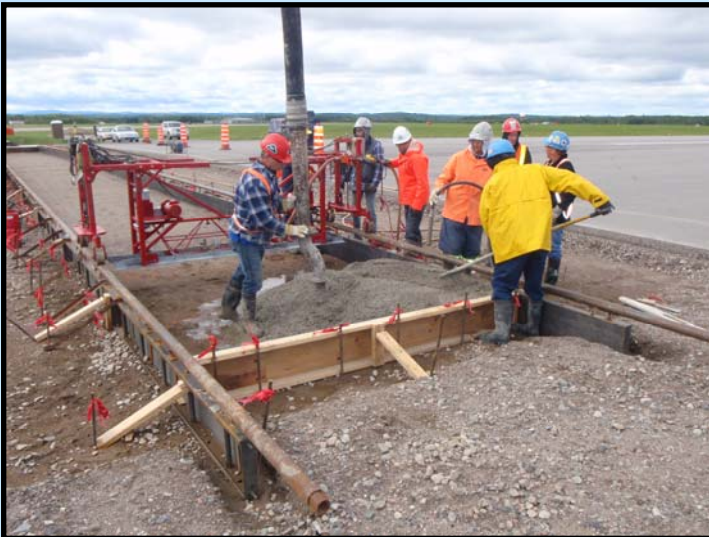
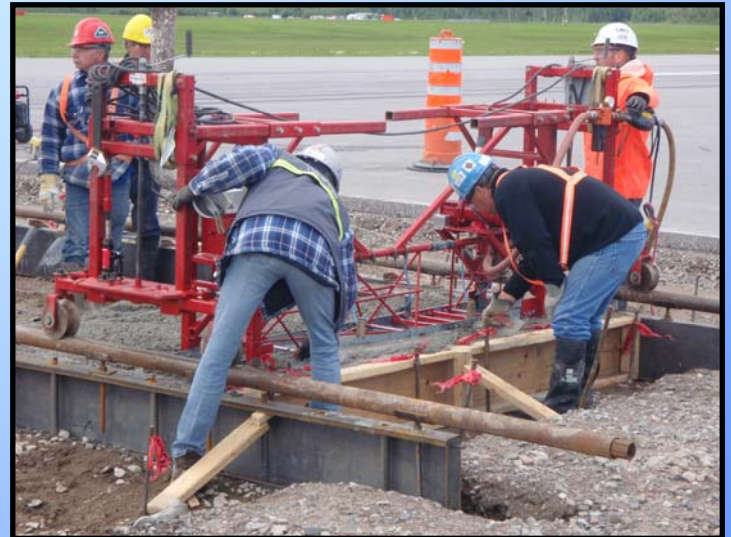
# THE REPAIR

- Runway reopened August 26<sup>th</sup>, 2010
- Arrestor gear was not employed until September 9<sup>th</sup> (28 day cure)
- Some elevation issues that conflict with arrestor gear operations
- Question is.....how long will the concrete last????

- Decided during the winter to complete a design of a concrete strip that would lie under the arrestor gear.
- Strip is 3.0m wide and 325mm thick
- Done at both ends of the runway
- Requires transition slab between concrete and asphalt to minimize rutting potential
- Runway will be closed for 3 weeks to accommodate construction
