“An Innovative Approach to Locate and Repair a Runway Roughness Event at YYZ”

Kevin Chee, GTAA
Robert Pouliot, Air Canada
Tony Gerardi, APR Consultants Inc.

Toronto Pearson Airport – Canada's Largest Airport

Reported Runway Roughness

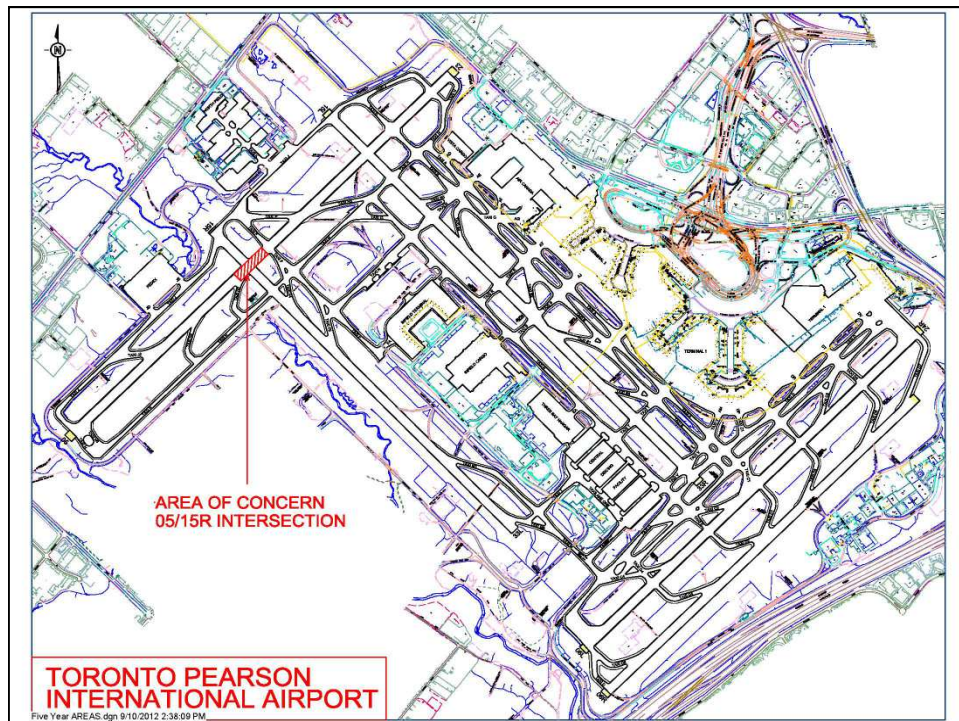
- It was first reported to GTAA by Air Canada in July 2011.
- Pilots operating Boeing 777 and Airbus A320 aircraft on runway 05-23 were reporting runway roughness in & around the intersection with 15R-33L.
- This was confirmed/quantified with on-board instrumentation measurements from the on-board Flight Data Monitoring (FDM) System.

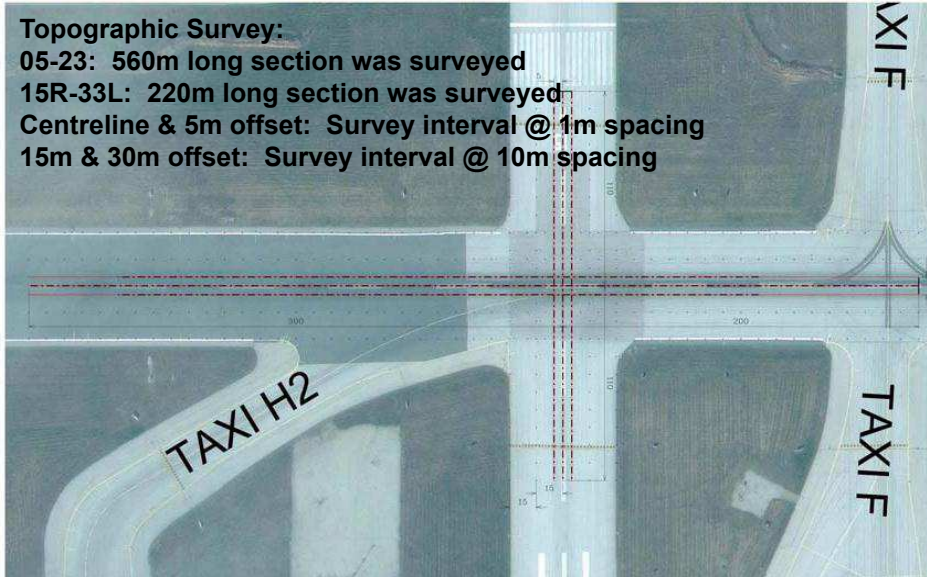
Topographic Survey:
05-23: 560m long section was surveyed
15R-33L: 220m long section was surveyed
Centreline & 5m offset: Survey interval @ 1m spacing
15m & 30m offset: Survey interval @ 10m spacing
