Runway Grooving, Norman Wells, NWT

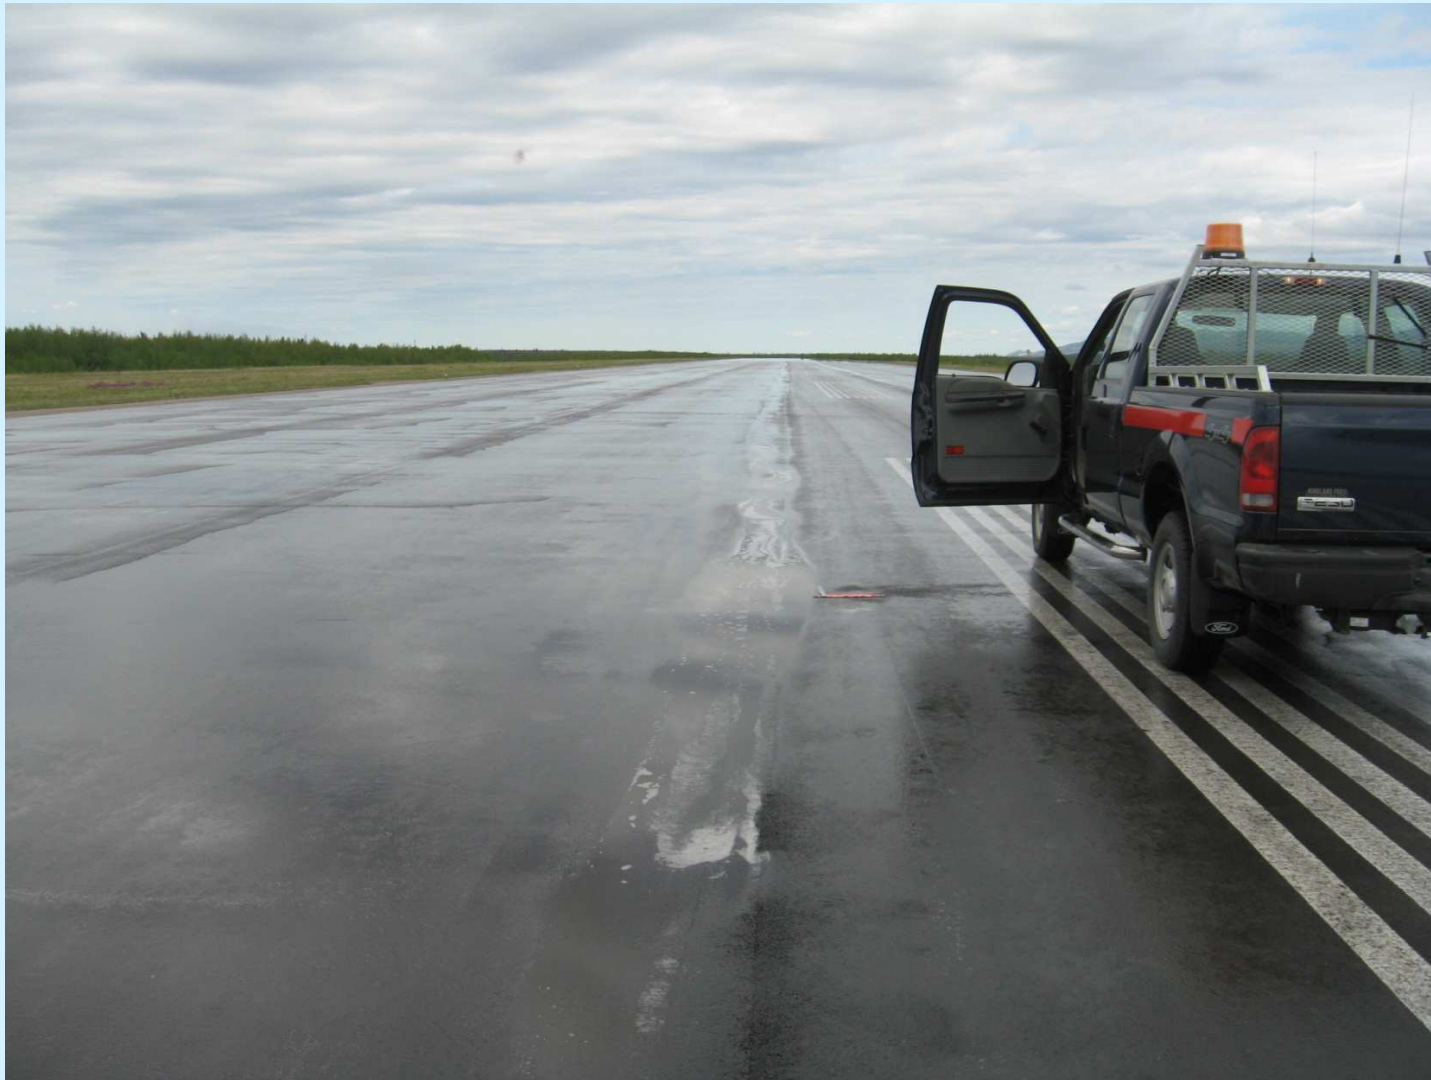
Summer 2007 - Ruts

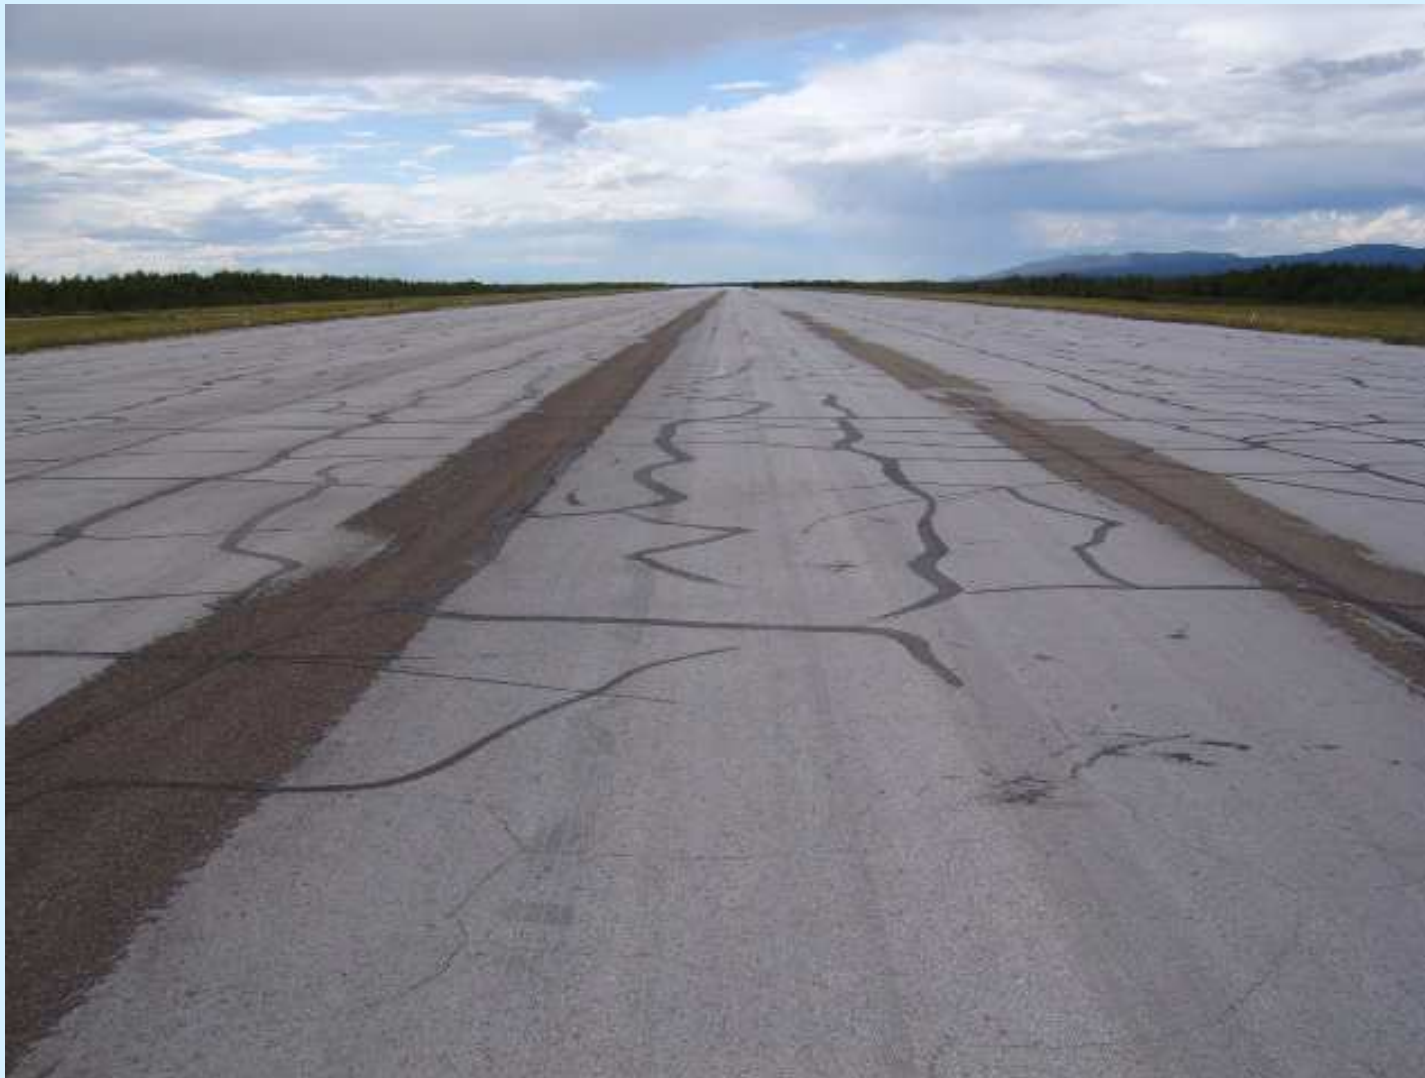
Summer 2007 - Patches

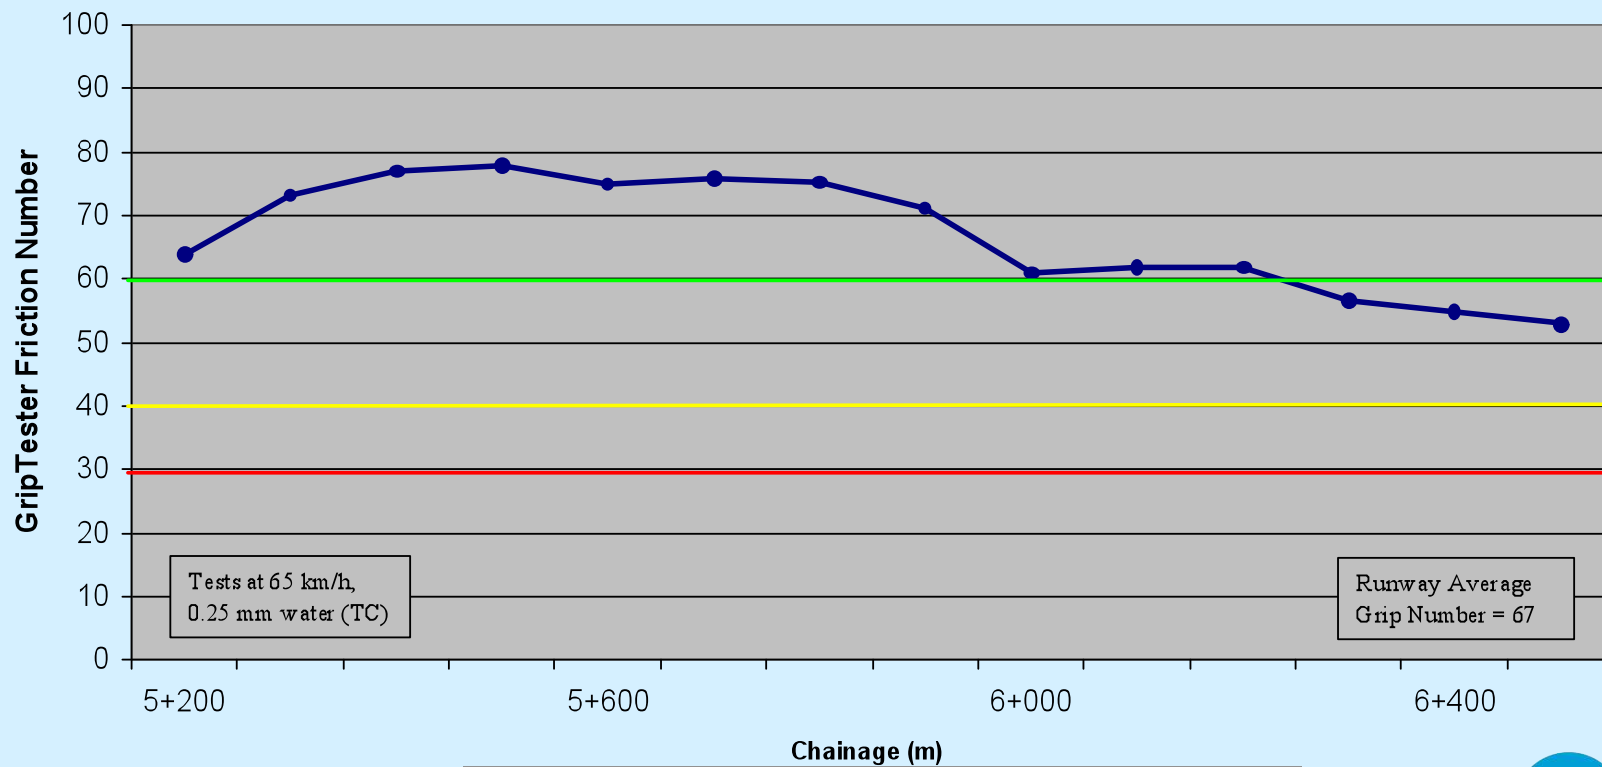
Friction Survey Results

Norman Wells Airport
Runway 09-27, July 5-6 2010
[3m L & R of CL, 0.25mm water]

Transport Canada Maintenance Planning Runway Average Level = 60
Transport Canada Minimum 100m Maintenance Planning Level = 40
Transport Canada Minimum 100m Action Level = 30

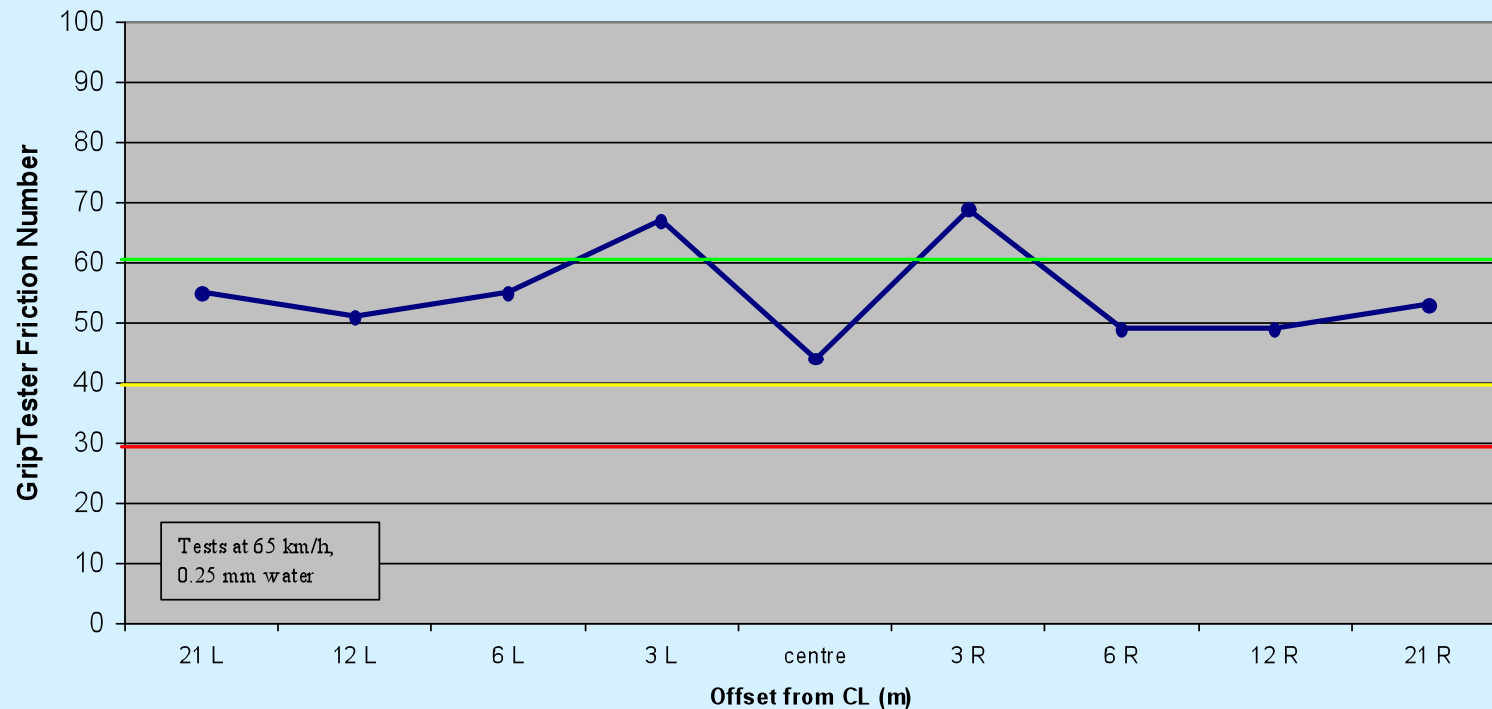
Friction Survey Results

Norman Wells Airport
Runway 09-27, July 5-6 2010
 [Multiple Offsets, 0.25mm water]

Transport Canada Maintenance Planning Runway Average Level = 60
 Transport Canada Minimum 100m Maintenance Planning Level = 40
 Transport Canada Minimum 100m Action Level = 30

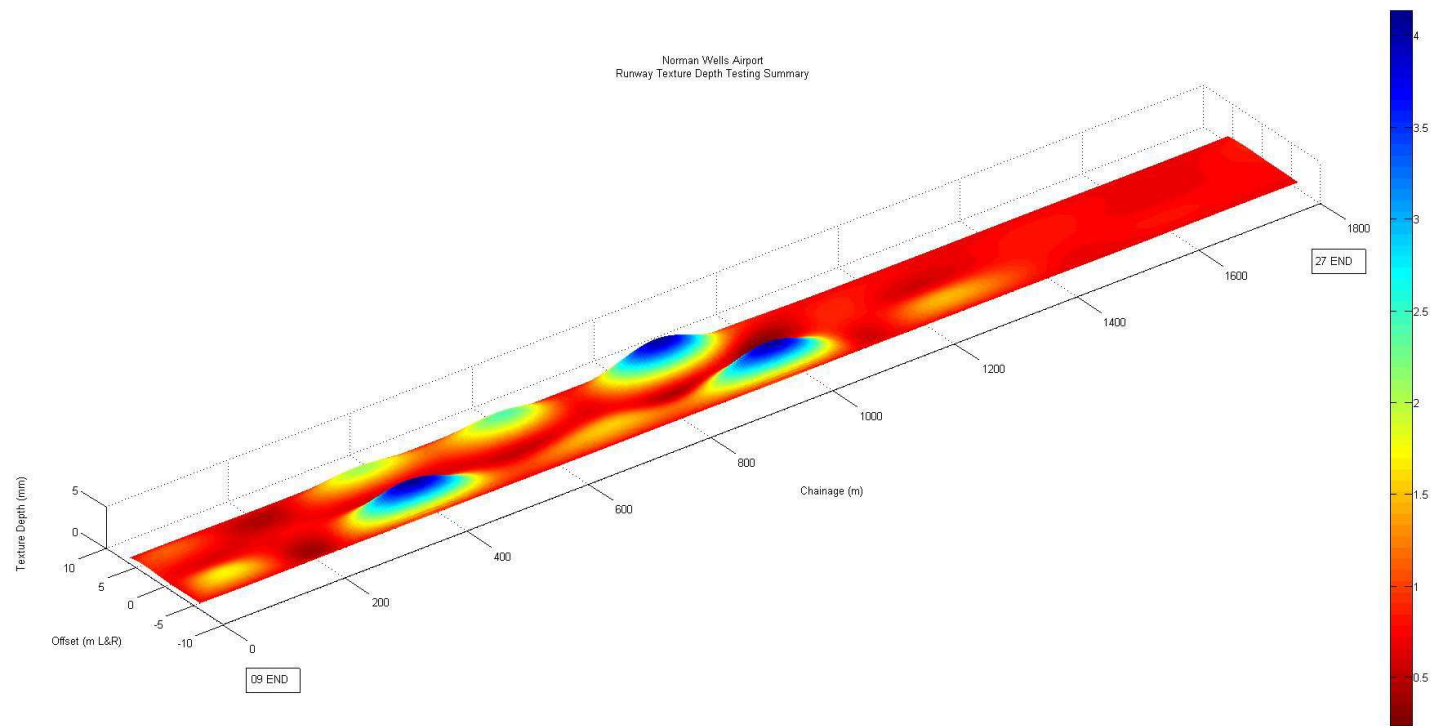
Texture Survey Results

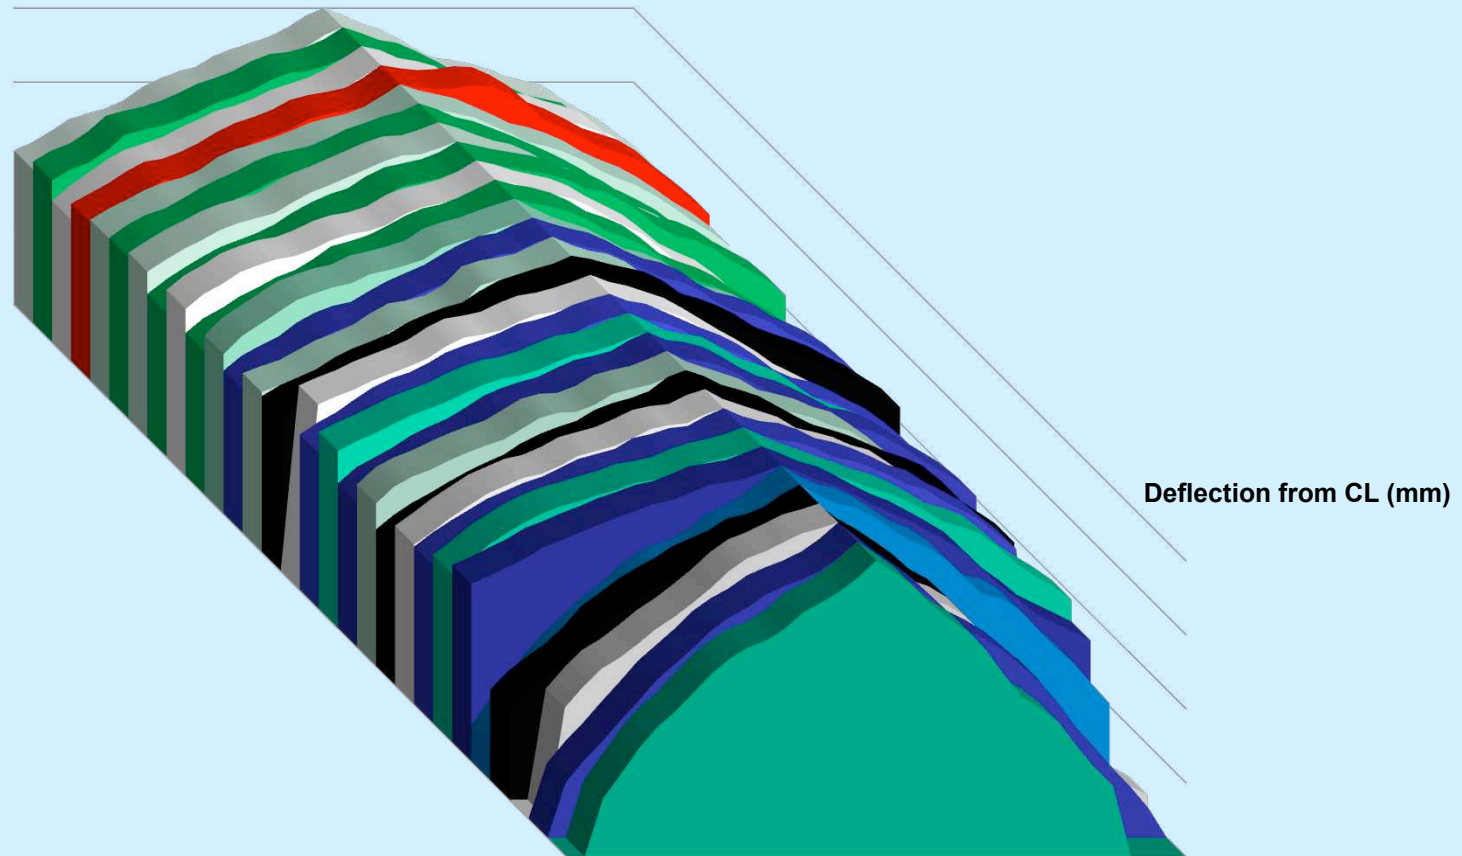
Threshold Runway 27

Cross-Slope Survey

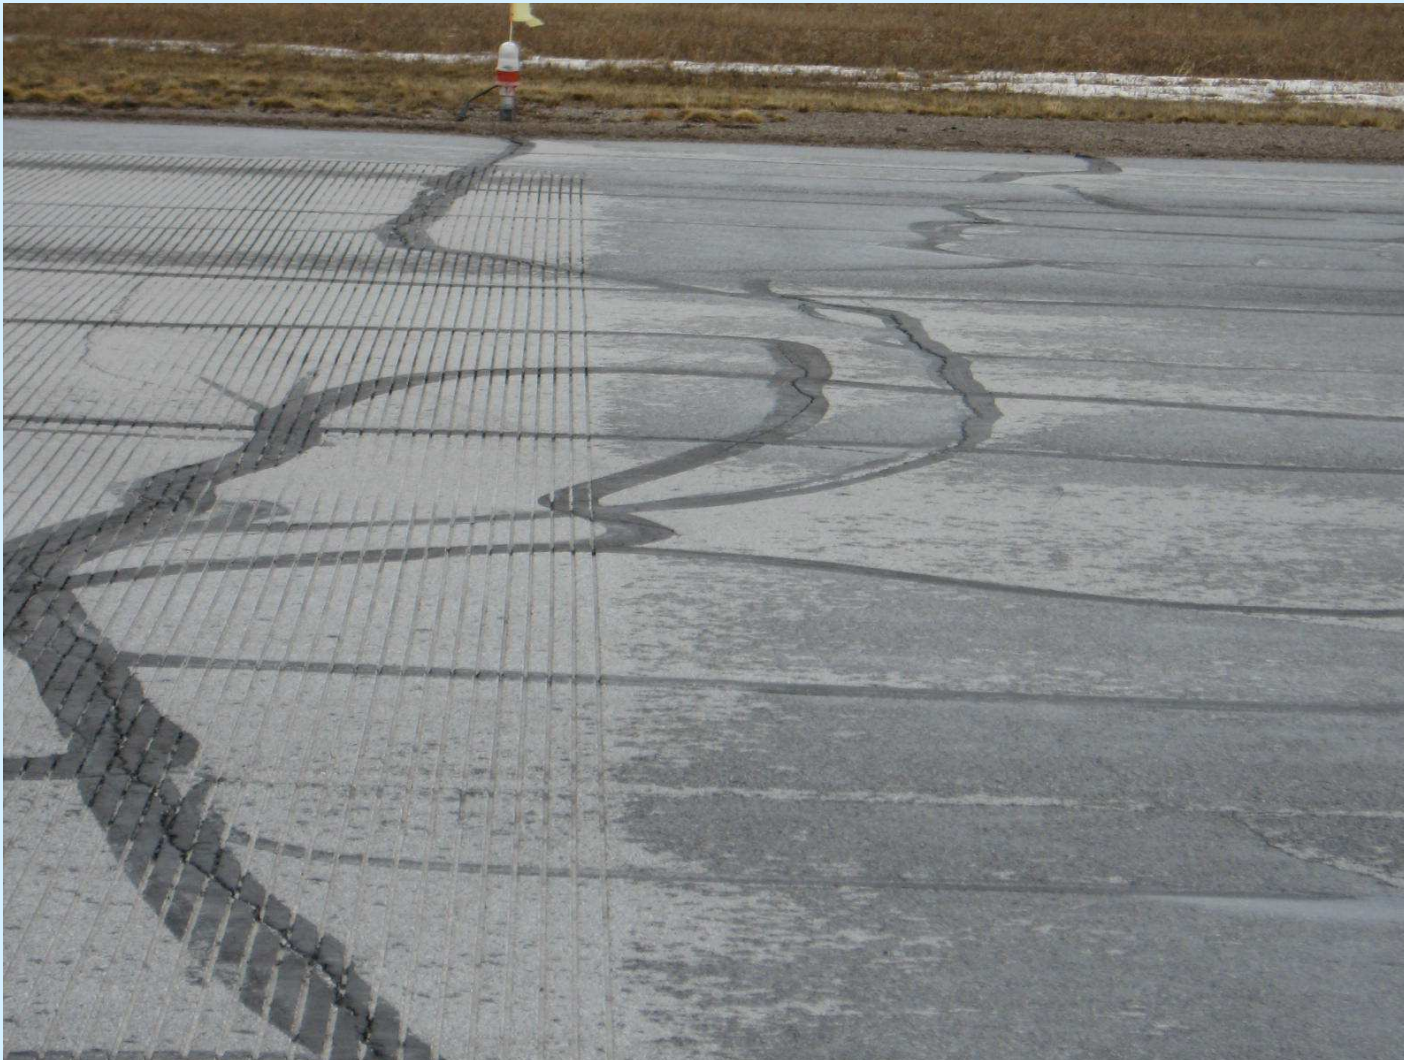
- 8 May 2012
- Grooved area dry, non-grooved area still wet.

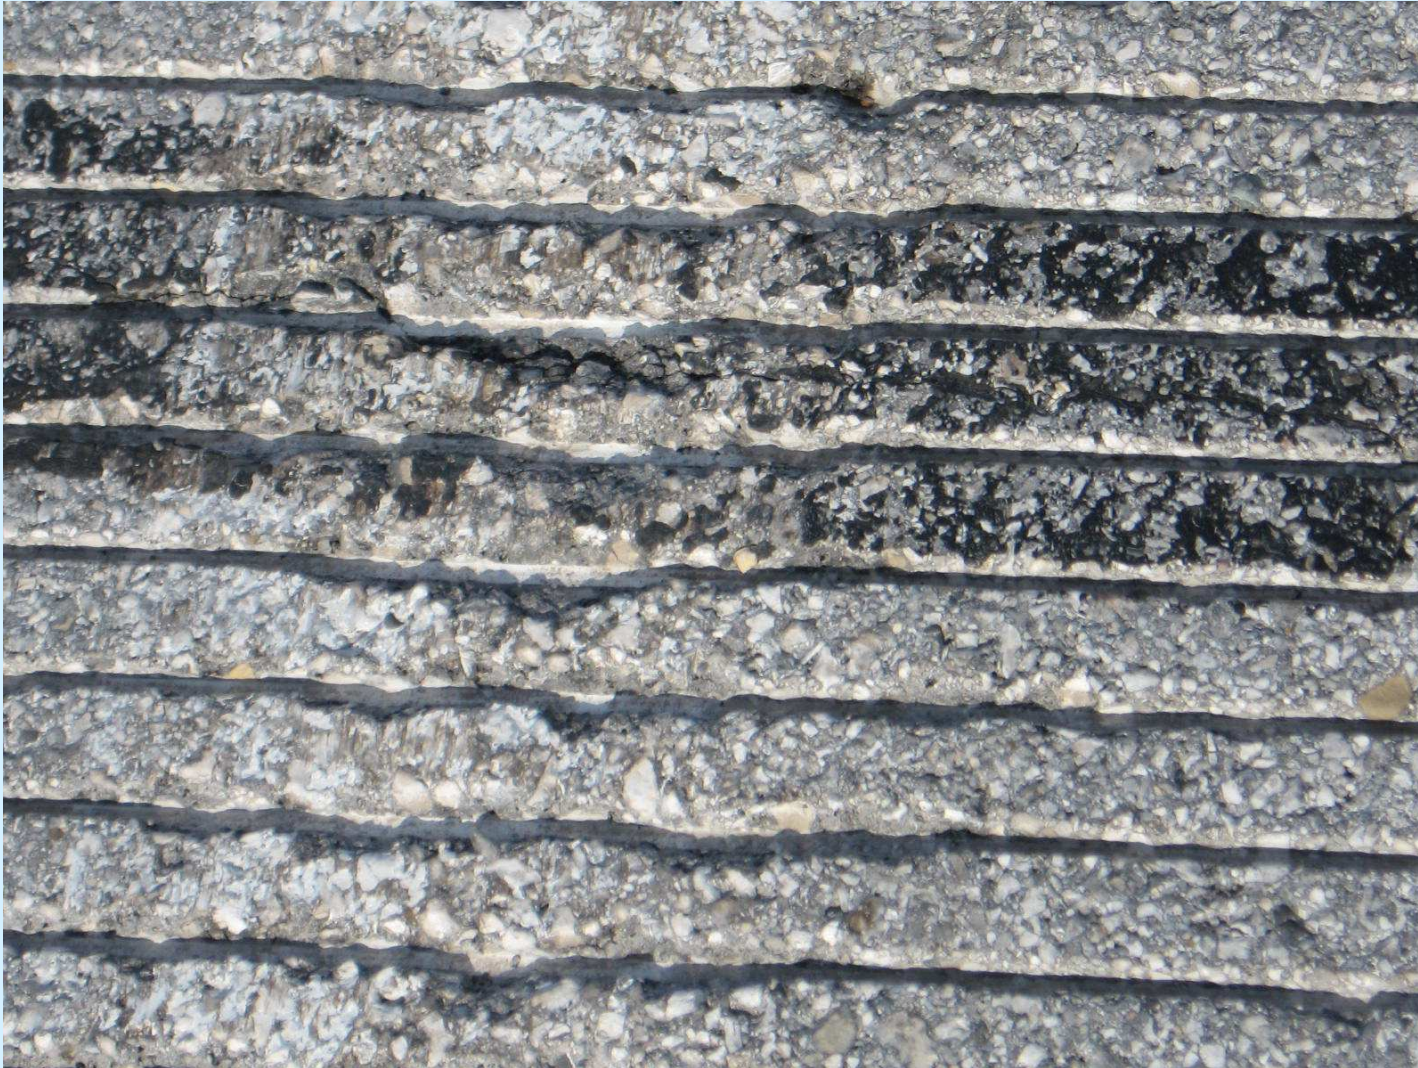
Damage at Runway Crown

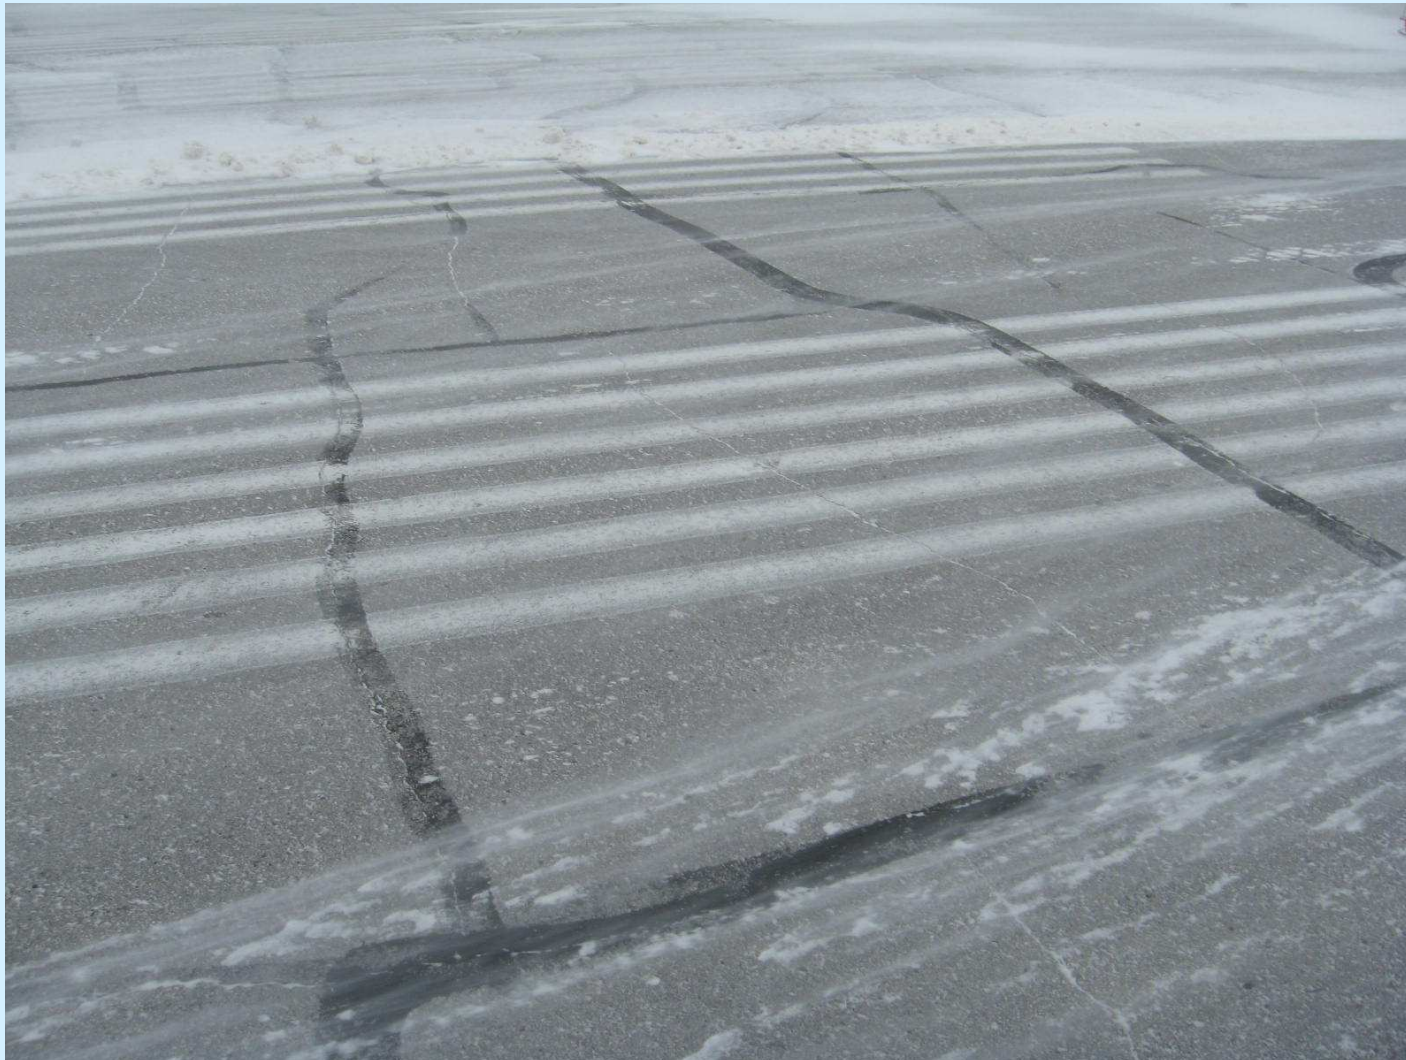
Ungrooved Areas are Slippery

- 5 May 2012
- Ungrooved Threshold 27 is slippery.
- CRFI .35 in this location.
Temperature -4°C

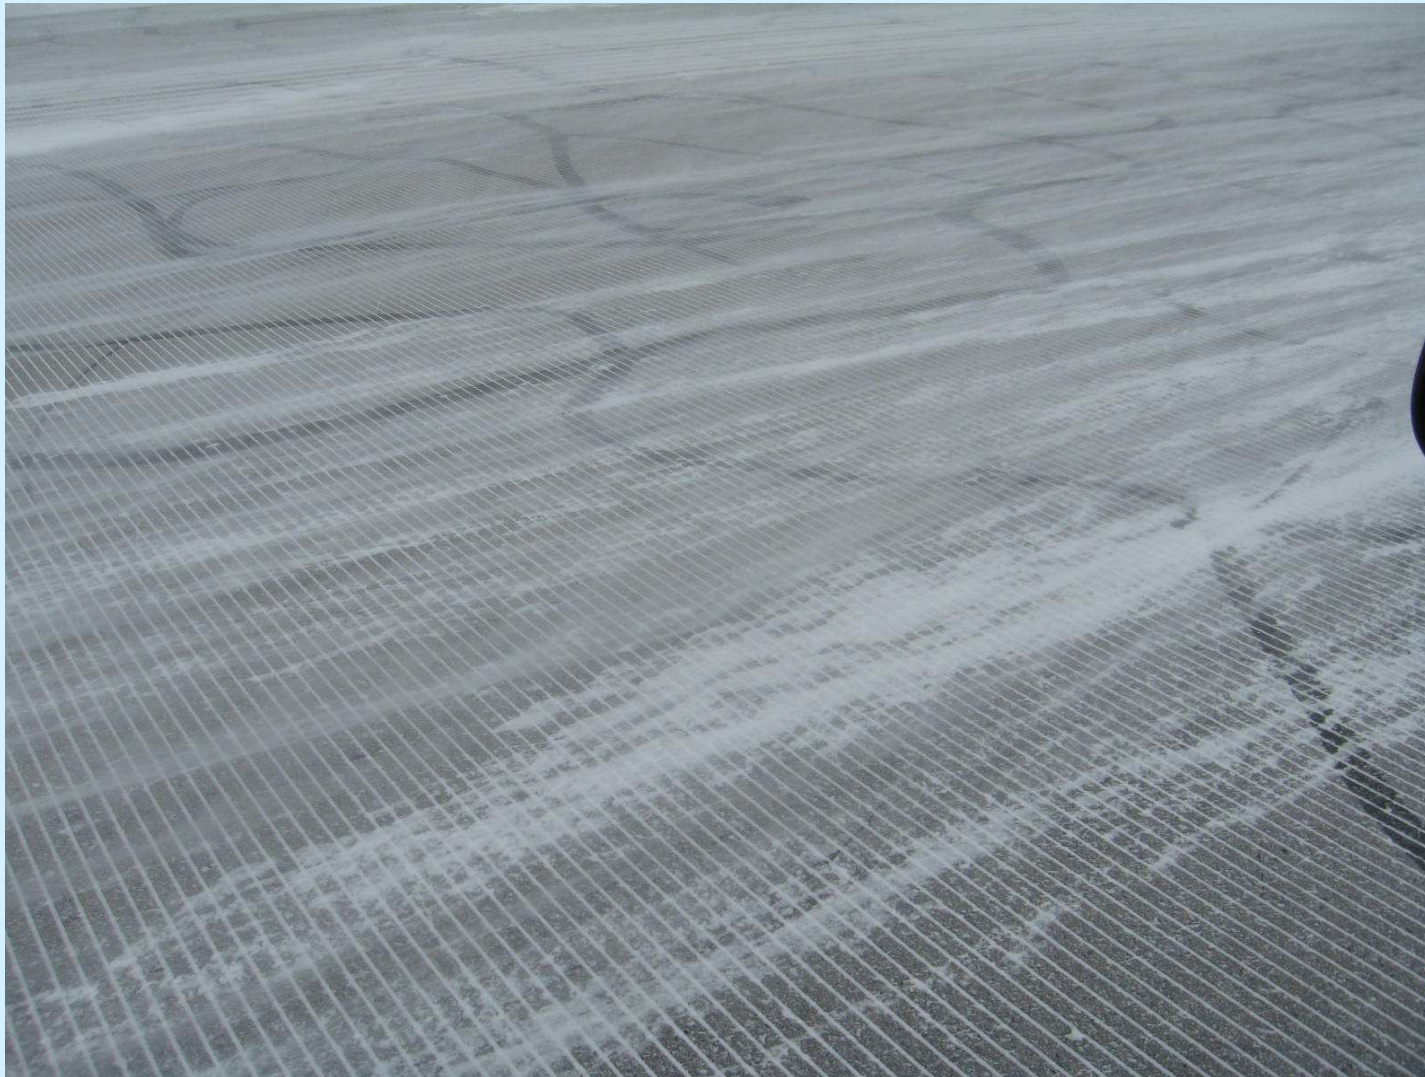
- 5 May 2012
- First sweeper pass
- CRFI .42
Temp. -4°C

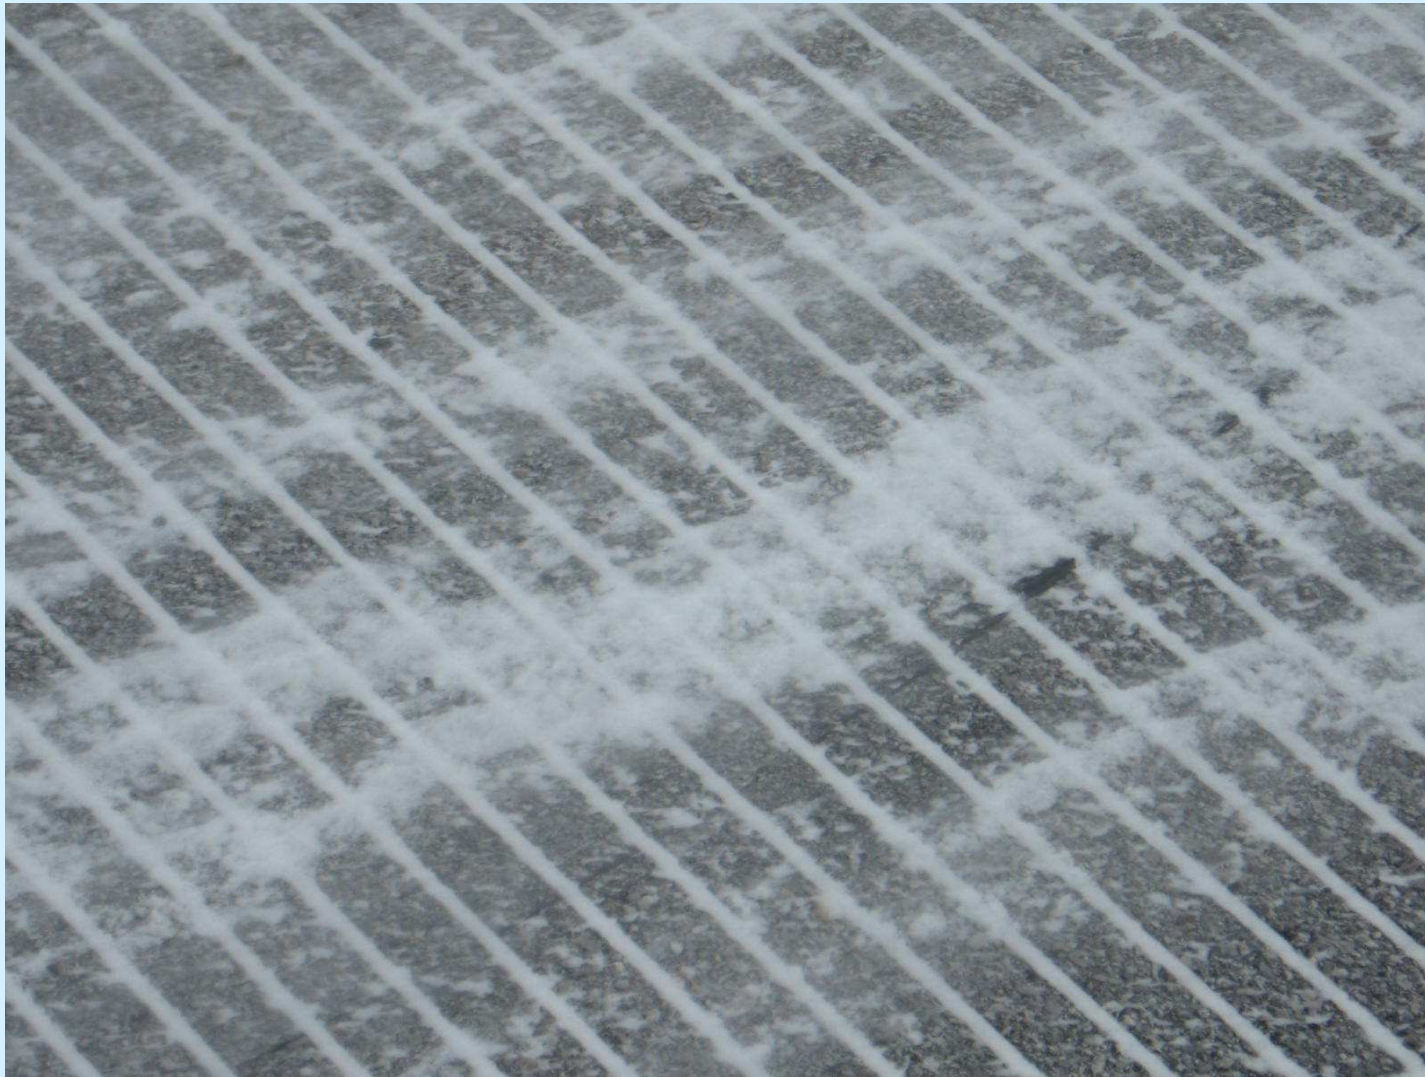
- May 05, 2012
- First sweeper pass--detail

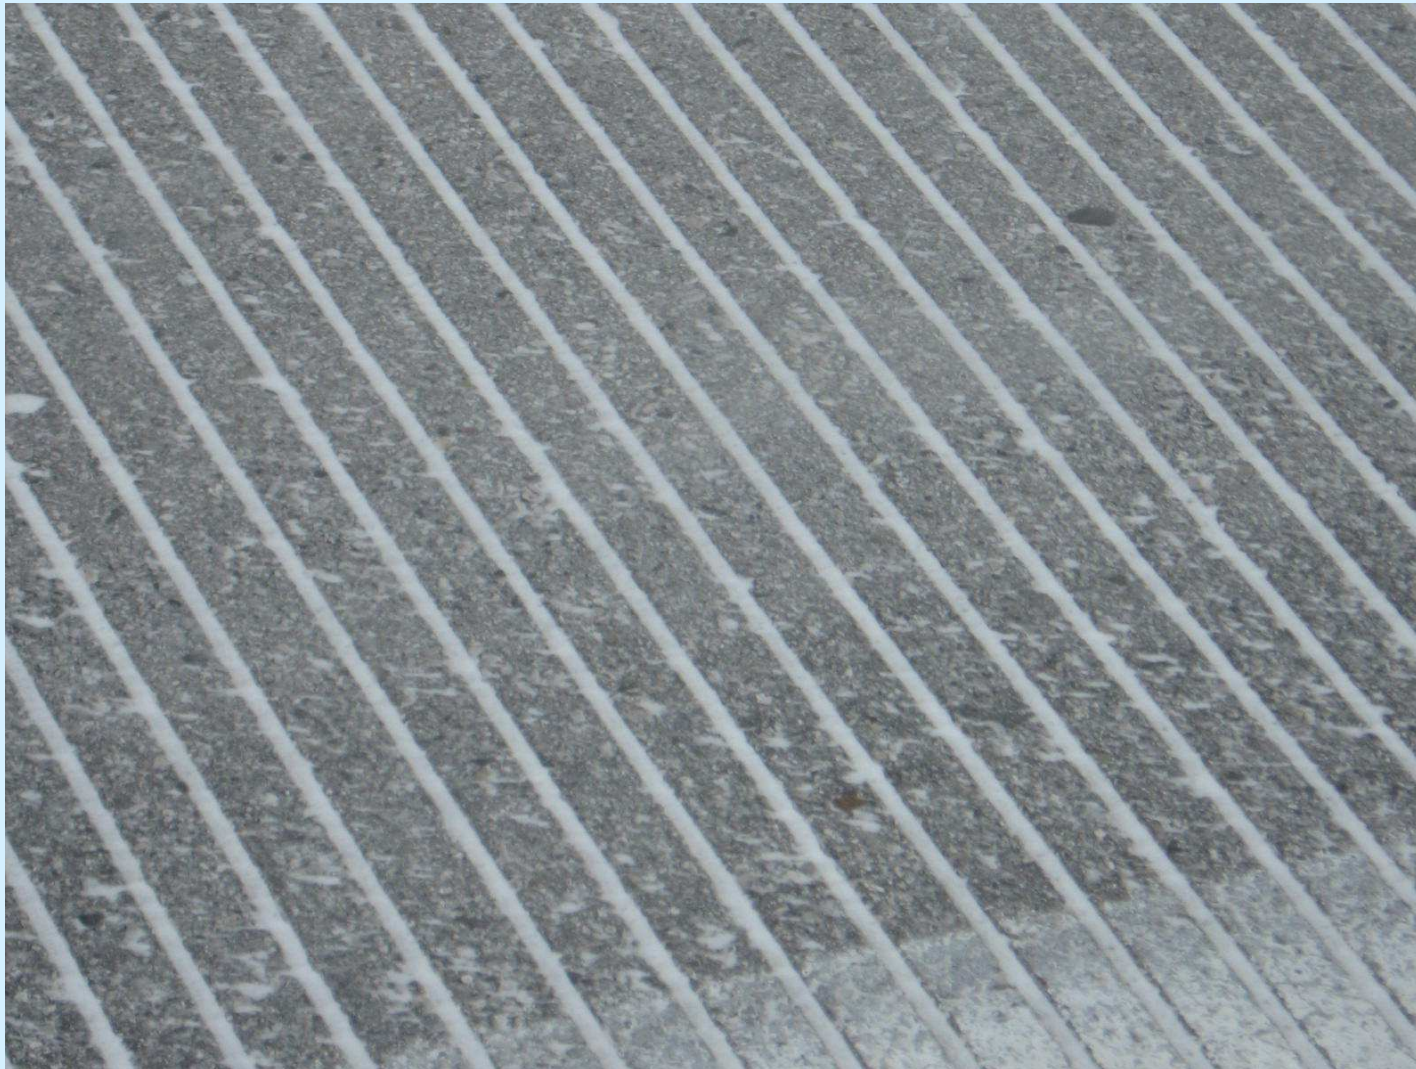
- May 05, 2012
- Second sweeper pass
- CRFI .57 -1°C

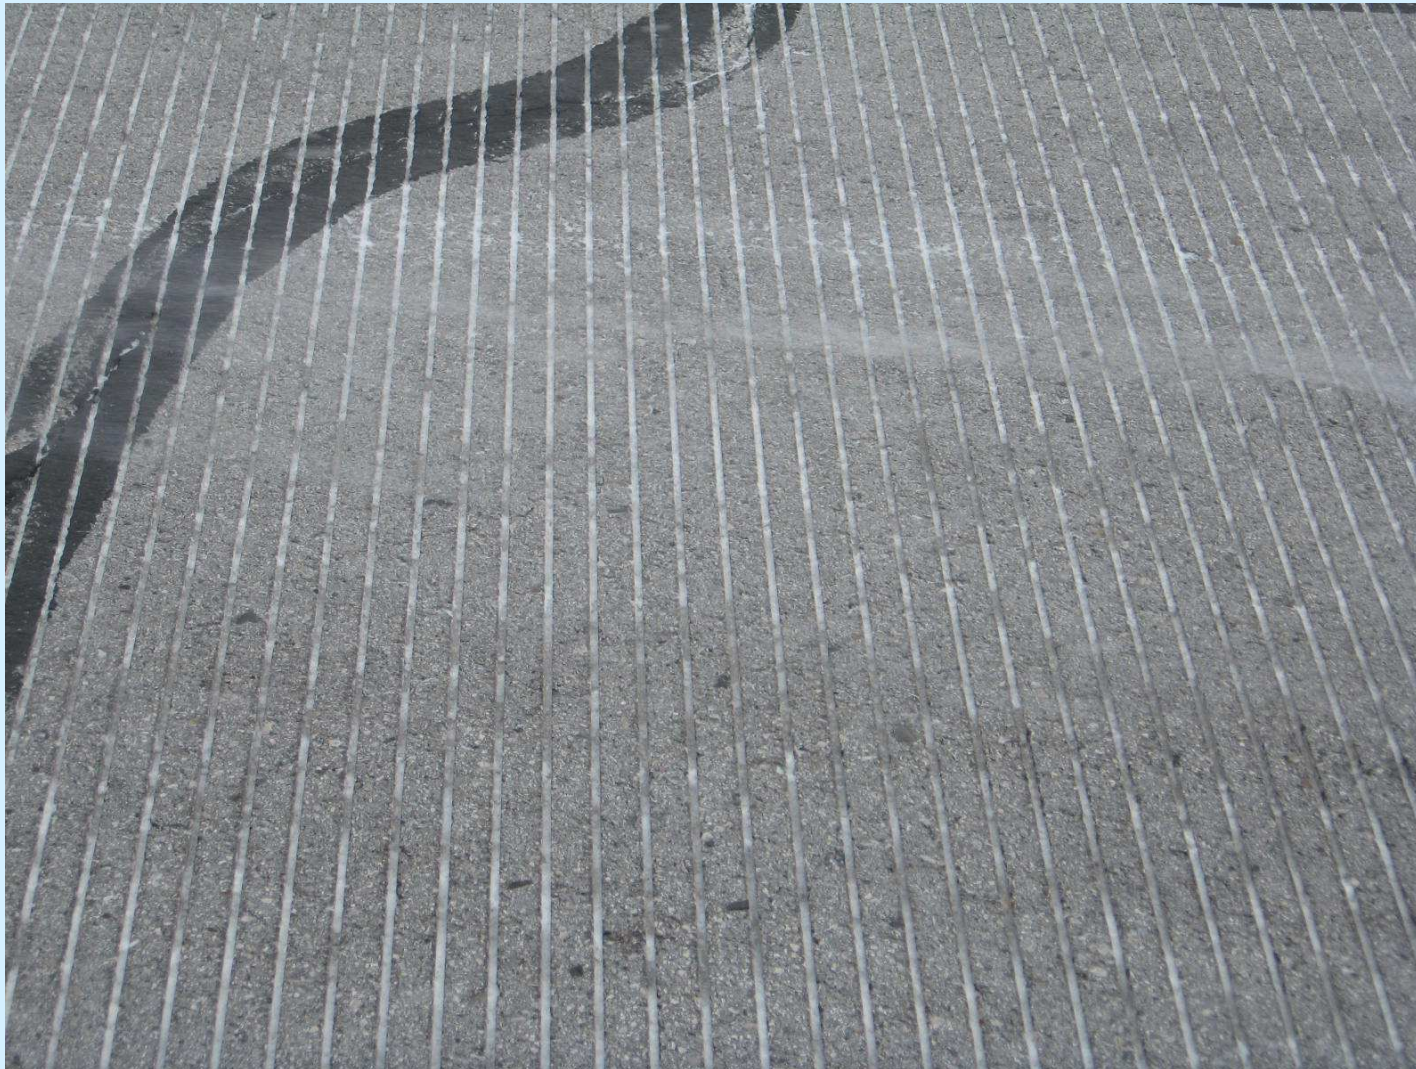
- 5 May 2012
- Third sweeper pass
- Most of the compact snow is gone

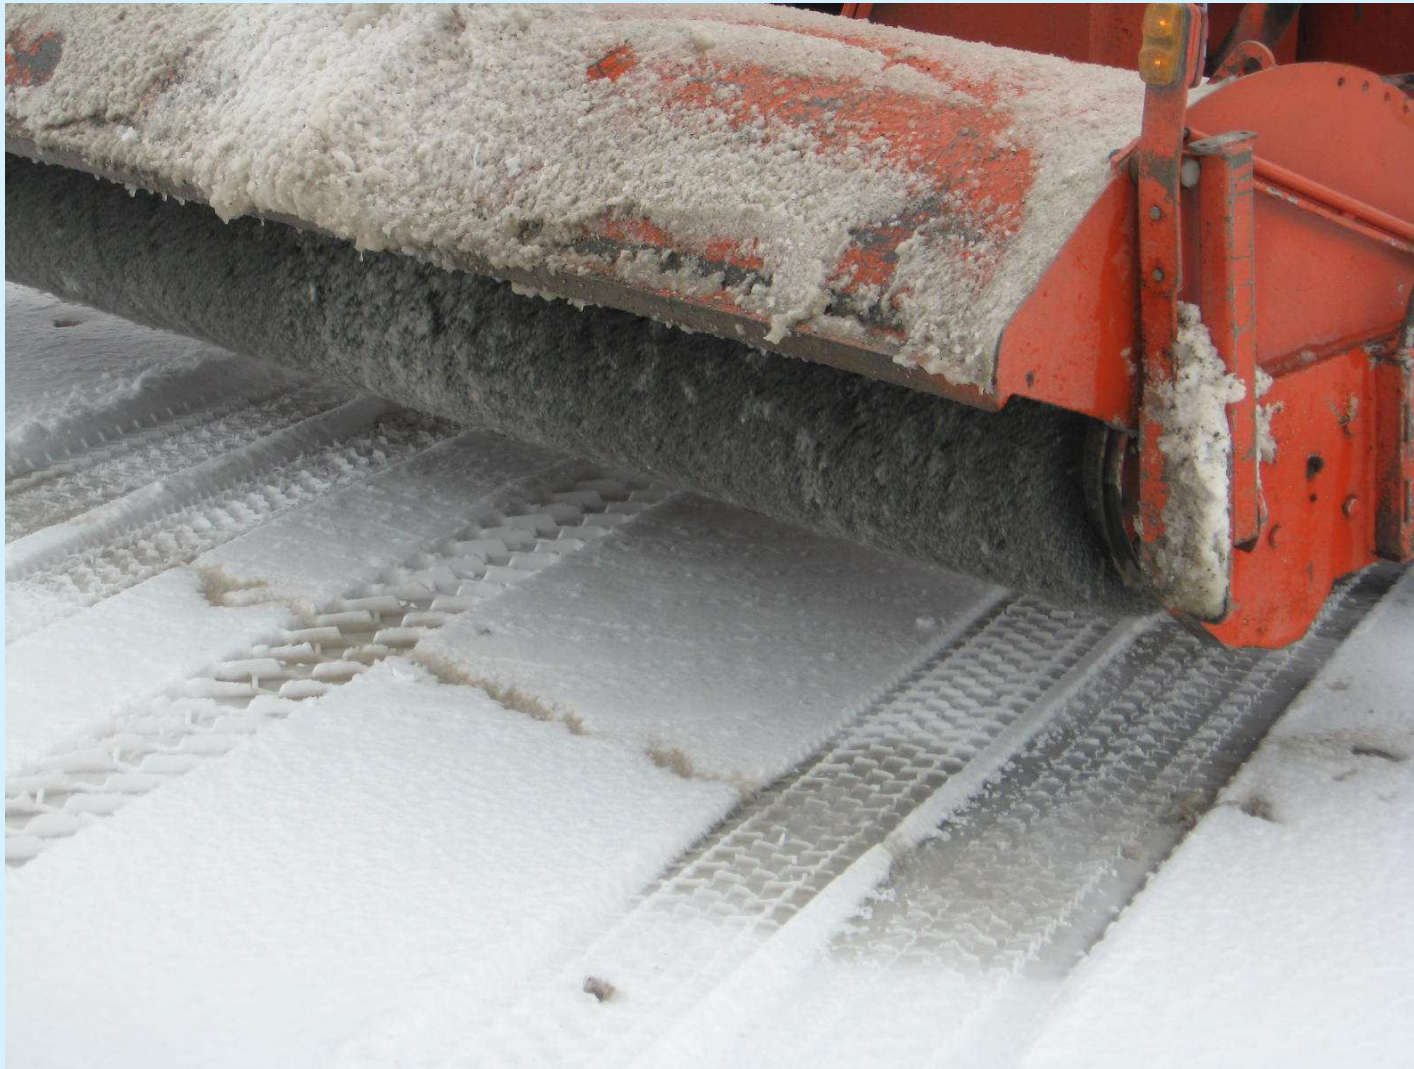
Increased Broom Wear

- Still on the broom
10 May 2012
(using every inch)

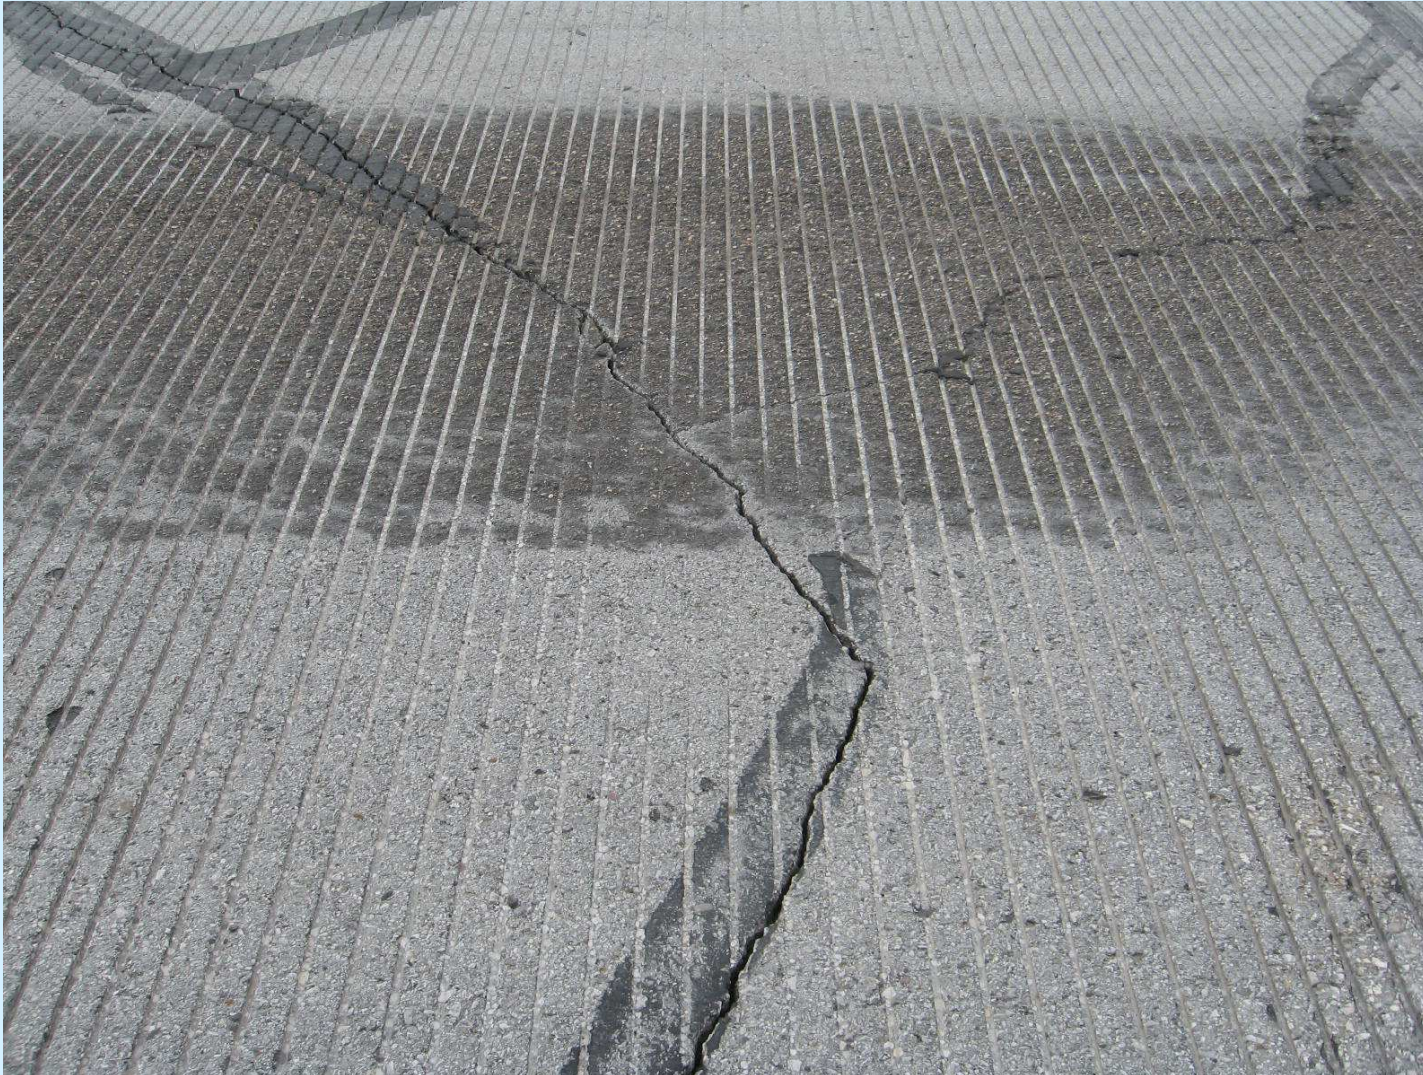
10 May 2012

Wear at Patch Edges
