YVR Taxiway Delta Rehabilitation

George Nowak, P.Eng.

SWIFT September 22, 2016

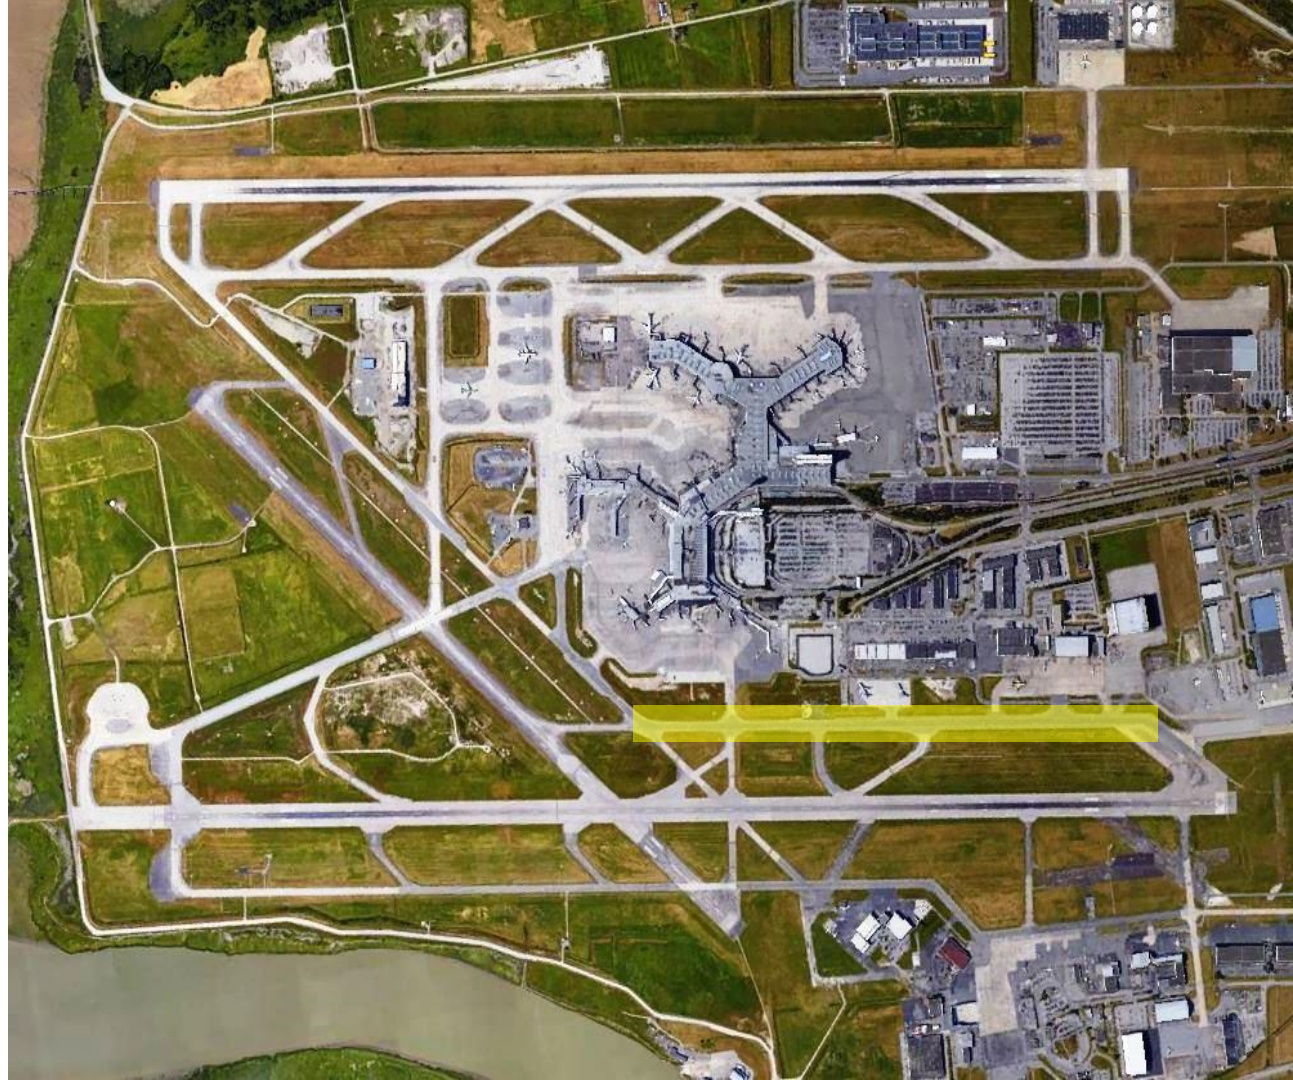
The Problems and Causes

Taxiway Delta, one of YVR's most vital arteries, required an unexpected repair.

Major ruts in pavement causing maneuverability issues for aircraft.

B777 using breakaway thrust to get out of ruts. Q400 deflecting pavement.

Direct Causes:

- Record-breaking hot summer in 2015
- Increasingly demanding aircraft mixes over recent years (160 wide-bodies per day; 16 B777's per day on Taxiway D)

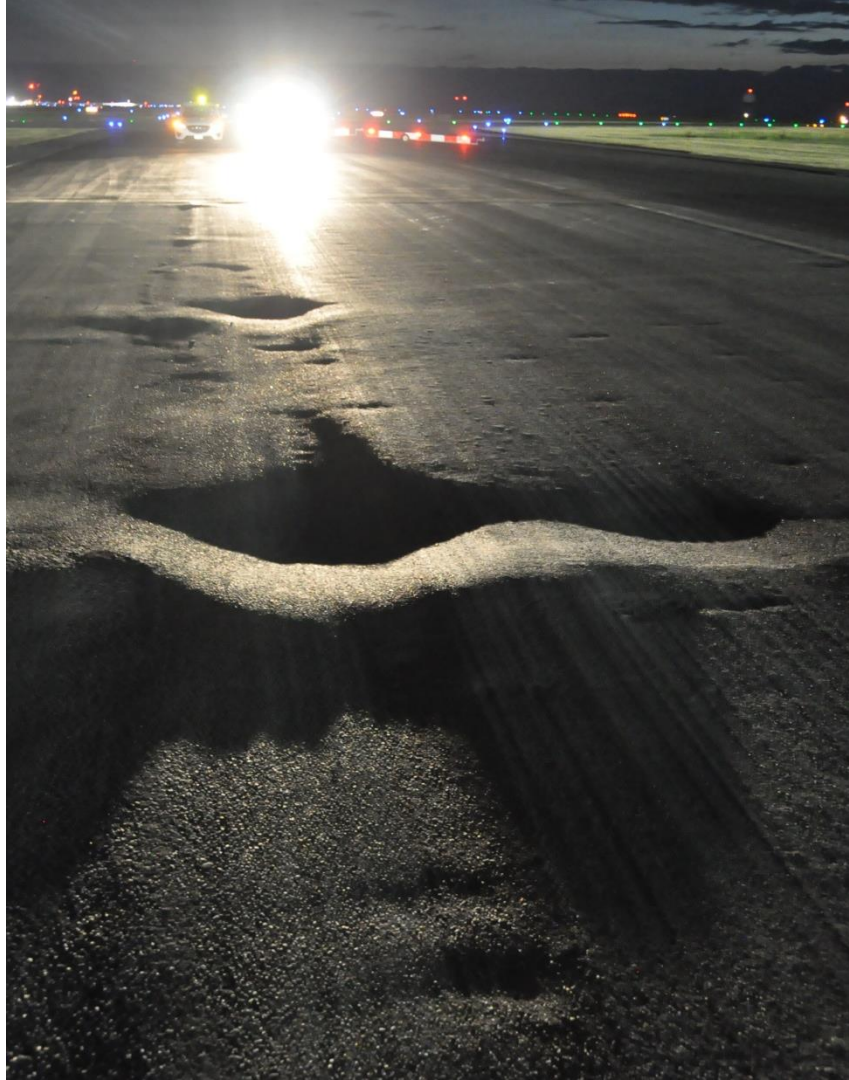
Pavement Loading and Hot Mix Ageing

- Pavement was not designed for increased heavy traffic (1960's vintage PCC: 360 mm + keyways , 150mm CGB, 460 mm river sand subbase, subgrade CBR=2-3% with 2+ HMA overlays)
- Select rigid ACN's : DC-8-62 (77), B747-400 (88), A380-800(110), B777-300ER (128) – for ICAO D Ultralow) - 66% increase.
- Extreme stripping in lower HMA layers

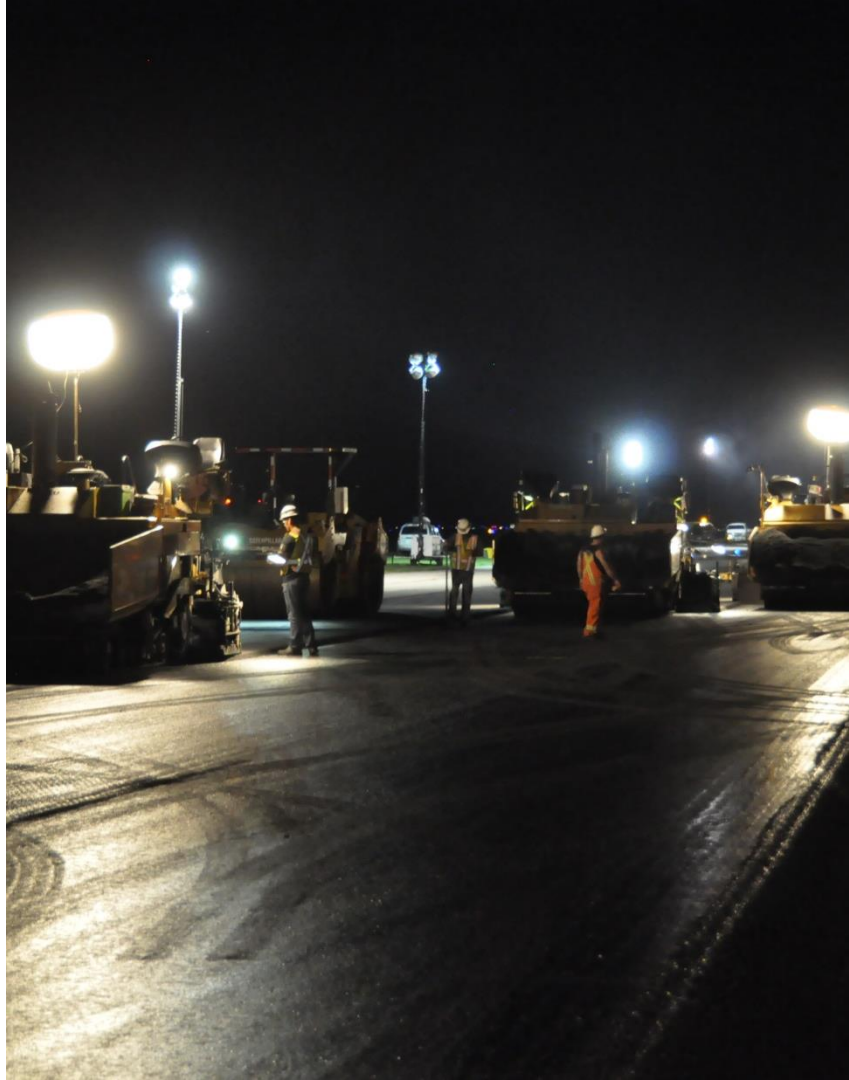
Challenges (2)

- Maintaining taxiway centreline paint markings
- Working around electrical infrastructure
- Constant adjustments to the milling depth was required to avoid grinding against the PCC surface below the asphalt overlay; this caused slower productivity.
