Runway 05-23 Rehabilitation

at Toronto Pearson International Airport

Presenter: Jessica Hernandez – Englobe, Kevin Chee – GTAA
Date: Sept 21, 2017
Location: 2017 SWIFT - Halifax

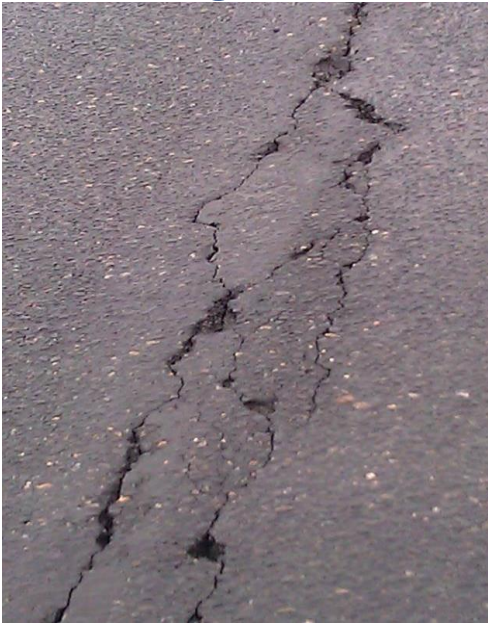
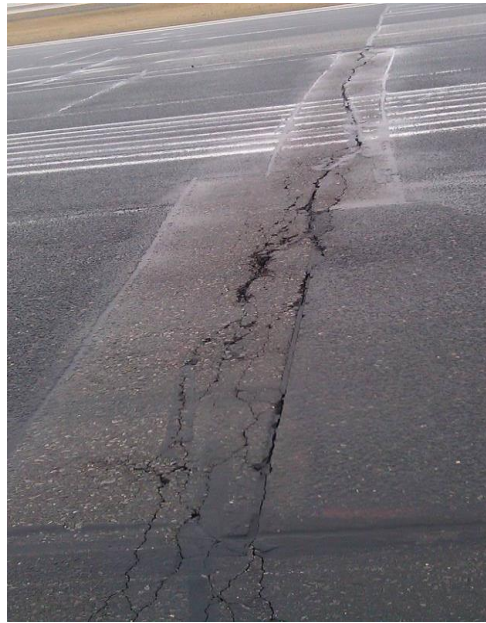
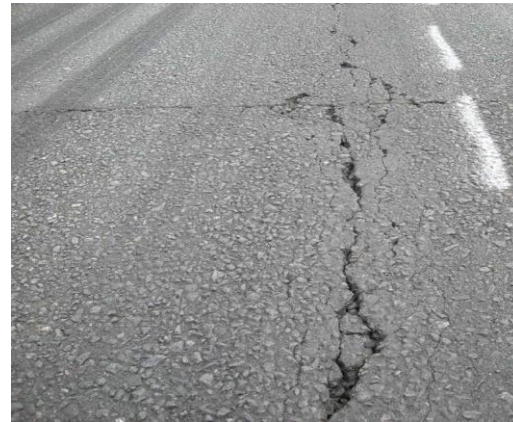
- Originally constructed in the early 50's as a concrete runway
- Extended, widened and overlaid in 1969, 1998 and 2004
- Runway west of 15R – experiencing multiple reflection cracking causing FOD concerns, slab faulting, localized alligator cracking, rutting along the wheel path area and aircraft ride quality issue near the intersection of Runway 15R33L
- Runway east of 15R – experiencing map cracking, transverse and longitudinal cracking, and rutting along the wheel path area

- The existing inset light cans were loose and sinking at various locations throughout the entire length of the runway
- Taxi H west of 15R – experiencing severe slab cracking and soft subgrade issues
- Taxi H east of Alpha taxiway – experiencing severe shoving twice within a year at the same location due to slow moving aircraft with stop and go movement

- Existing Pavement Condition Photos

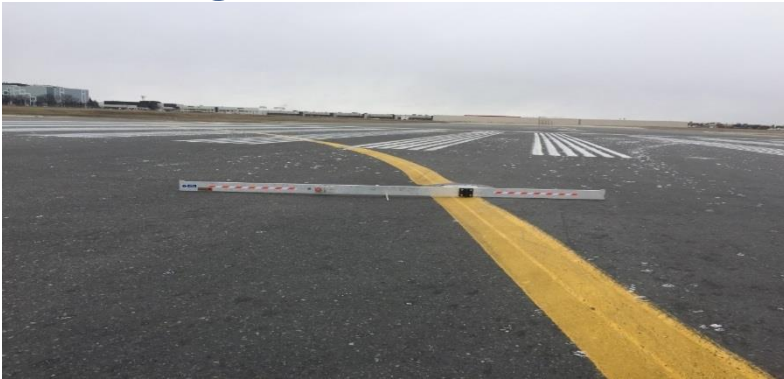
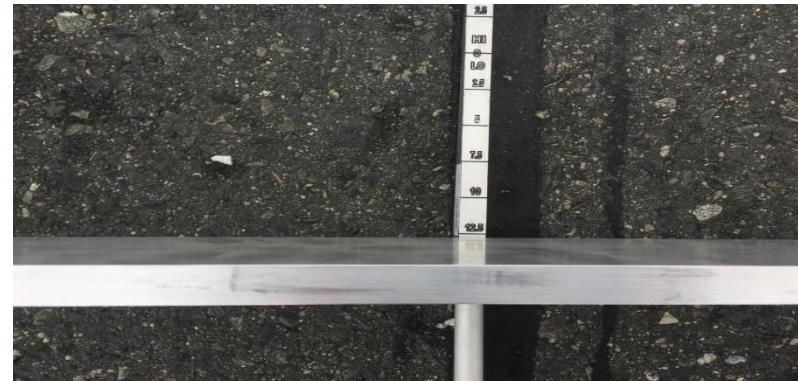
- Existing Pavement Condition Photos

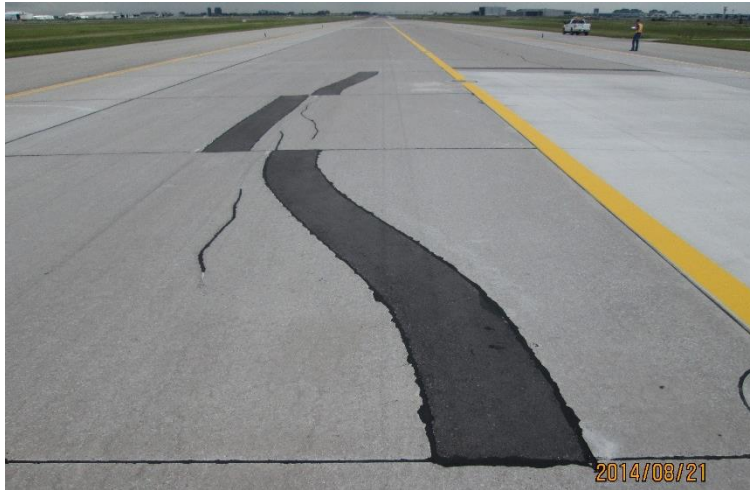
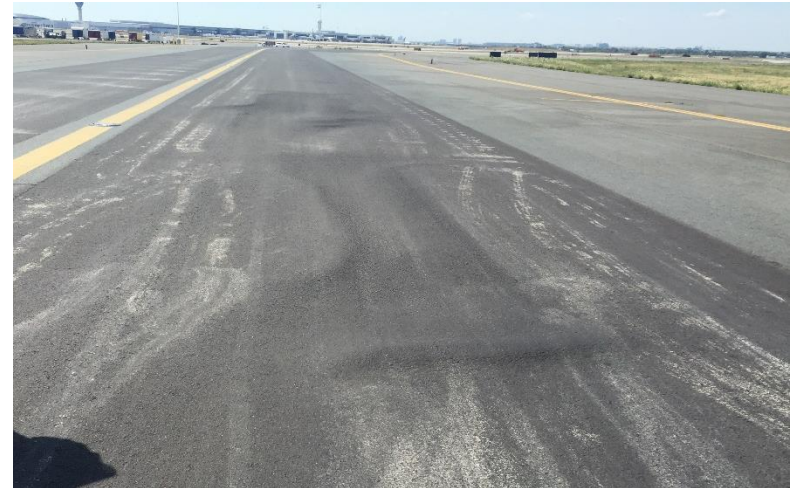
- Existing Pavement Condition Photos

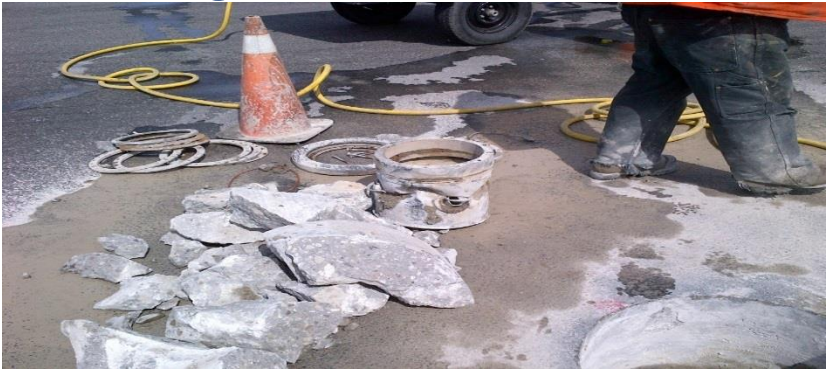
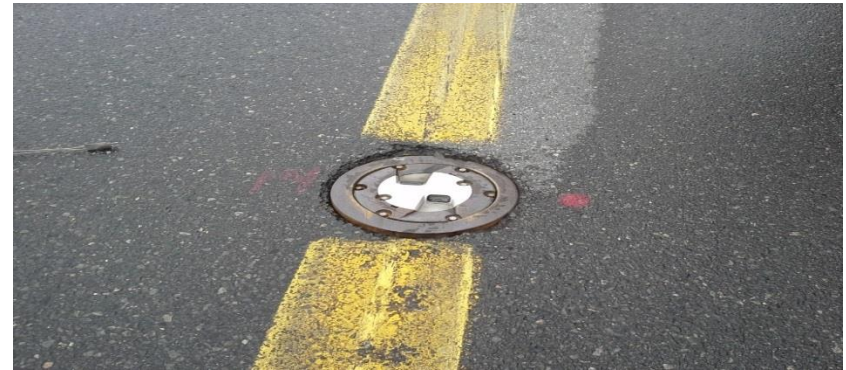
- Existing Pavement Condition Photos

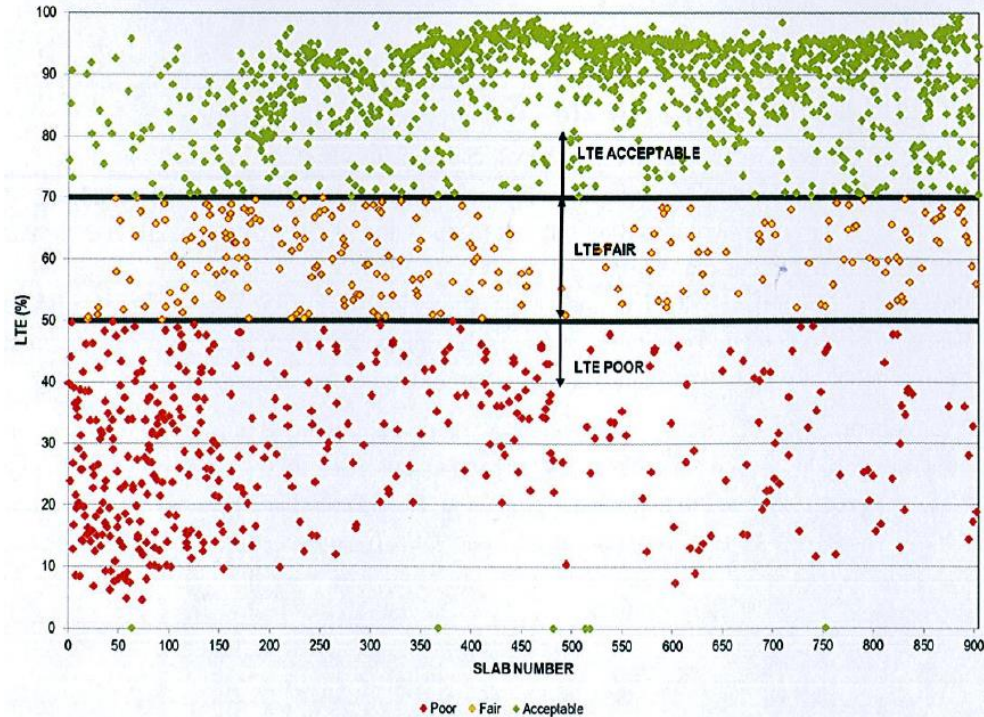
Figure 4 Load Transfer Efficiency at transverse Joints

LTE CONDITION	NUMBER OF TRANSVERSE JOINTS	PERCENTAGE (%)
Acceptable	1,135	62.8
Fair	235	13.0
Poor	432	23.9
Not Estimated	6	0.3
TOTAL	1,808	100

- ◆ The void detection analysis indicated the presence of voids or soft spots under some slab panels (101 of 904 slab panels tested, or 11 percent)

- ◆ **Joints where voids/soft spots were identified:** Underslab grouting (to fill voids under the slabs and in the CSB)
- ◆ **Joints with Load Transfer Efficiency (LTE) less than 60%:** Load transfer restoration techniques (dowel bar retrofit using 35 mm diameter, 600 mm long dowels at 450 mm spacing)

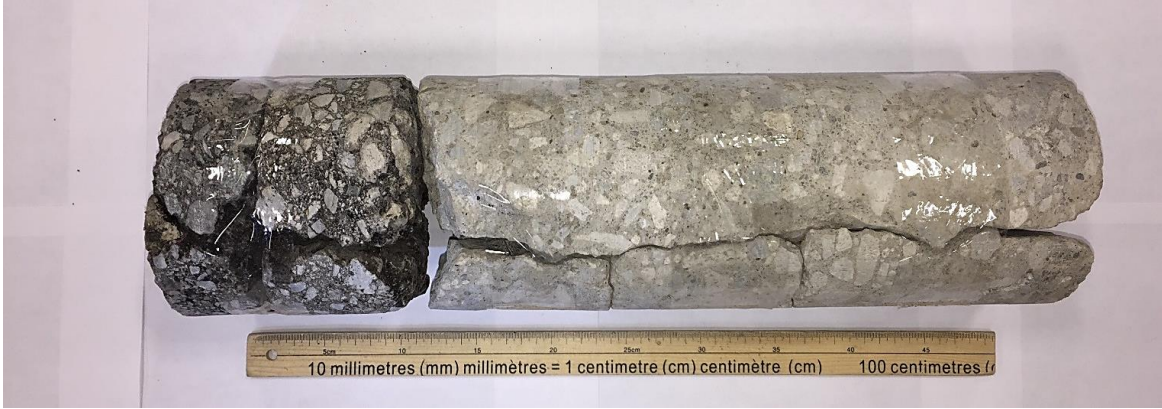
Coring

- Core advanced through a transverse joint, located in a Poor Load Transfer Efficiency (LTE) Slab Panel
- No intact cement stabilized base was observed/recovered during coring operations
