**PG Binder Test Section
Calgary International Airport
Second Year Technical Analysis**

PG Binders for Canadian Airport Pavements
Calgary Field Trial

**PG BINDER TEST SECTION
CALGARY INTERNATIONAL AIRPORT
SECOND YEAR TECHNICAL ANALYSIS**

Project No. 0104-00-22756

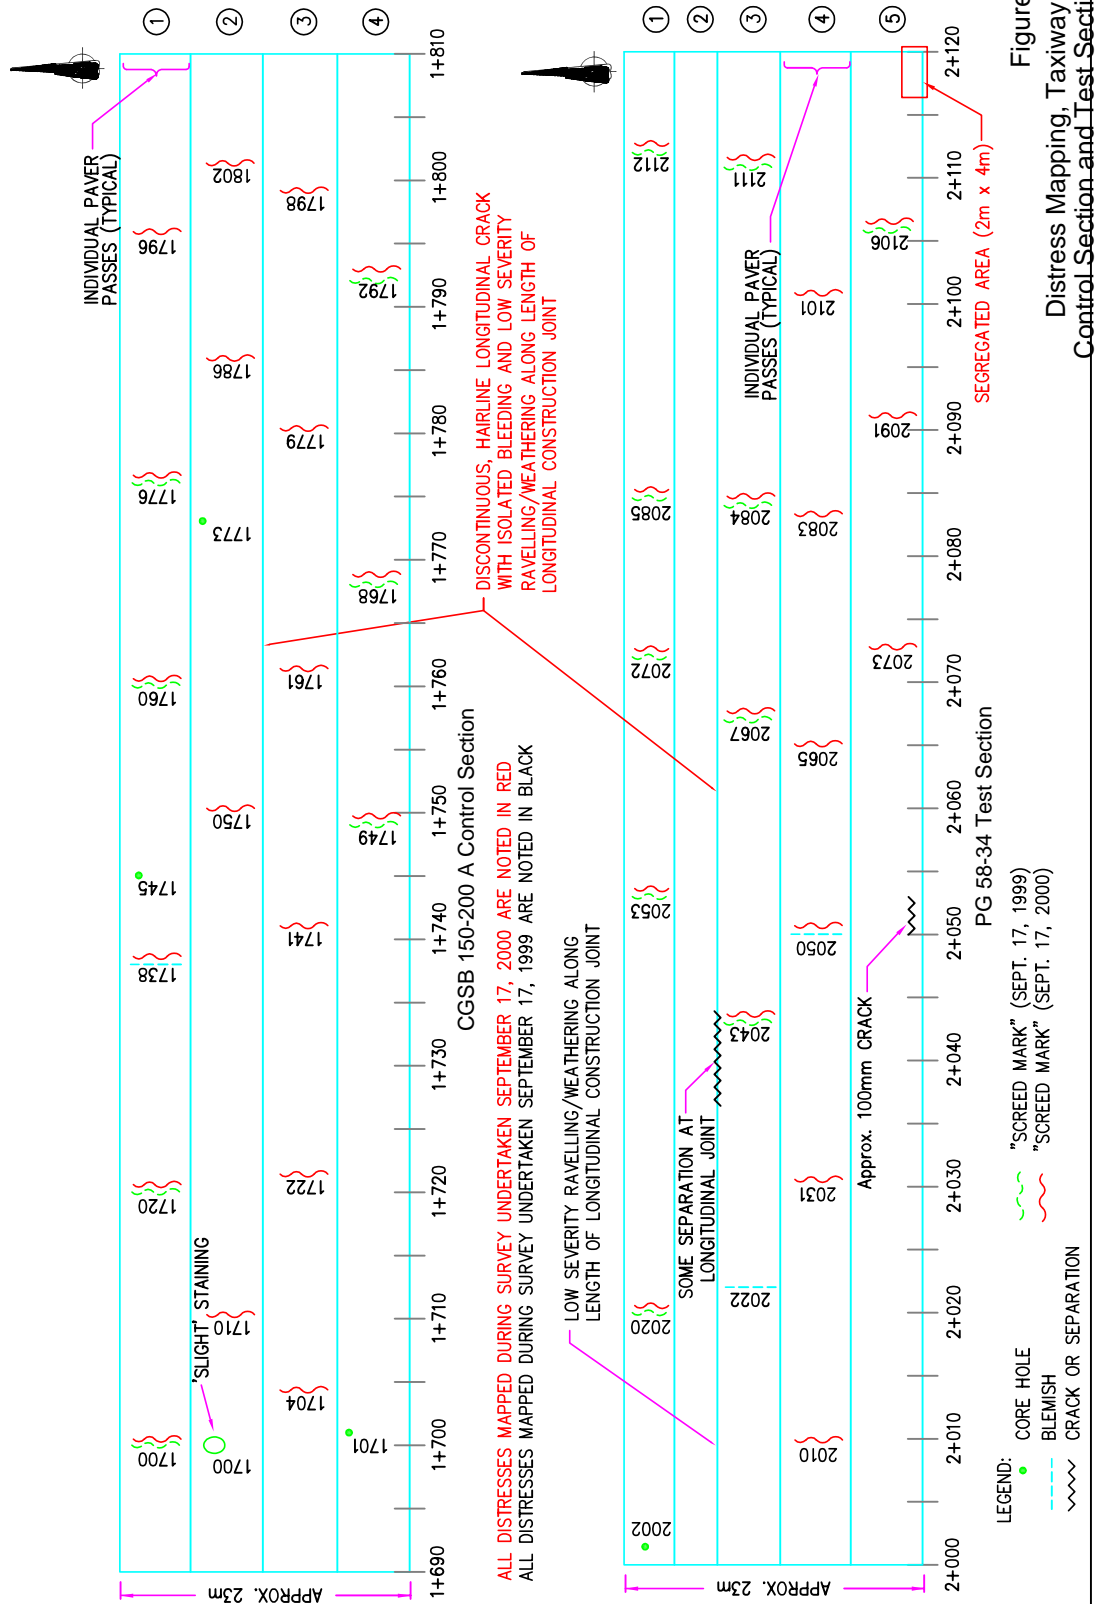
The observed distresses are mapped in Figure 2.

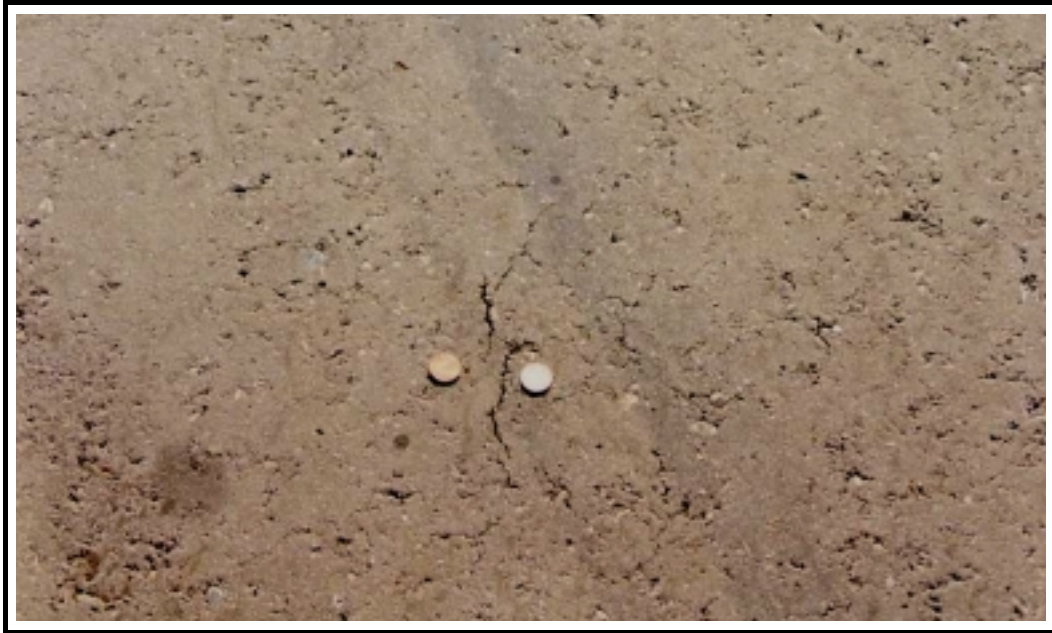
Photo 1 Very minor crack in PG Binder Test Section (~2+050) - September 1999

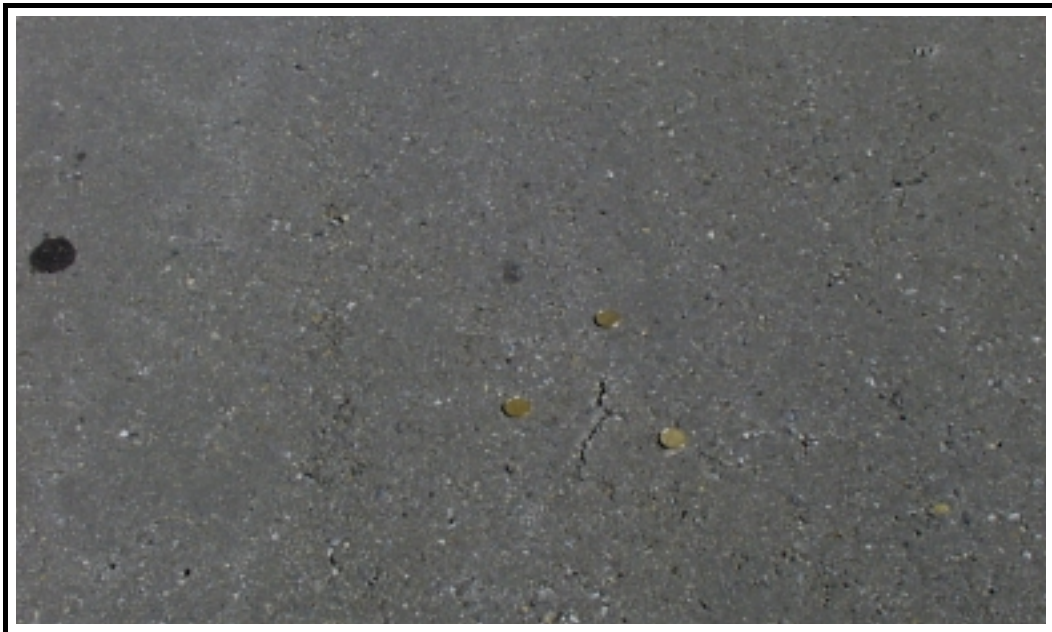
Photo 2 Very minor crack in PG Binder Test Section (~2+050) - September 2000

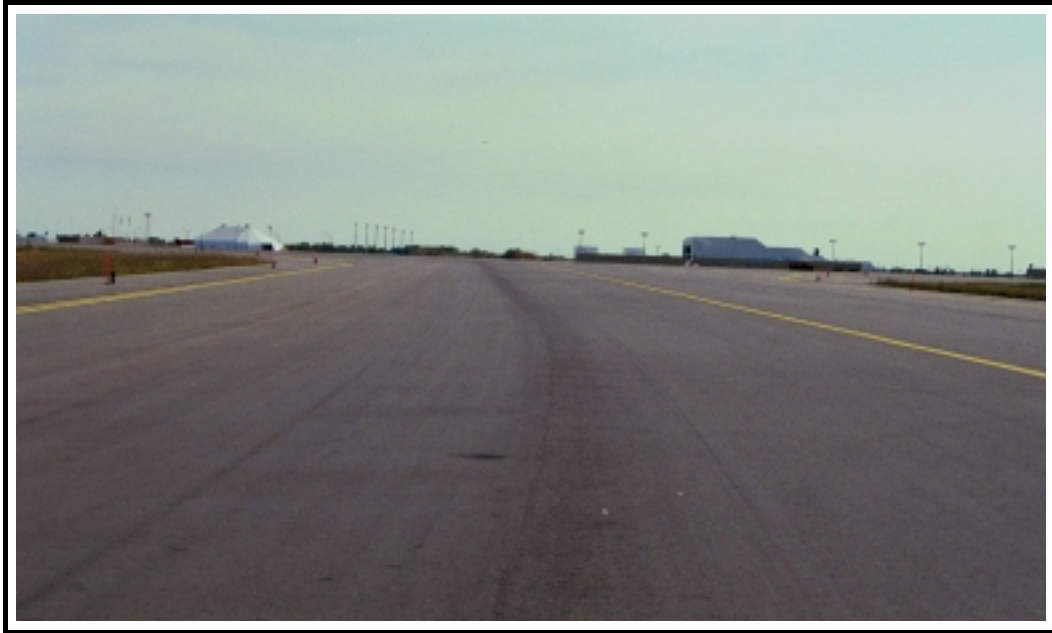
**Photo 3 Low severity ravelling/weathering along longitudinal joint
in PG Test Section - September 1999**

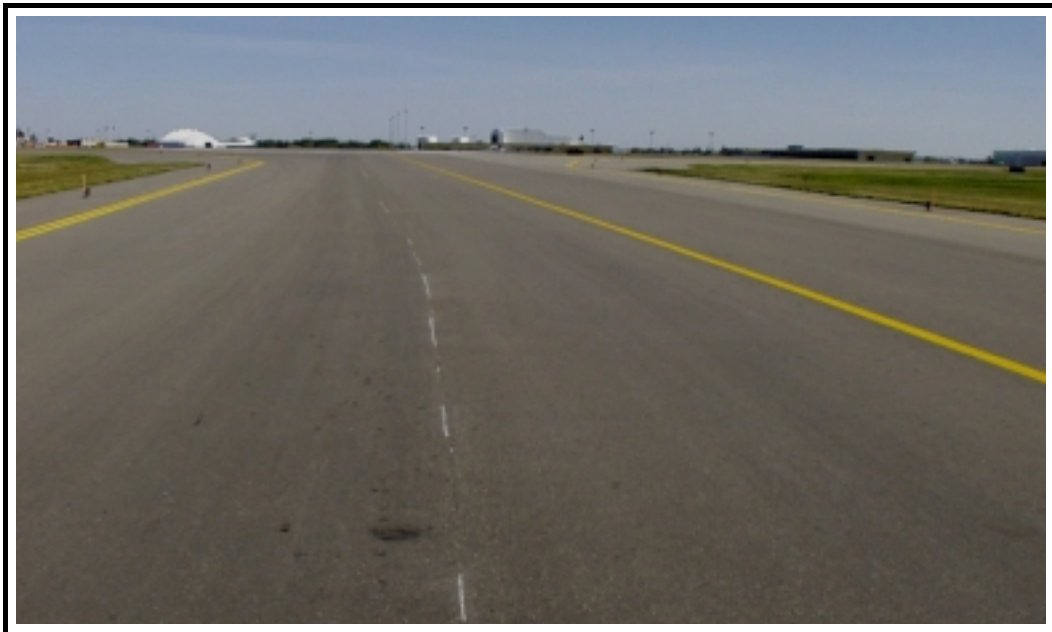
Longitudinal cracking was observed along the longitudinal construction joint between mats two and three (Photo 4). The crack was hairline in width (Photo 10) and discontinuous and was recorded as low severity.

**Photo 4 Low severity ravelling/weathering along longitudinal joint
in PG Test Section - Chalk highlights hairline crack at longitudinal joint
September 2000**

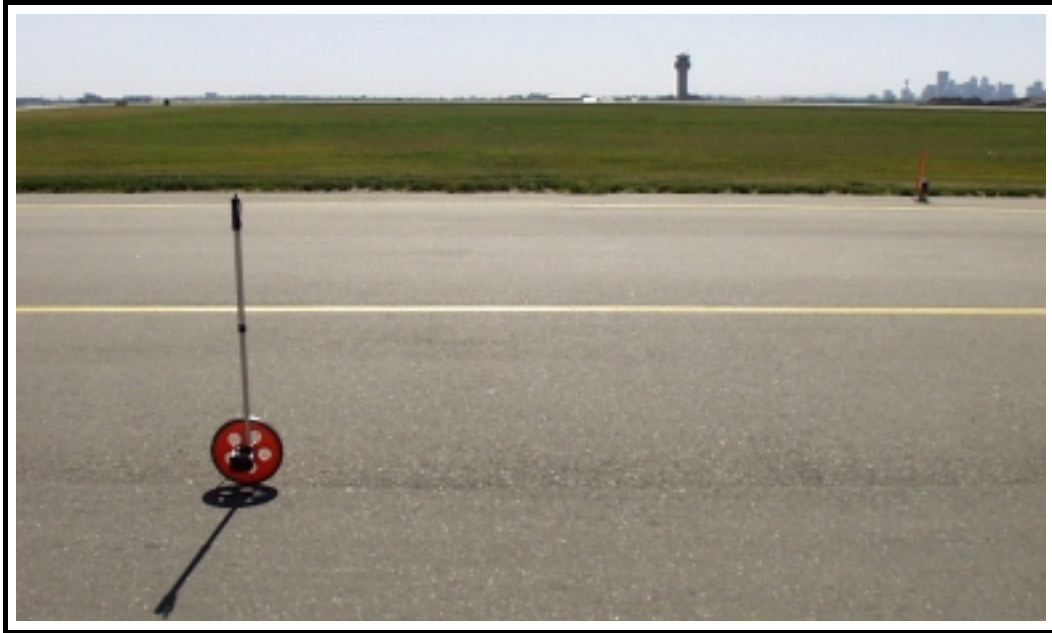
Additional ravelling was measured along the longitudinal joint between mats two and three which was considered as a distress for the purpose of the PCI determination (Photo 5) and was recorded as low severity. The width of ravelling was estimated at about 0.5 m which was less than the 1.5 m estimated in 1999; this is considered due to the overall general surface weathering.

**Photo 5 Low severity ravelling/weathering along longitudinal joint
in PG Test Section - September 2000**

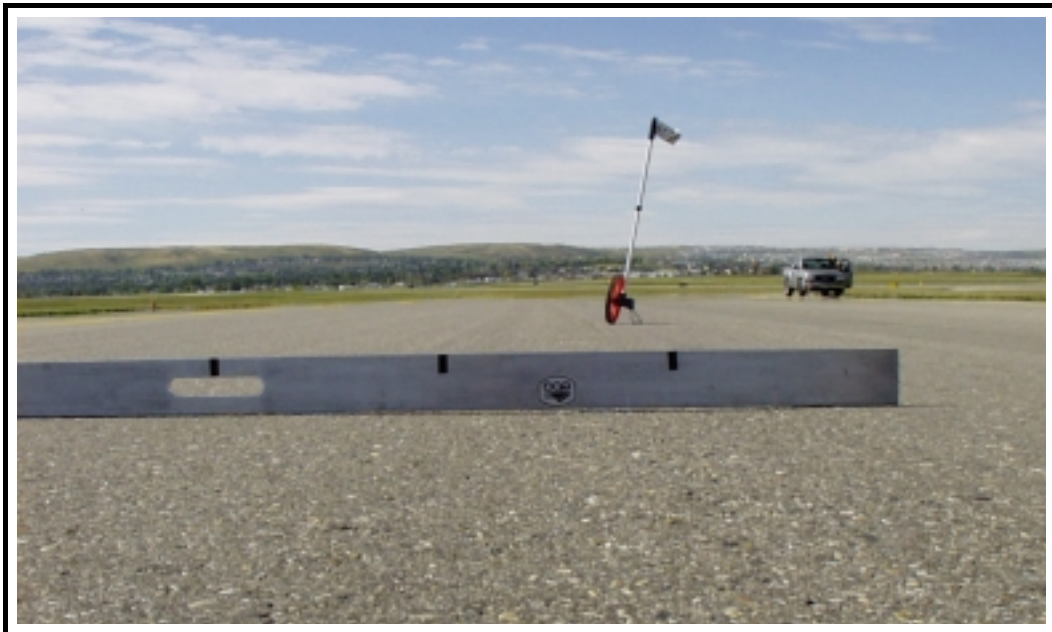
A depression was measured at one location along a longitudinal construction joint (Photo 6). This depression was less than 3 mm and was not visible without very close scrutiny. This depression was considered to be related to construction. It did not count as a distress for the purpose of PCI determination.

**Photo 6 Very minor depression along longitudinal joint with low
severity ravelling/weathering in PG Test Section - September 2000**

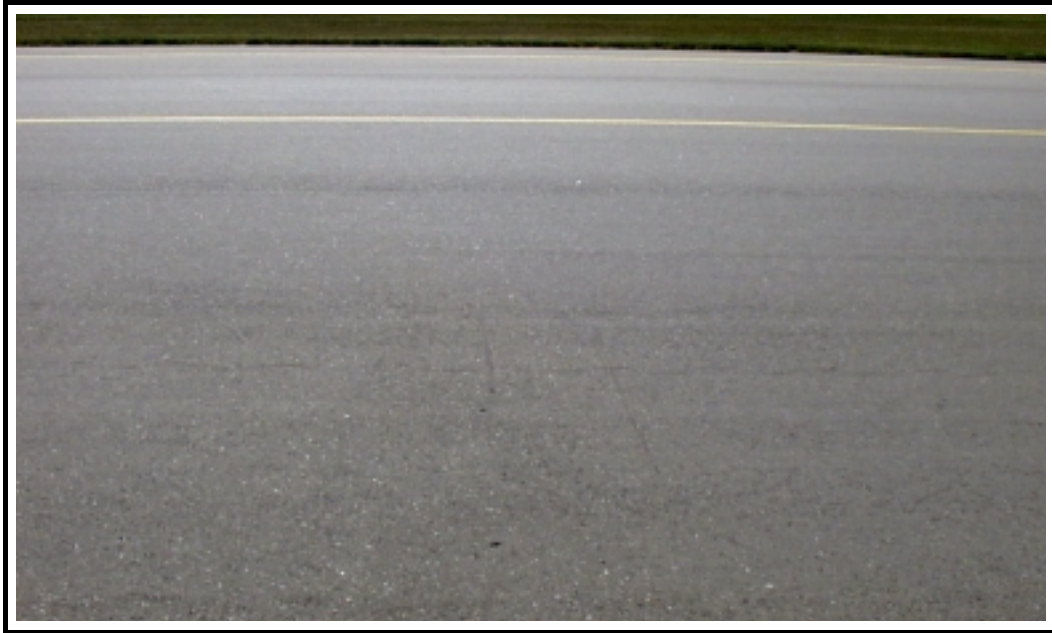
Transverse marks were attributed to the paver screed on all mats (Photo 7). These screed marks, observed in 1999, were less discernible in 2000 and were considered a blemish and did not count as a distress for the purpose of PCI determination.

Transverse marks were attributed to the paver screed which did not count as a distress (Photo 7).

Photo 7 Example of screed mark in PG Test Section (also represents screed marks in Control Section) - September 2000

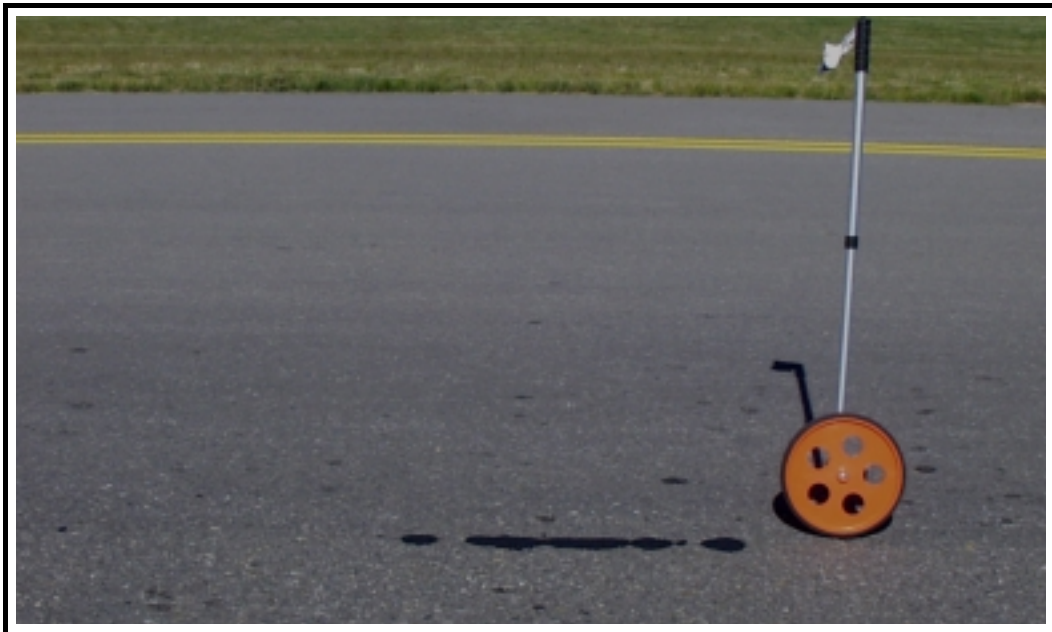
At isolated locations some minor bleeding at the crack was observed (Photo 8 and Photo 14). The bleeding observed was not extensive enough to cause a reduction in skid resistance and did not count as a distress for the purpose of PCI determination.

At isolated locations some minor bleeding was observed (Photo 8 and Photo 14). This was not extensive enough to cause a reduction in skid resistance and was not counted as a distress.

**Photo 8 Minor bleeding along longitudinal joint in PG Test Section
September 2000**

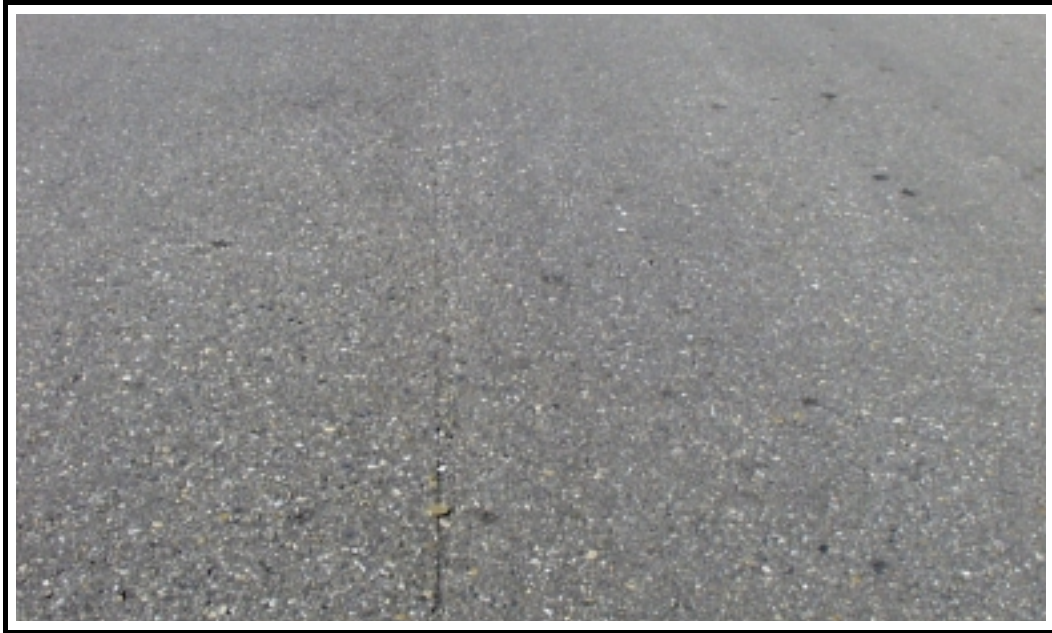
**Photo 9 Hairline crack at saw cut longitudinal joint in PG Test Section (~2+110)
(also represents Control Section) - September 2000**

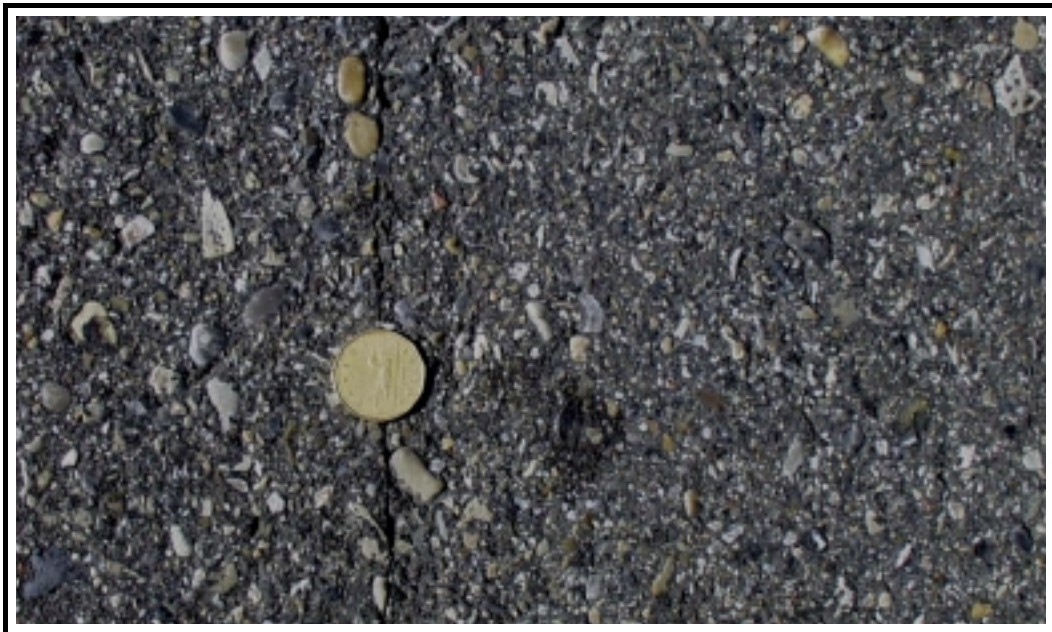
Longitudinal cracking was observed along the longitudinal construction joint down the centre of the taxiway (Photo 15). The crack was hairline in width (Photo 10) and discontinuous and was recorded as low severity.

The PG Test Section (HMAC Utilizing PG58-34) was exhibiting very minor ravelling/weathering over the total area (Photo 10). As with the Control Section, this weathering was manifested by the loss of fine sand-size aggregate from the pavement surface.

**Photo 10 Close-up of hairline crack at saw cut longitudinal joint
in PG Test Section (~2+110) (also represents Control Section)
September 2000**

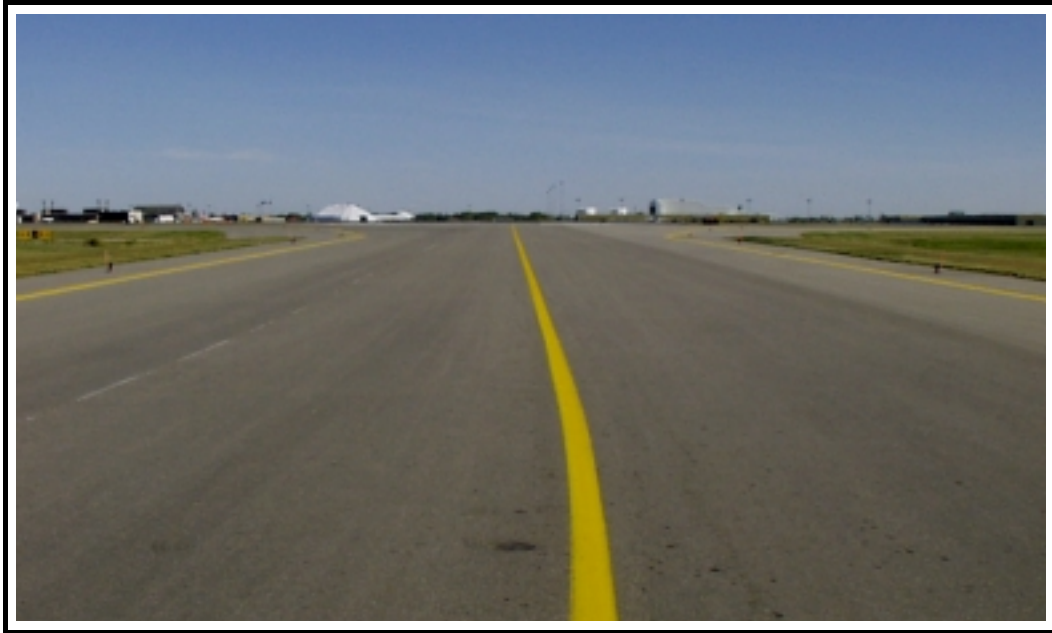
Photo 11 General condition of PG Test Section - September 2000

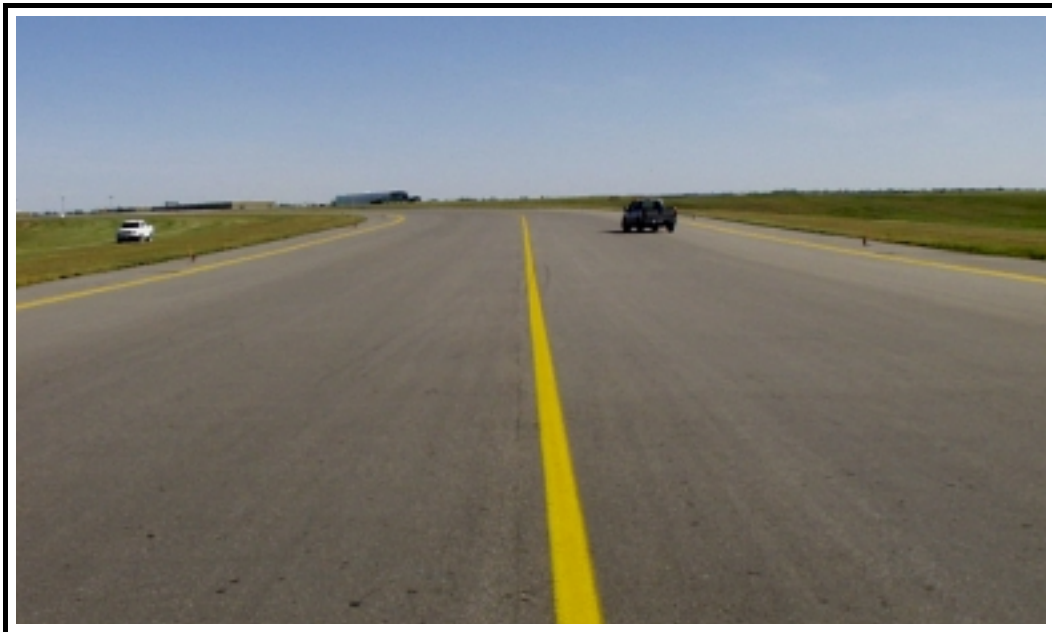
Photo 12 General condition of Control Section - September 2000

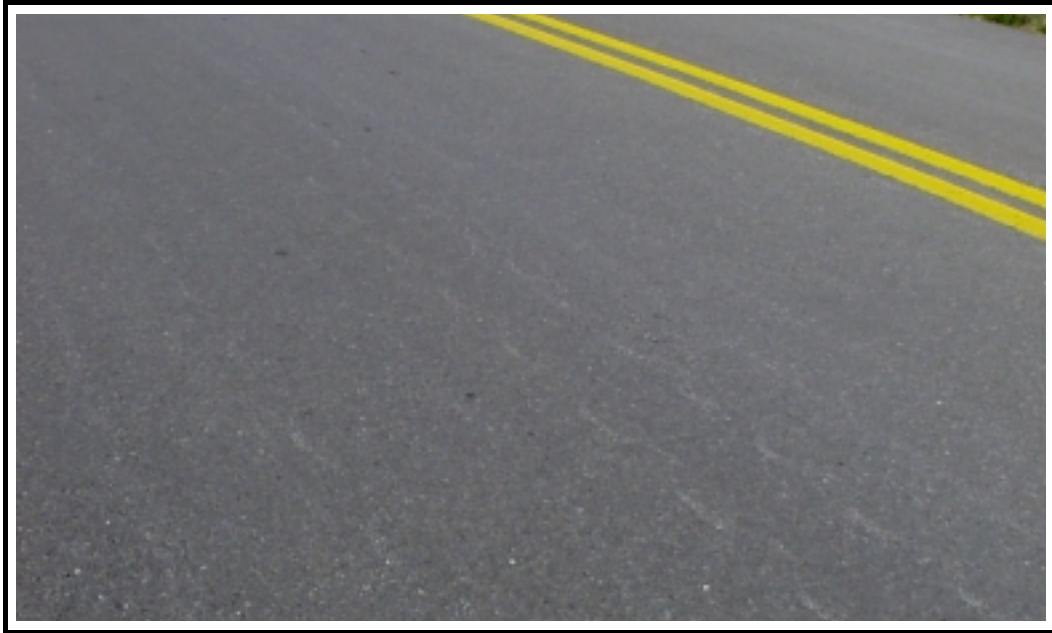
Some surface marks that could have been caused by brooming operations (Photo 13) were observed. These marks were considered blemishes and did not count as a distress for the purpose of PCI determination.

Photo 13 “Broom Marks” in Control Section - September 2000

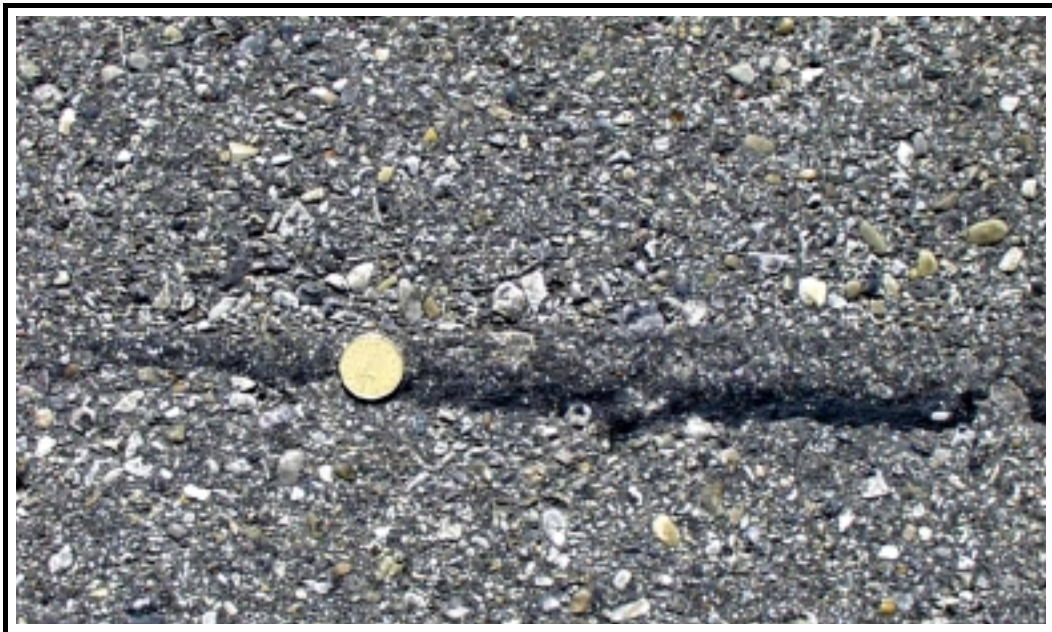
The CGSB Control Section (HMAC utilizing CGSB 150-200A asphalt) was exhibiting very minor ravelling/weathering over the total area (Photo 14). This weathering, which was considered normal for a two year old pavement, was manifested by the loss of fine sand-size aggregate from the pavement surface and did not count as a distress for the purposes of PCI determination.

**Photo 14 Minor bleeding at saw cut longitudinal joint in Control Section
September 2000**

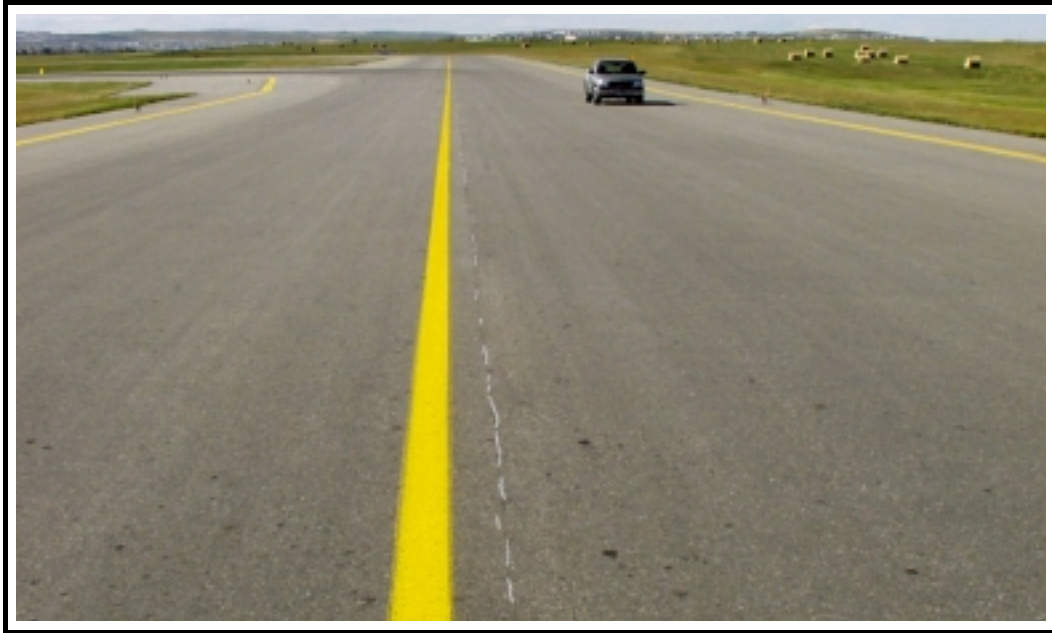
**Photo 15 Chalk highlights hairline crack at longitudinal joint in Control Section
September 2000**
