Airfield Pavement Forensic Investigations

CAPTG – 2022 Montréal

Airfield Pavement Forensic Investigation

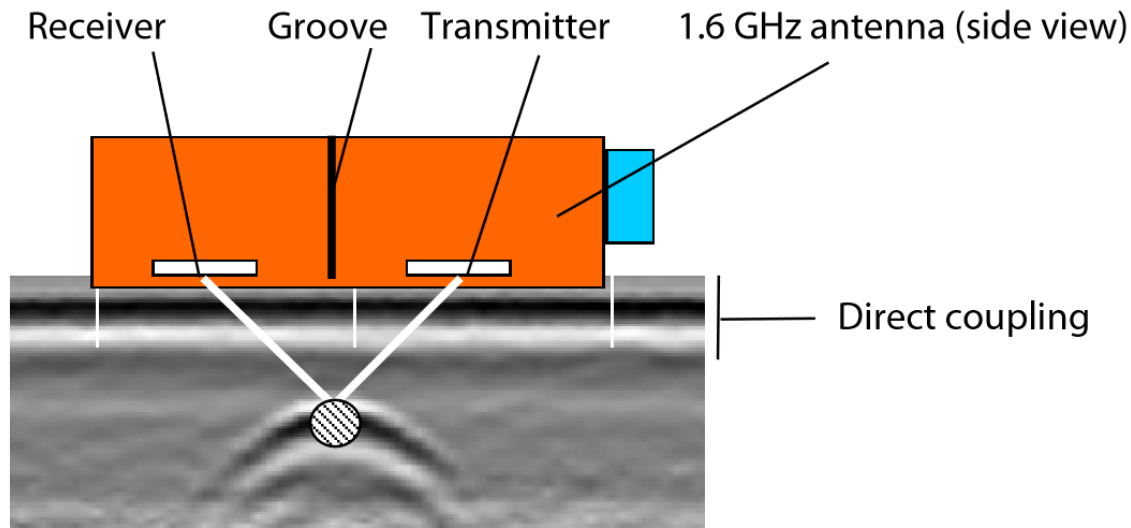
Void Detection

- Ground-Coupled GPR (400 MHz and/or 1,600 MHz antenna)
- Air pockets that the GPR signal cannot penetrate
 - Ex. Beneath concrete at approaches to a structure
 - Ex. Beneath the concrete at the joint

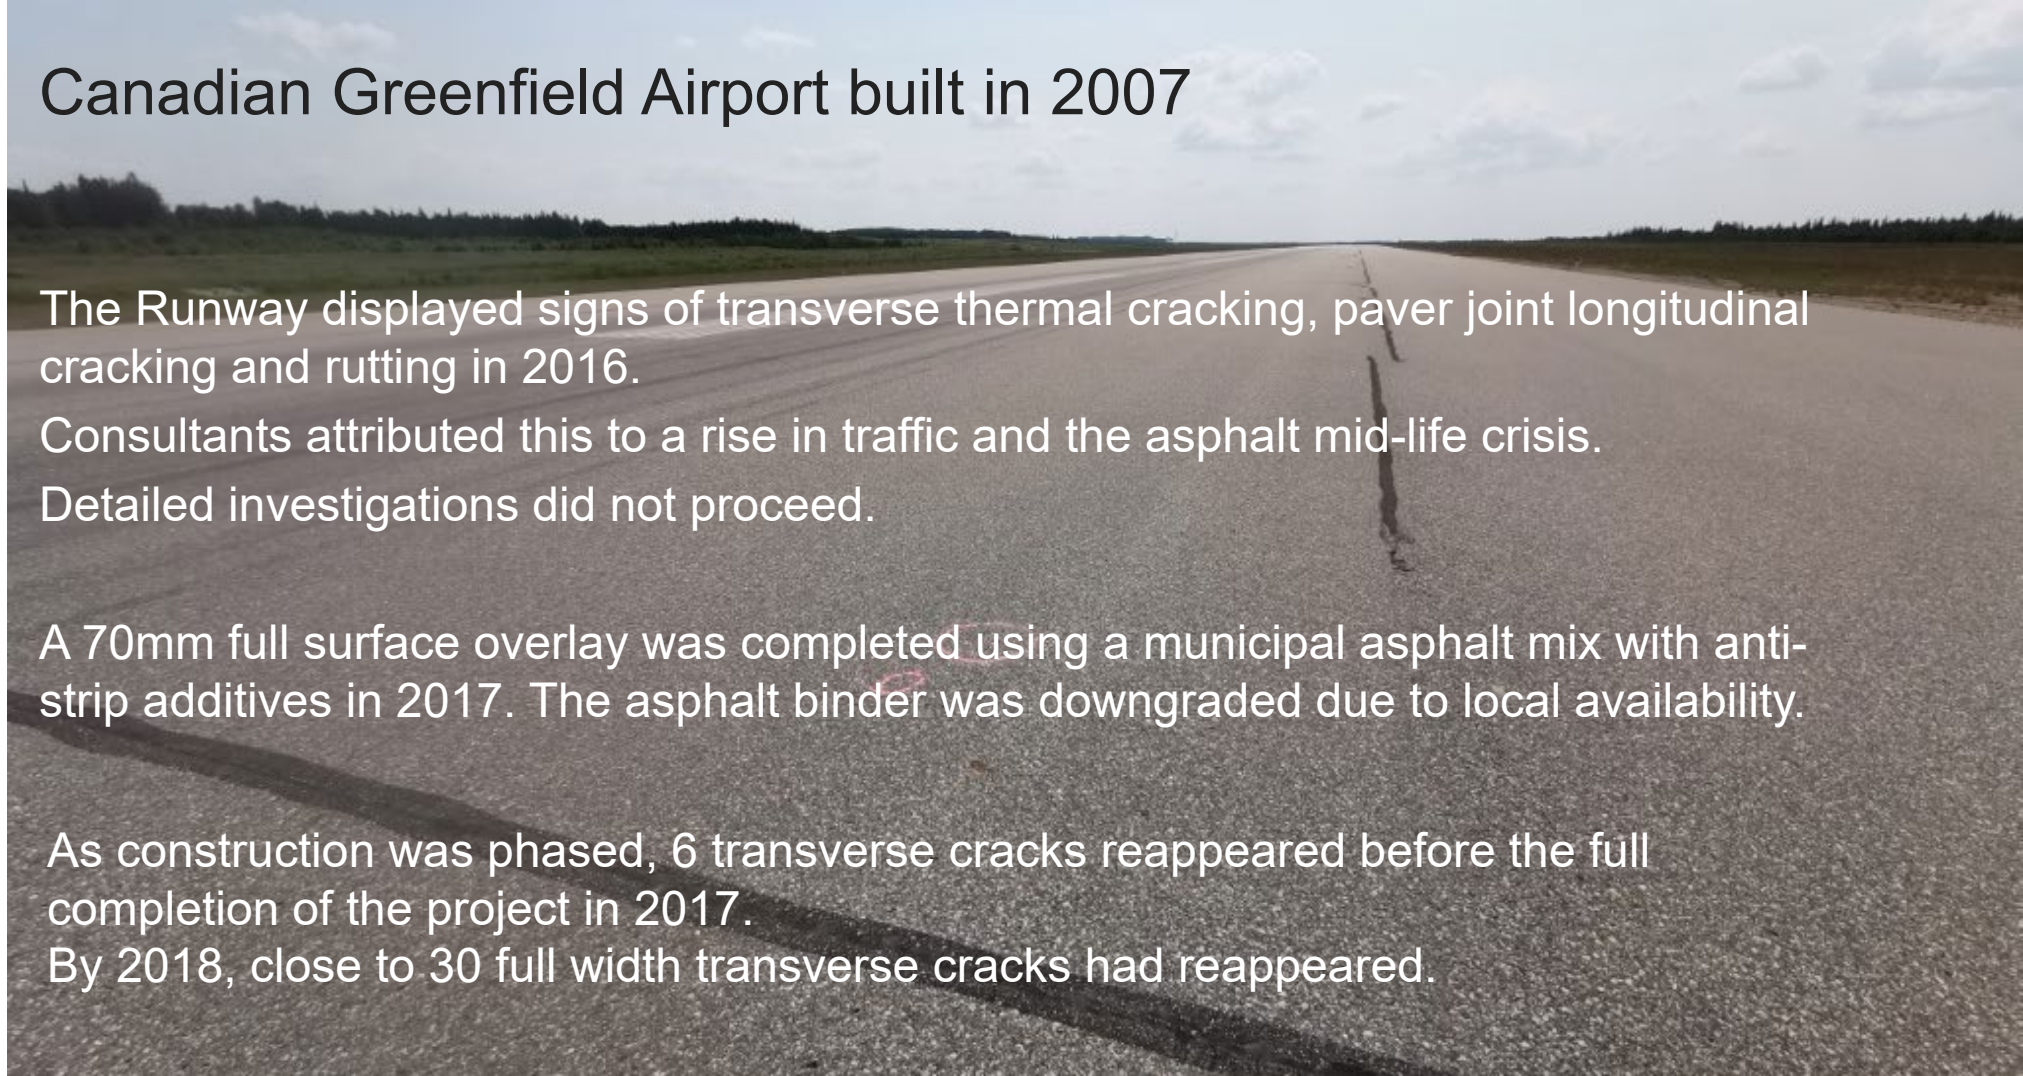
The Runway displayed signs of transverse thermal cracking, paver joint longitudinal cracking and rutting in 2016.

As construction was phased, 6 transverse cracks reappeared before the full completion of the project in 2017.

By 2018, close to 30 full width transverse cracks had reappeared.

A 70mm full surface overlay was completed using a municipal asphalt mix with anti-strip additives in 2017. The asphalt binder was downgraded due to local availability.

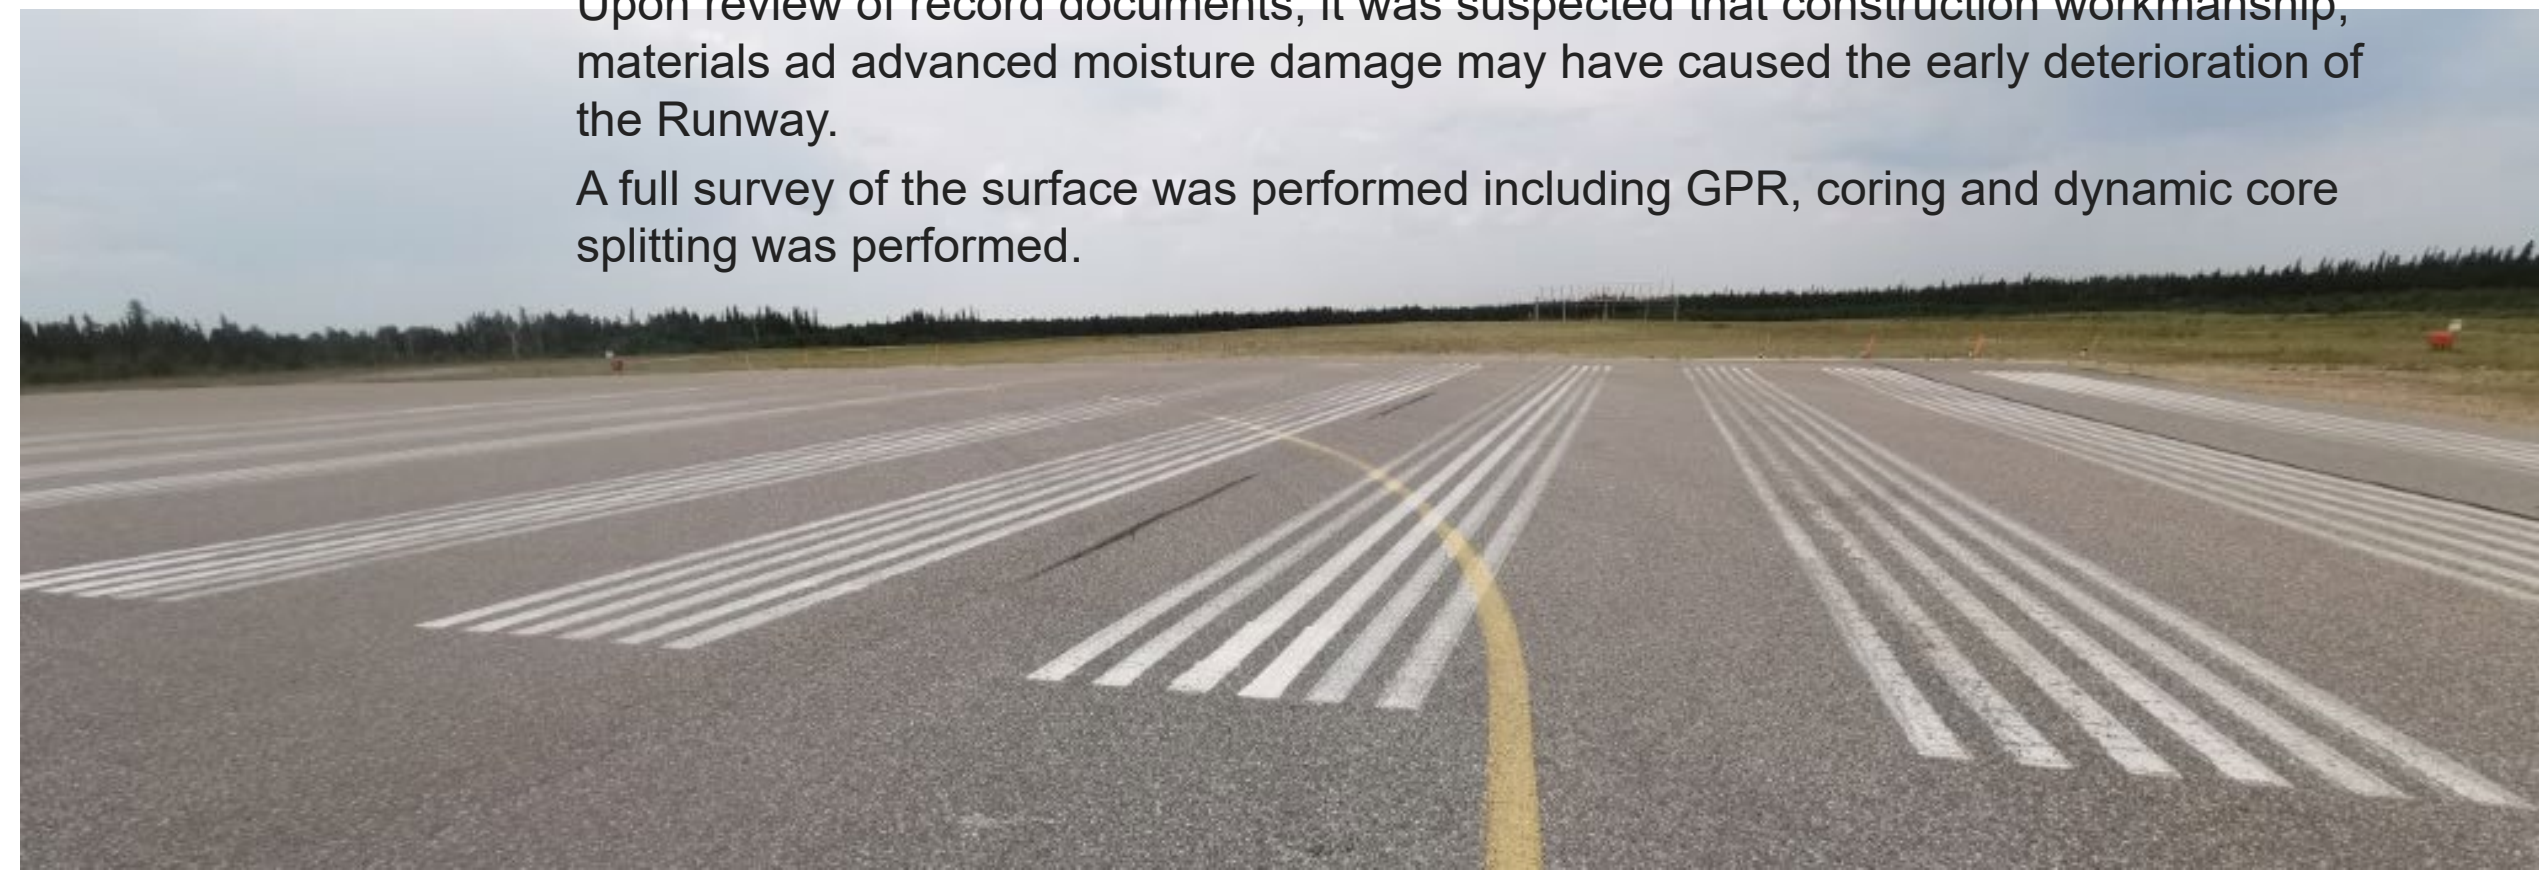
Upon review of record documents, it was suspected that construction workmanship, materials and advanced moisture damage may have caused the early deterioration of the Runway.

A full survey of the surface was performed including GPR, coring and dynamic core splitting was performed.

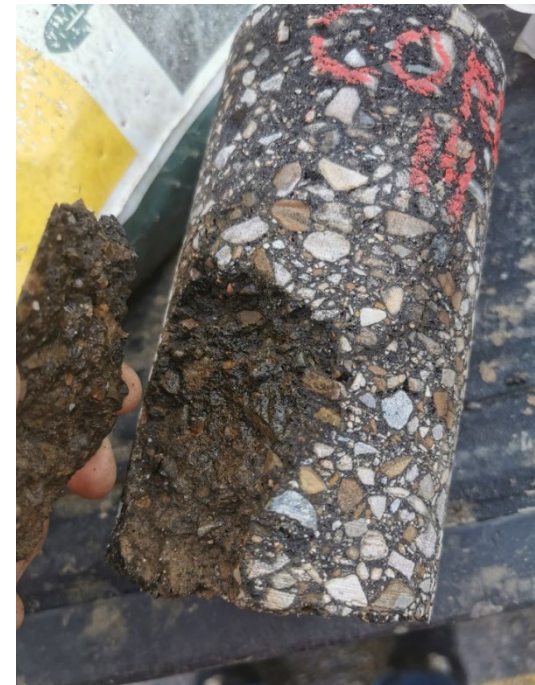
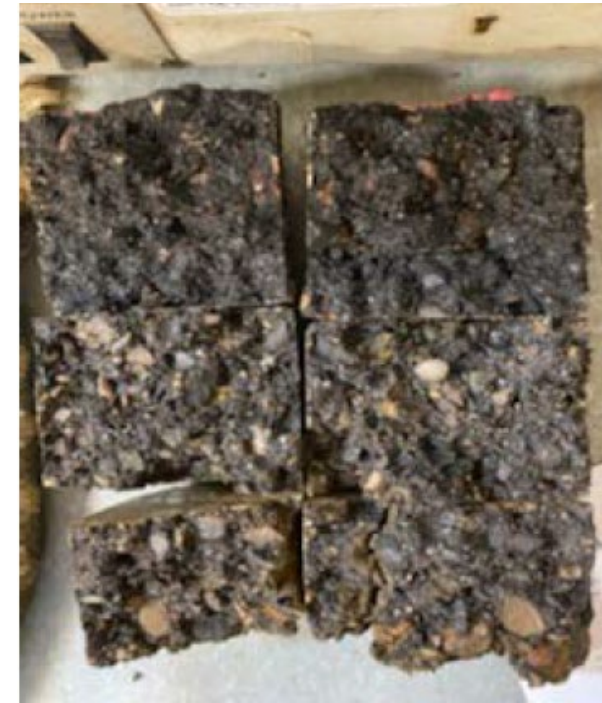
The GPR investigation revealed that the runway pavement layers were relatively consistent in thickness. However, the base gravel layer was generally thinner than expected from project records.

Looking closely at split cores, it was evident that the original asphalt had advanced moisture damage issues.

The cause of the distresses were therefore attributed to the quality of materials and stripping.

The 2017 overlay had no chance to survive through its expected life-cycle.
