USING IMAGERY TO COLLECT ASSET MANAGEMENT DATA

at Toronto Pearson International Airport

Presenter: Alain Duclos, MSc., P.Eng.

Location: SWIFT 2023 - Winnipeg

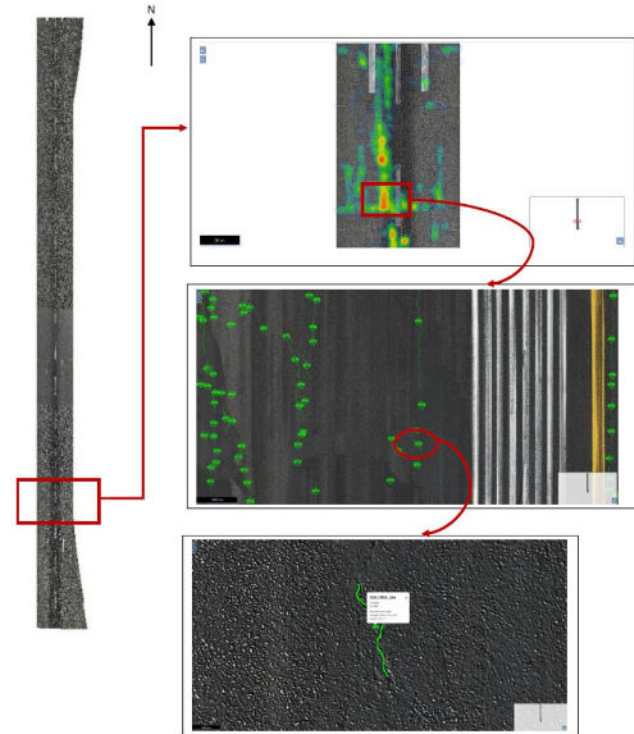
Example of Cracking Defects-2mm GSD

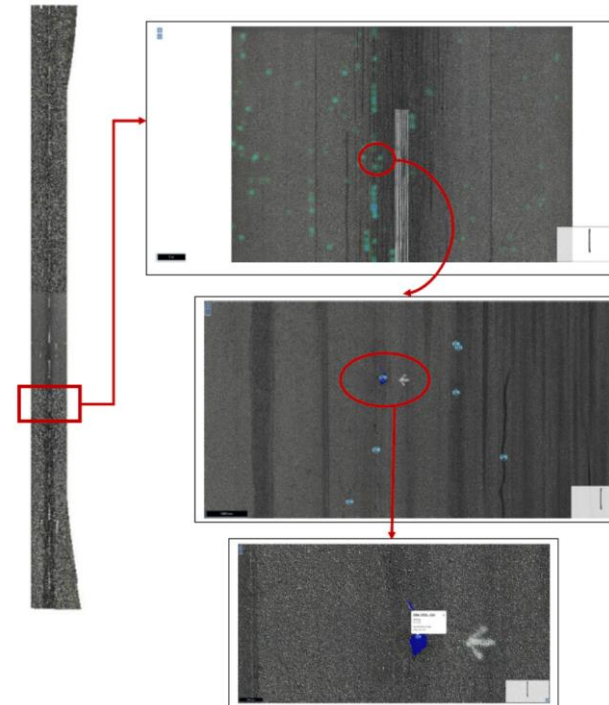
Example of Spalling Defects-2mm GSD

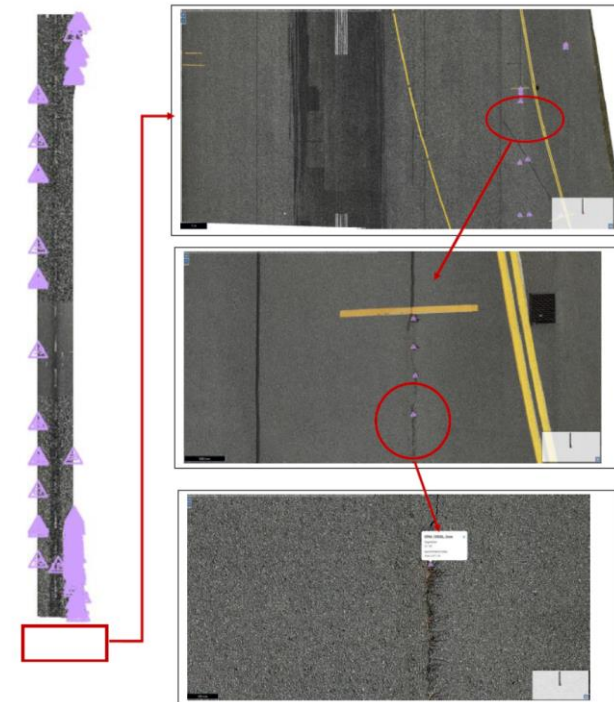
Example of Vegetation Defects-2mm GSD

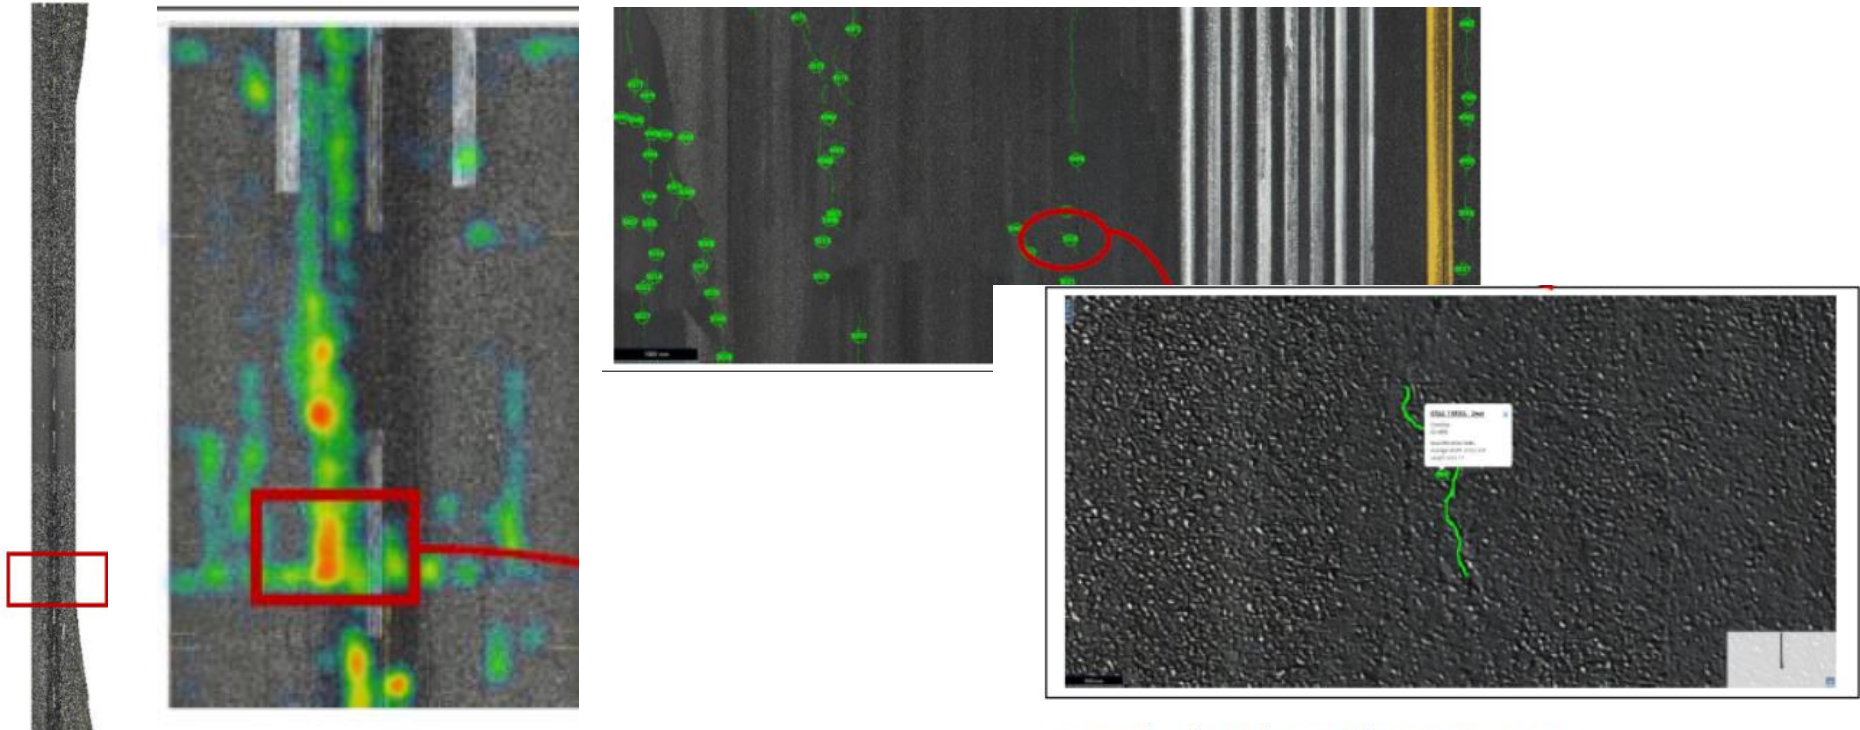
Example of Cracking Defects-2mm GSD
