Airfield Pavement Rehabilitation Planning *“Choosing the right fix”*

Rob McLure, M.Eng., P.Eng. Senior Associate
Hatch Mott MacDonald

Case Studies for: Effective Pavement Rehabilitation Strategy Development

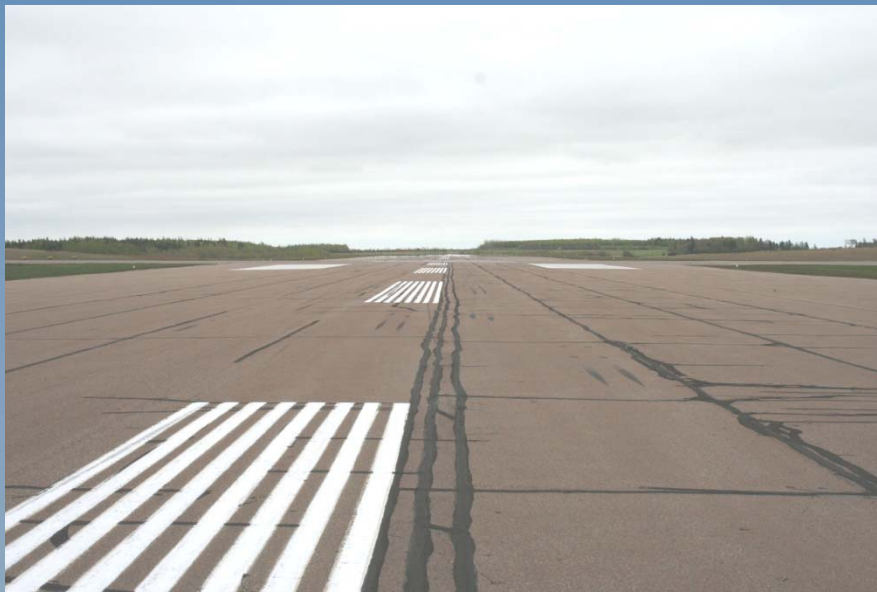
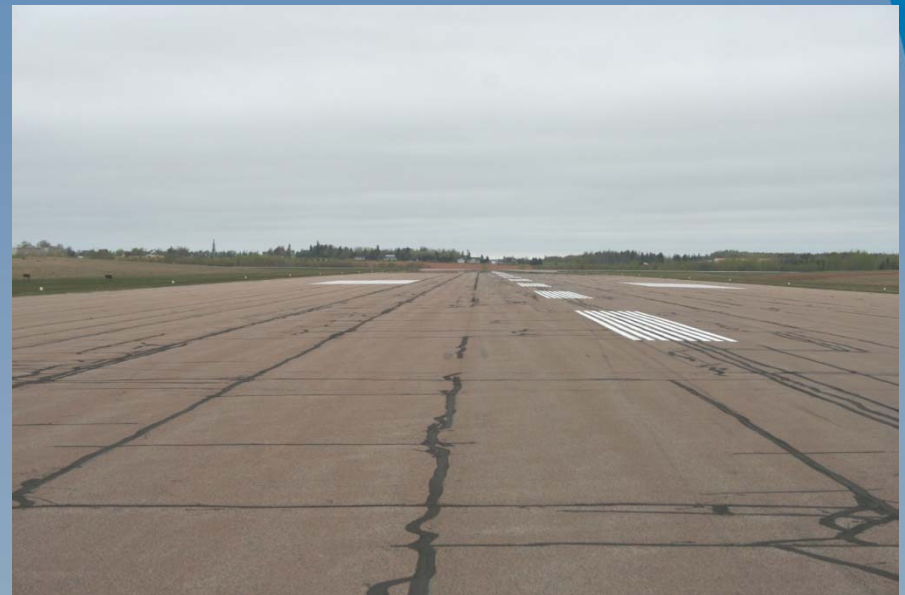
- **Runway 10-28 has excellent crown and experiences no drainage concerns.**
- **The edge drain system was recently sampled by video and revealed a system in excellent condition.**
- **The surface exhibits extensive longitudinal cracking along paving joints. These longitudinal cracks have an average width of 10mm.**

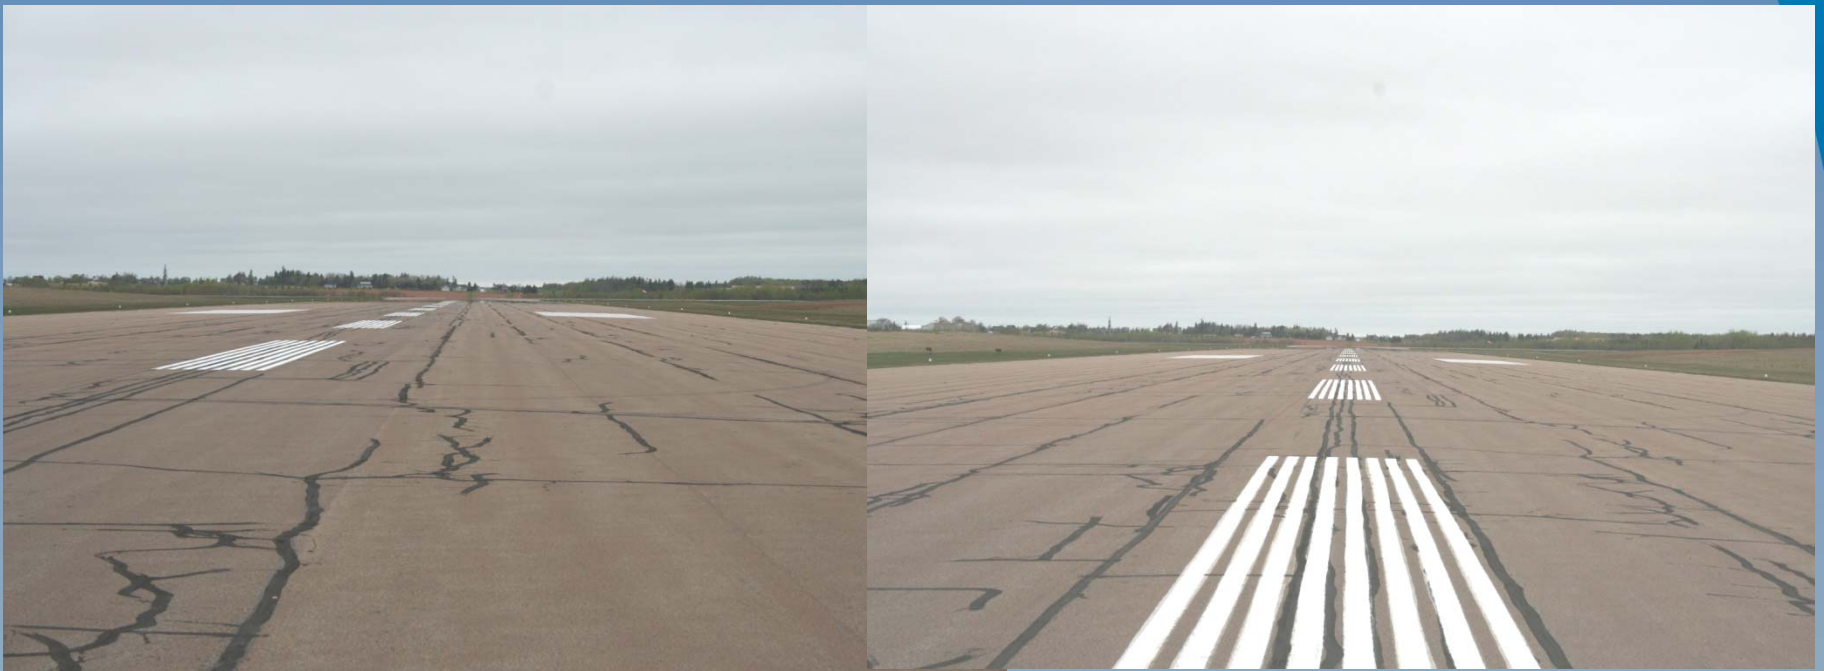
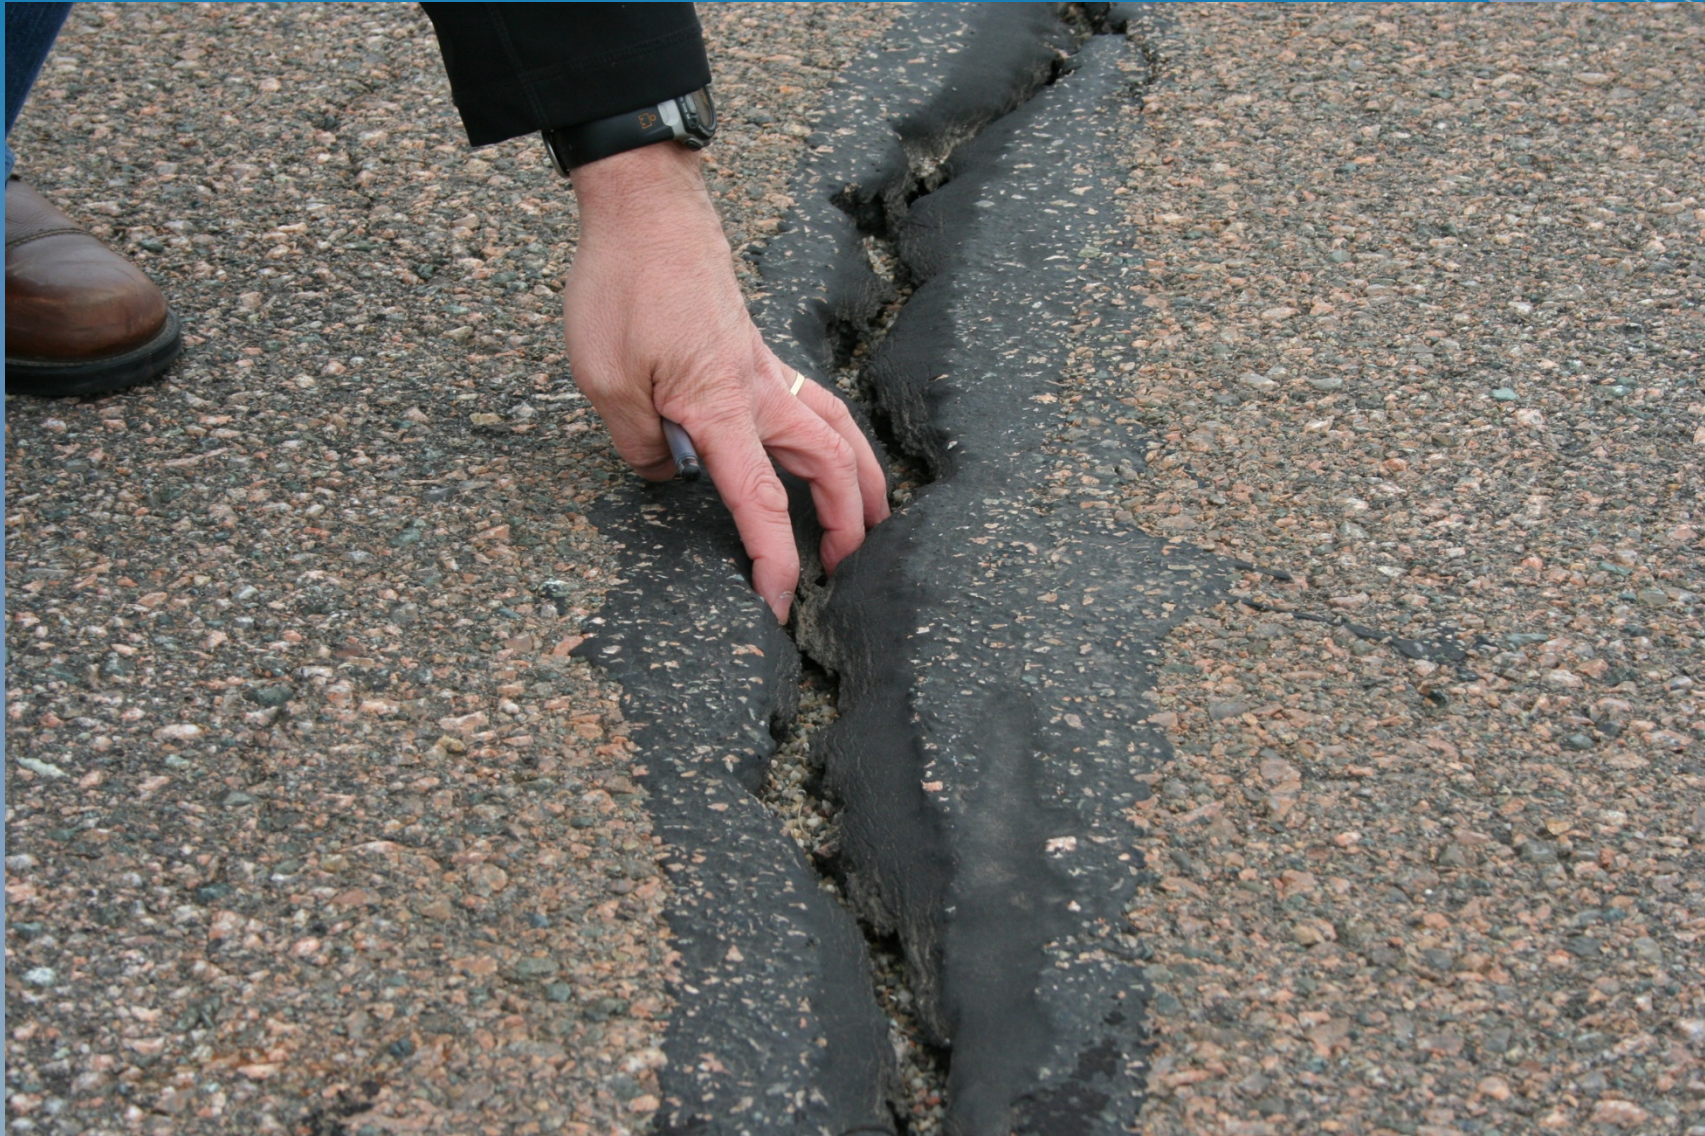
Major Transverse Cracking!!

- The transverse cracks are more pronounced on the north end of the runway and average 9 meter spacing with a coverage of 50% north of runway 03-21 and 25% coverage on the south end.
- The transverse cracks are severe and the average width is 15mm. Over 50% of the major cracking and transverse cracking occurs in the centre 30m width of the runway.

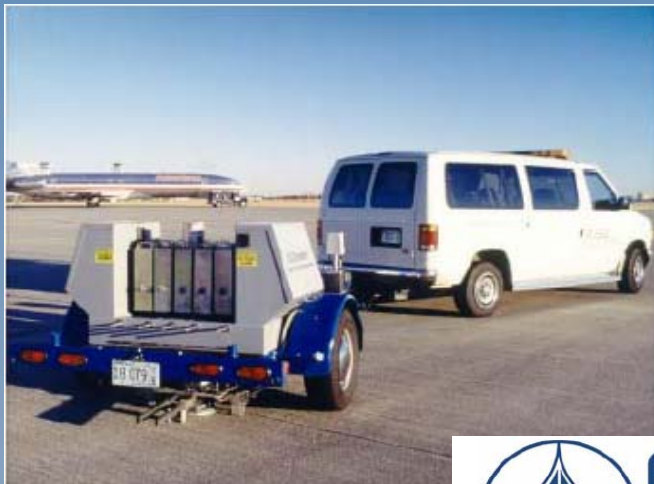
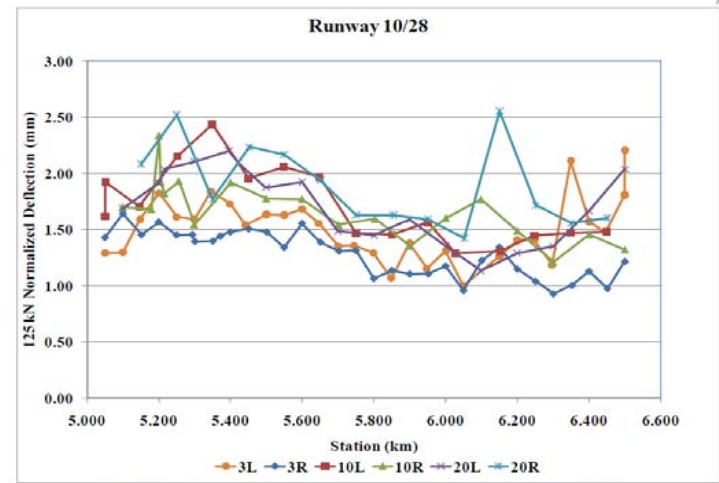
3. Normalized (125 kN) Deflection Analysis Results - Runway 10-28.

- **Confirmed structural strength**
- **Weak load transition across the system**
- **All surface repairs, age and functional**
- **The strategy will involve;**
 - **Reduction of runway width and focus on the centre**
 - **Mill 30-50mm (to be determined) to a 45 meter width**
 - **Mill all deep cracks 300mm wide and pad with AC**
 - **Remove 30m width total 100 mm depth of AC (15 meters each side of centreline)**
 - **Pave 70mm of AC in the centre 30m strip**
 - **Pave 30-50 mm AC overlay 45 meters wide the entire length of runway.**
 - **Replace edge lights**
 - **Total Cost \$5.5M (savings of \$1.5M)**

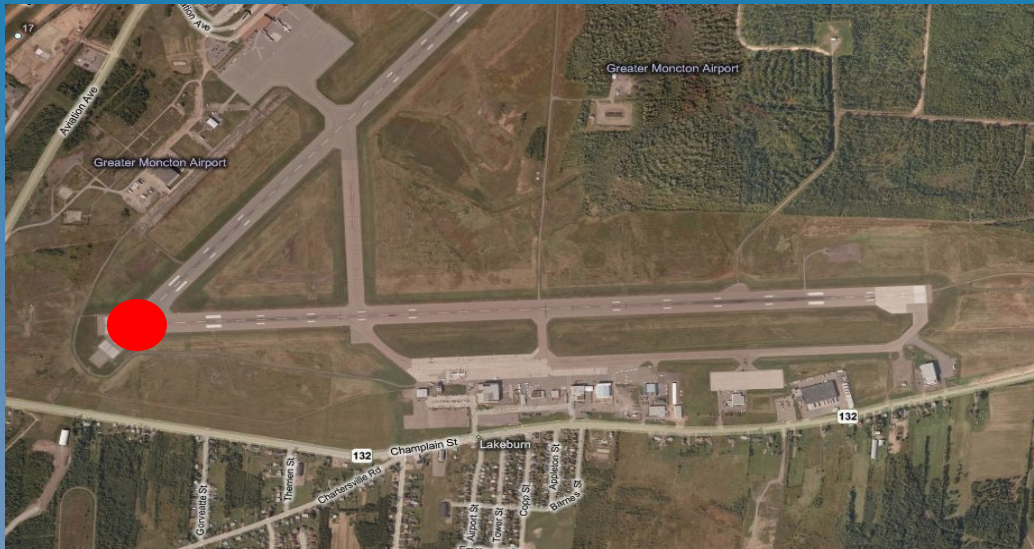
Runway Intersection

- Exhibiting Numerous Surface Distresses
- Elastic Modulus of Asphalt is Low
- Structural Integrity was found to be acceptable using the HWD.
- Most Cracking is Not Associated with structural Failure.

Remove Existing Asphalt Full Depth and Repave in Order to Address the Soft Asphalt.

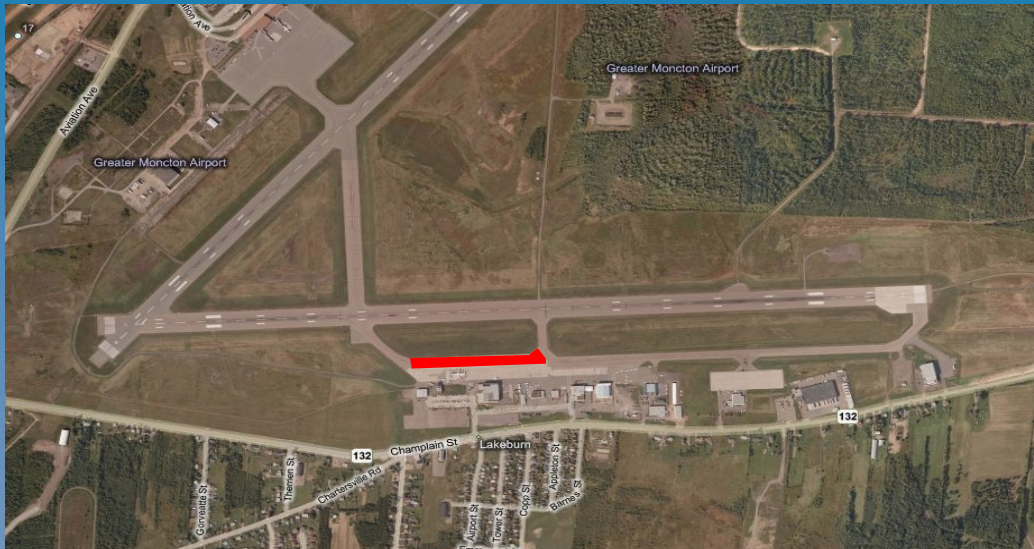
Apron 1 - Rehabilitation

- 42 Year old Concrete Apron
- Already Undergone Extensive Repairs
- 75% of the Concrete Panels require Continual Maintenance.
- Structurally Sound

- Remove Top 50mm and place New Asphalt Surface.
- Remove Top 50mm, Place Crack Relief Layer, Place New Asphalt Surface.
- Rubblize Existing Concrete and Place New Asphalt Surface
- Remove Concrete and Place New Flexible Pavement Structure.

Remove Existing Concrete and Place a New Asphalt Pavement Structure.

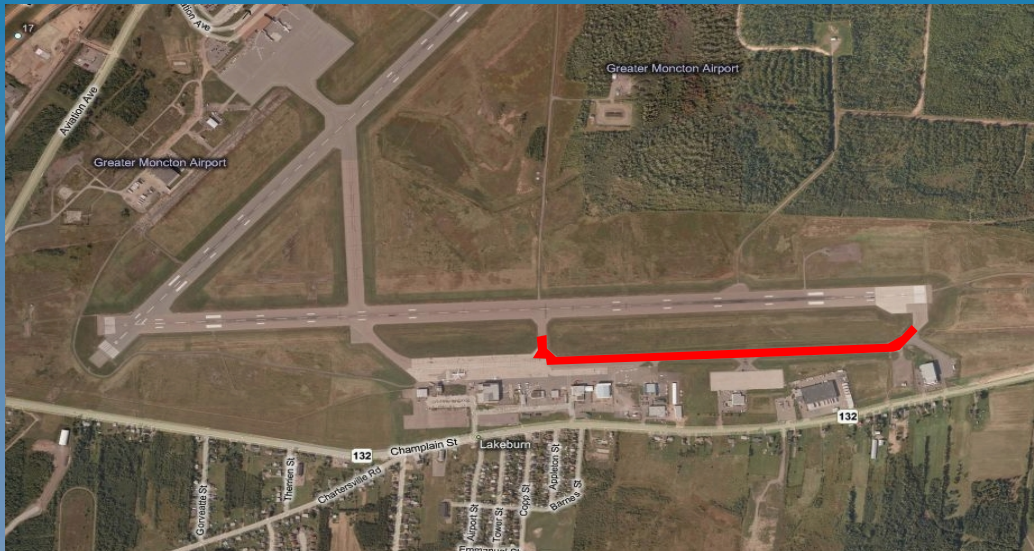
Taxi A

- Last Resurfaced in 1991
- Significant Cracking in Wheelpaths
- Some Isolated Alligator Cracking
- Performed Well to Date
- HWD Analysis Indicates that the Pavement Requires Strengthening.

1. Where Alligator Cracking is Present, Remove the 65mm of Asphalt and Repave.
2. Tack Coat and Place 60mm Asphalt Overlay over the Entire Surface.

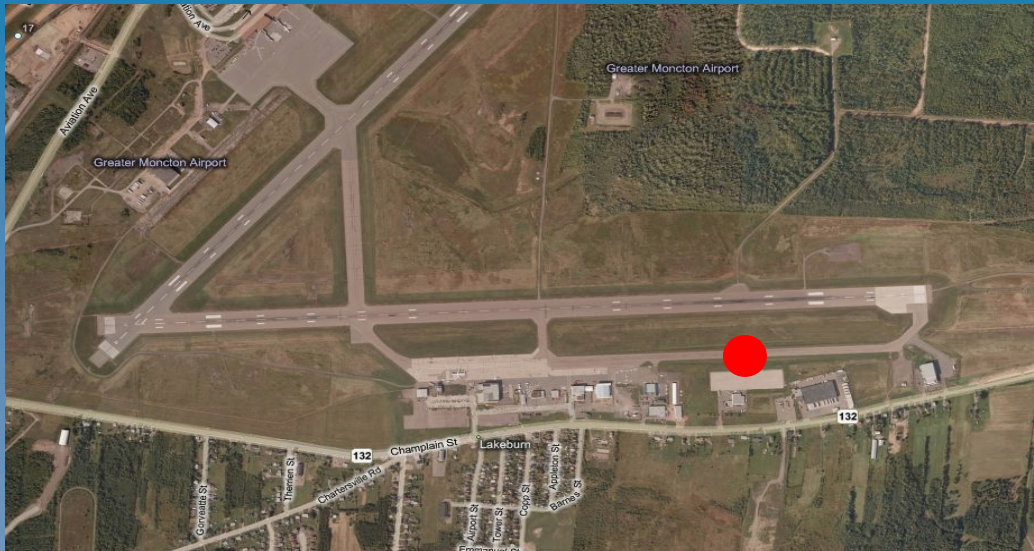
Apron 5 Entrance

- Constructed in 1996
- Significant portion has been repaired since then.
- Moderate Alligator Cracking
- Some cracking at Construction Joints
- Distresses are indicative of Ongoing Structural Failure.

Reconstruction of the entire Pavement Structure.
