RUNWAY 06L24R RECONSTRUCTION AND LESSONS LEARNED Toronto Pearson International Airport

Presenter: Kris Bourgeois, P.Eng. Date: Sept 26, 2023 Location: SWIFT 2023 - Winnipeg

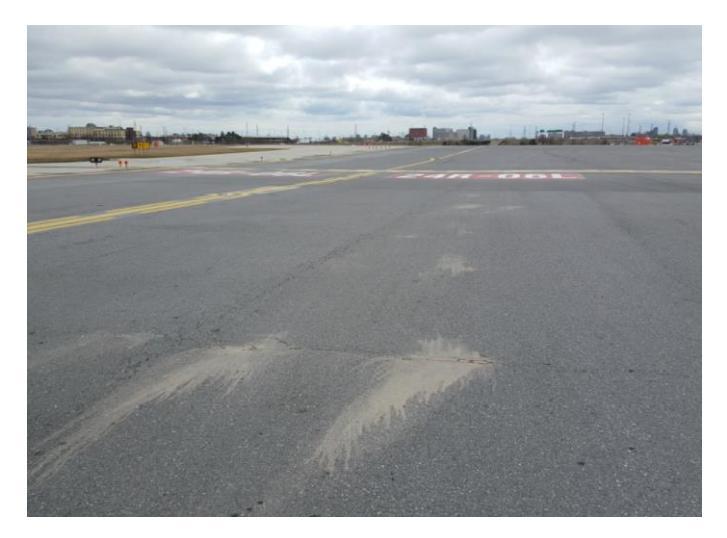
Pumping at the concrete joint underneath the pavement surface indicating poor joint load transfer

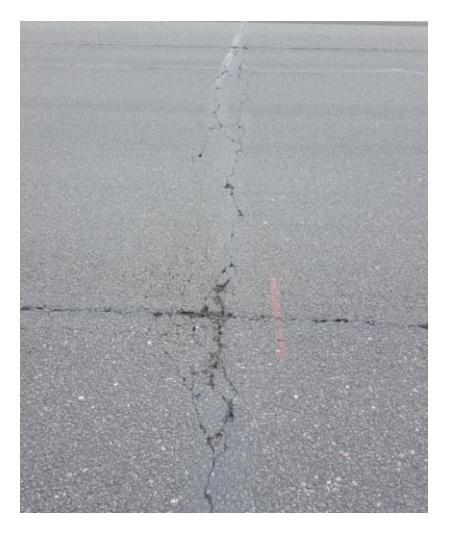
High Severity Multiple Transverse Reflective Crack with FOD concerns

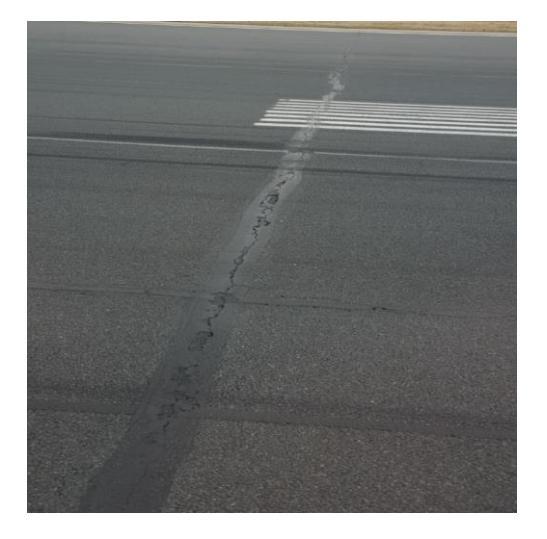
Medium Severity Transverse Reflective Crack with FOD concerns

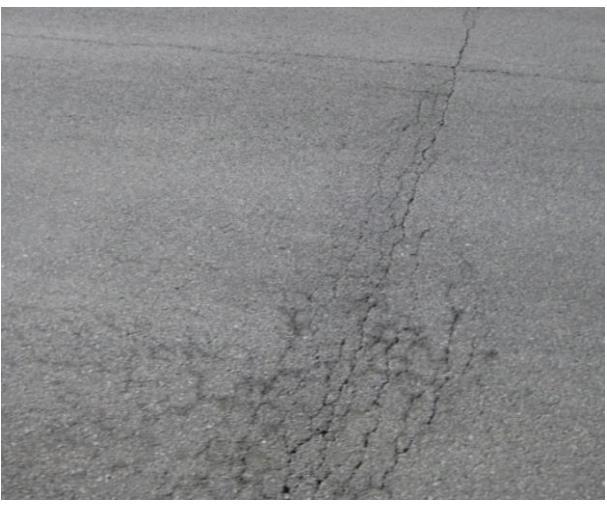
Localized Severe Crack in Composite Pavement

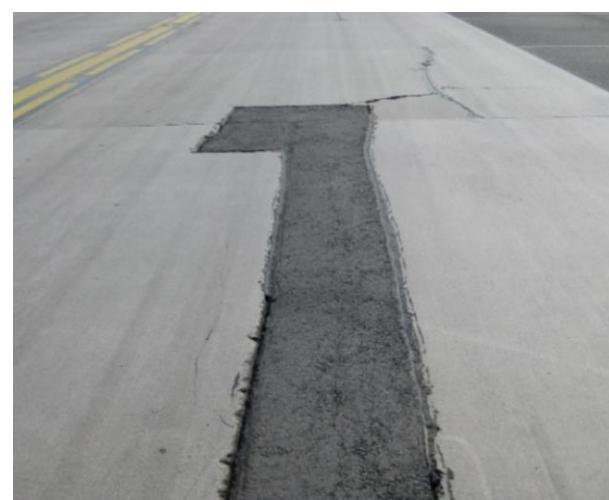
Patched Longitudinal Crack in Concrete Slab and Adjacent Shattered Concrete Slab

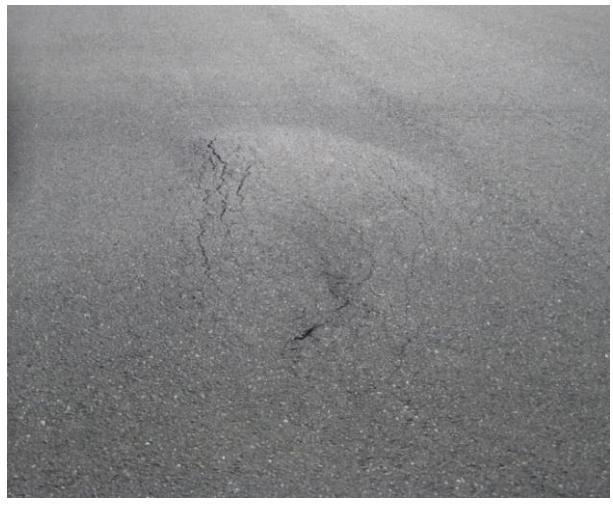
Severe Asphalt Shoving north of HB24R

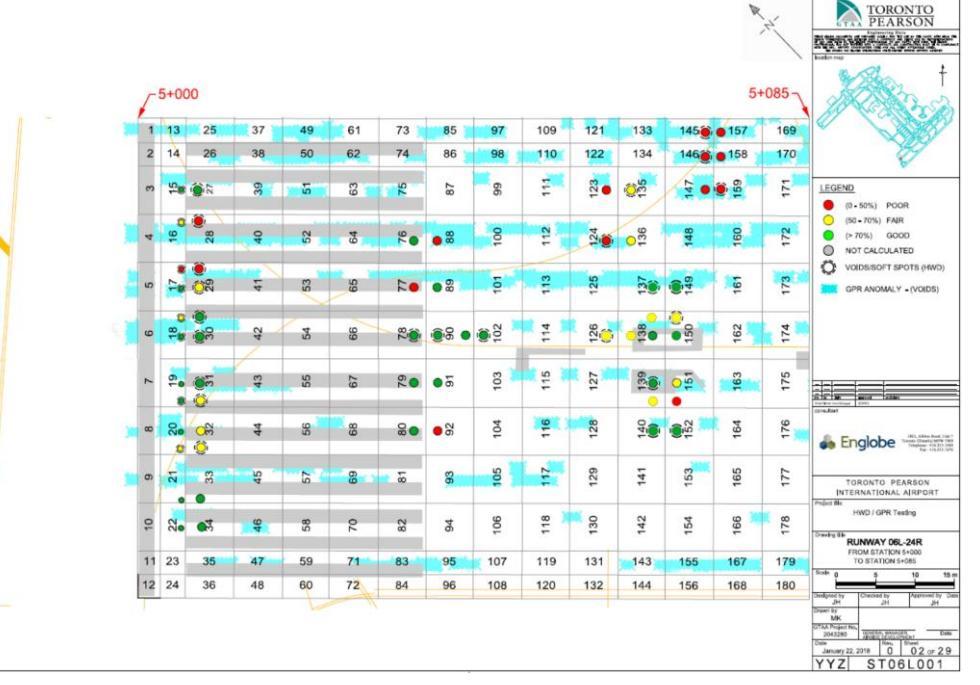
The GPR survey and analysis indicated many anomalous zones that were interpreted as possible voids or settlements below the concrete layers. The drawing on the left showed the typical GPR findings on 06L24R.
