*Findings and Recommendations  
from AAPT 04-01, Developing  
Rubblization Guidelines for  
Airport Pavements*

Mark Buncher, Ph.D., P.E.  
SWIFT Conference in Toronto, CA  
Sept 17th, 2009

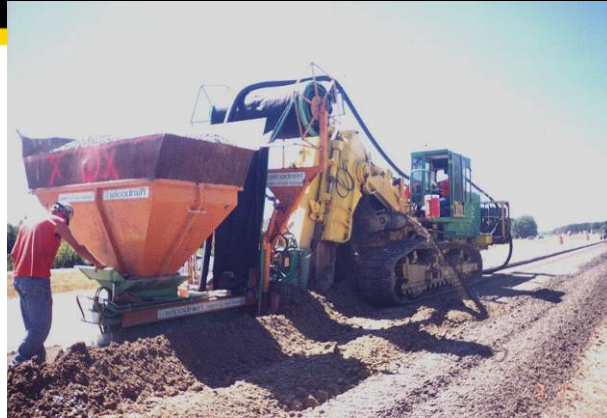
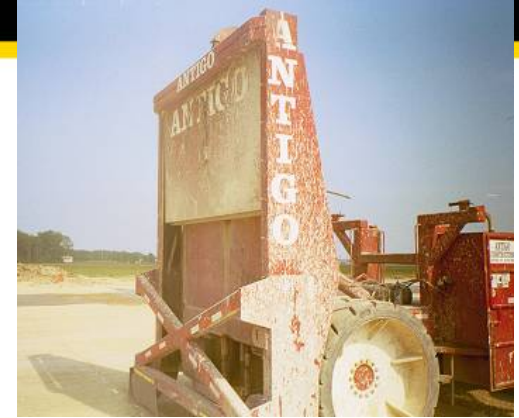
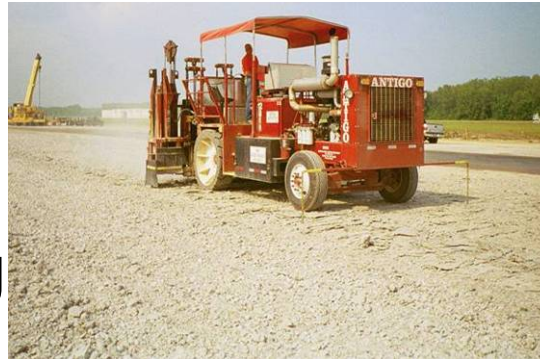
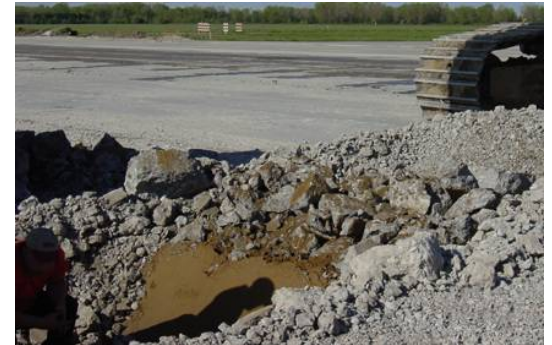
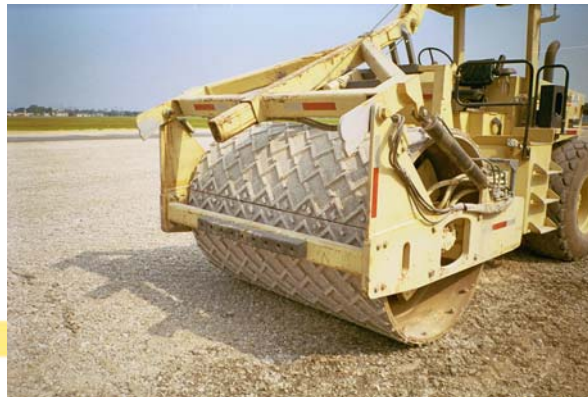
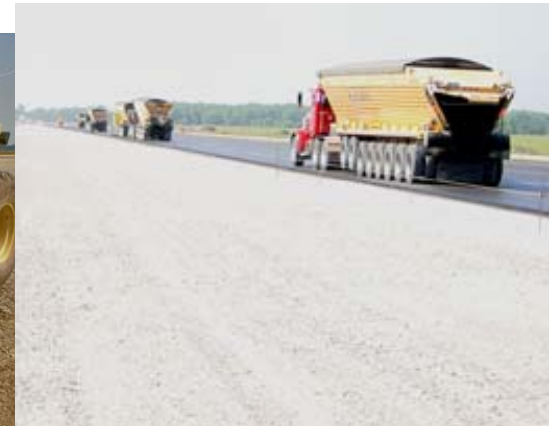
# Rubblization Process with MHB at Selfridge ANGB w/ 21" thick PCC, 2002

- Edgedrains and Cross Underdrains
- Pre-fracture
- Rubblize
- Test Pits
- Rolling
- Aggregate Leveling Course
- HMA Paving

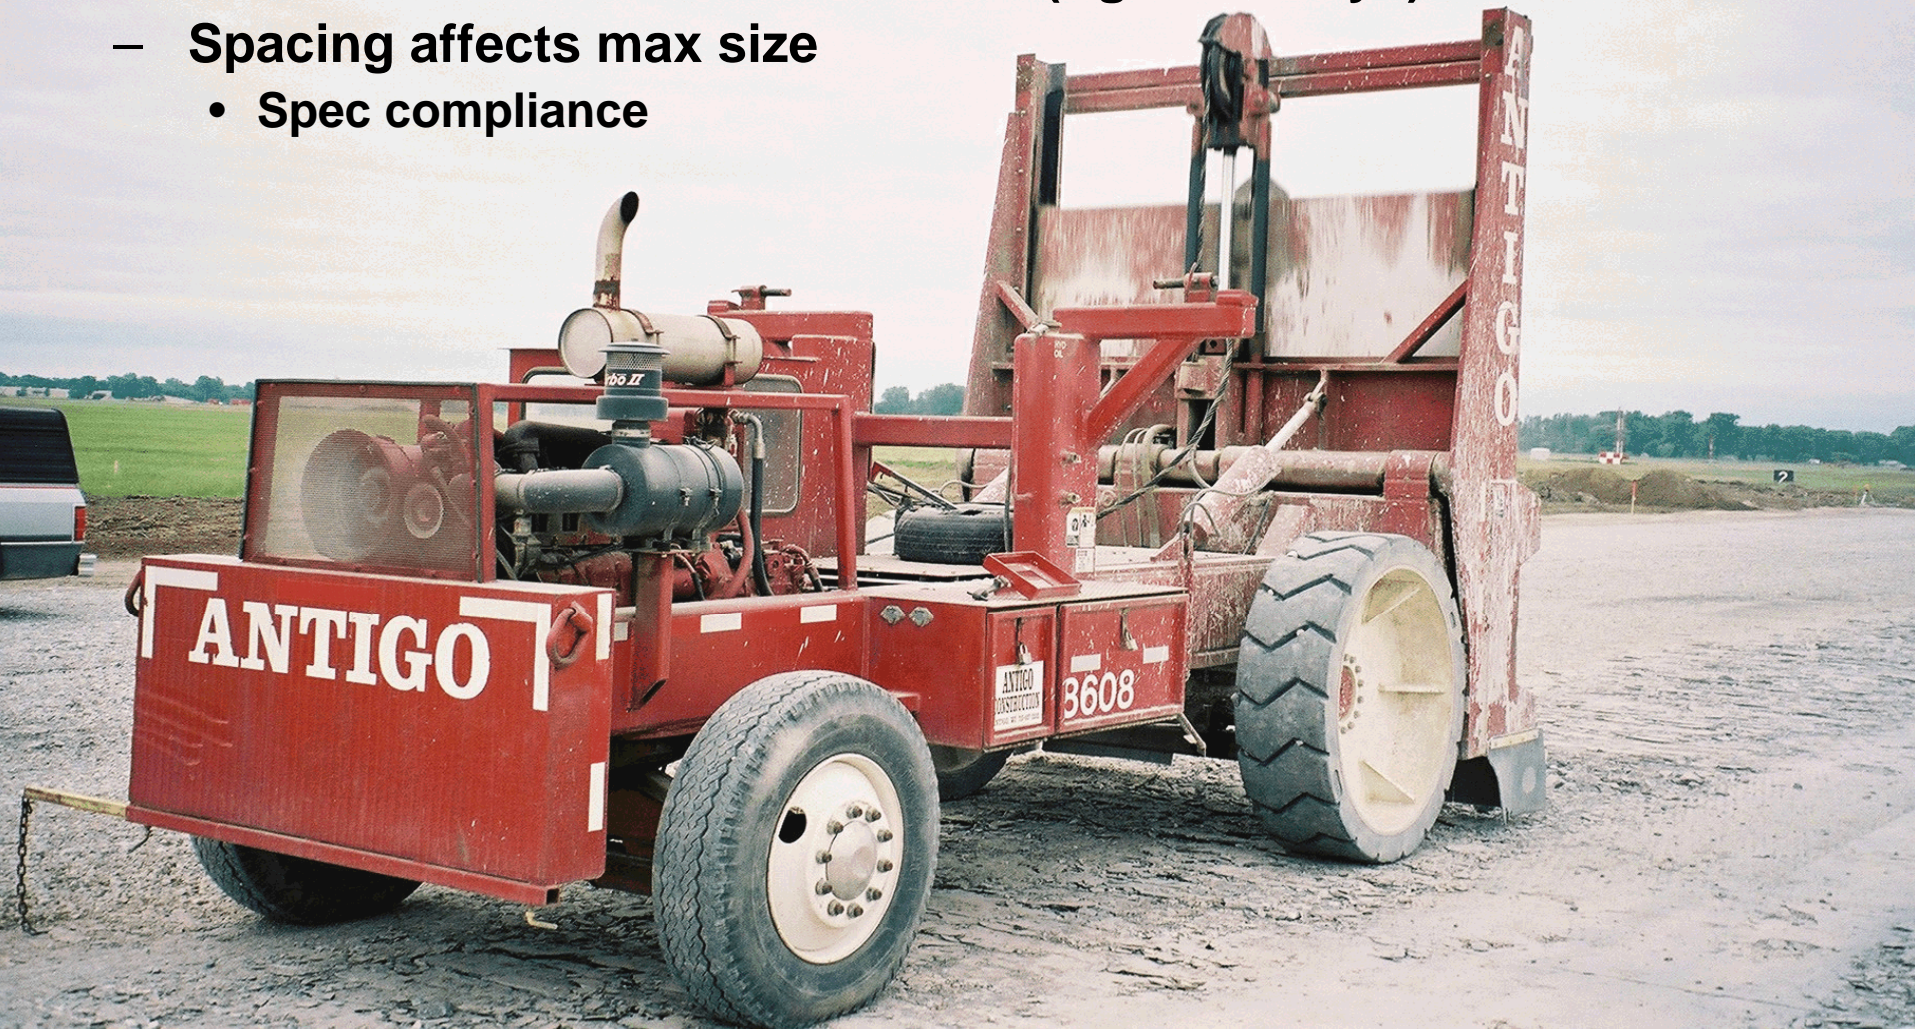
# Pre-fracture Equipment

- Precede MHB to ensure full depth fracture
  - Typically only necessary for PCC >14in
  - Sometimes for PCC with interface (rigid overlays)
  - Spacing affects max size
    - Spec compliance

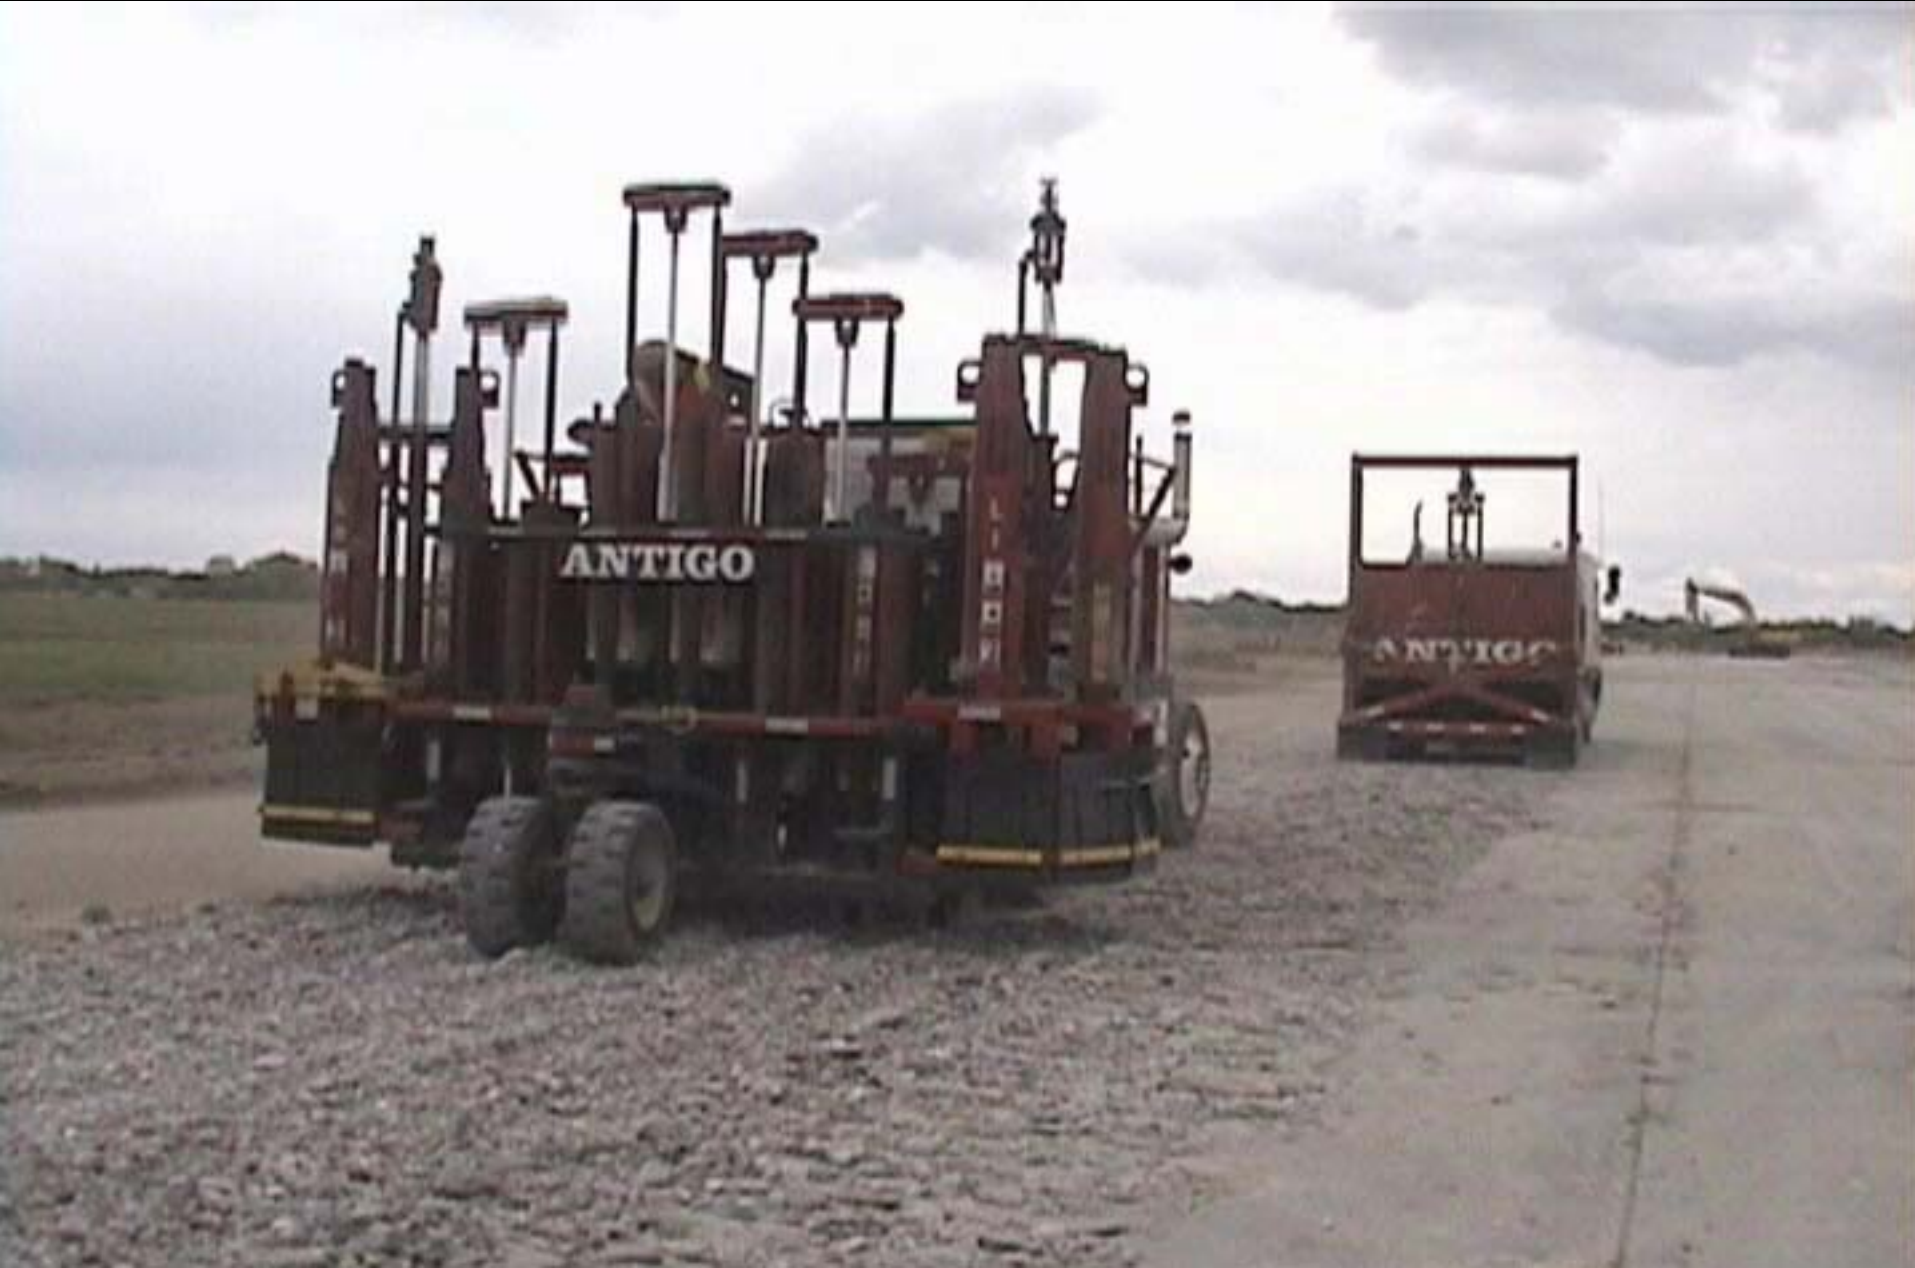
# Selfridge Test Pit

agency approval before full scale rubblelization

- Excavate after all fracturing and rolling within test strip
- Include a transverse and longitudinal joint
- Determine if spec criteria is met
  - Full depth fracture
    - Particle size criteria (next slide)
  - Steel “substantially” debonded
    - Dowels can be sawed
- At free edges, allow larger PCC pieces
  - Due to lack of support

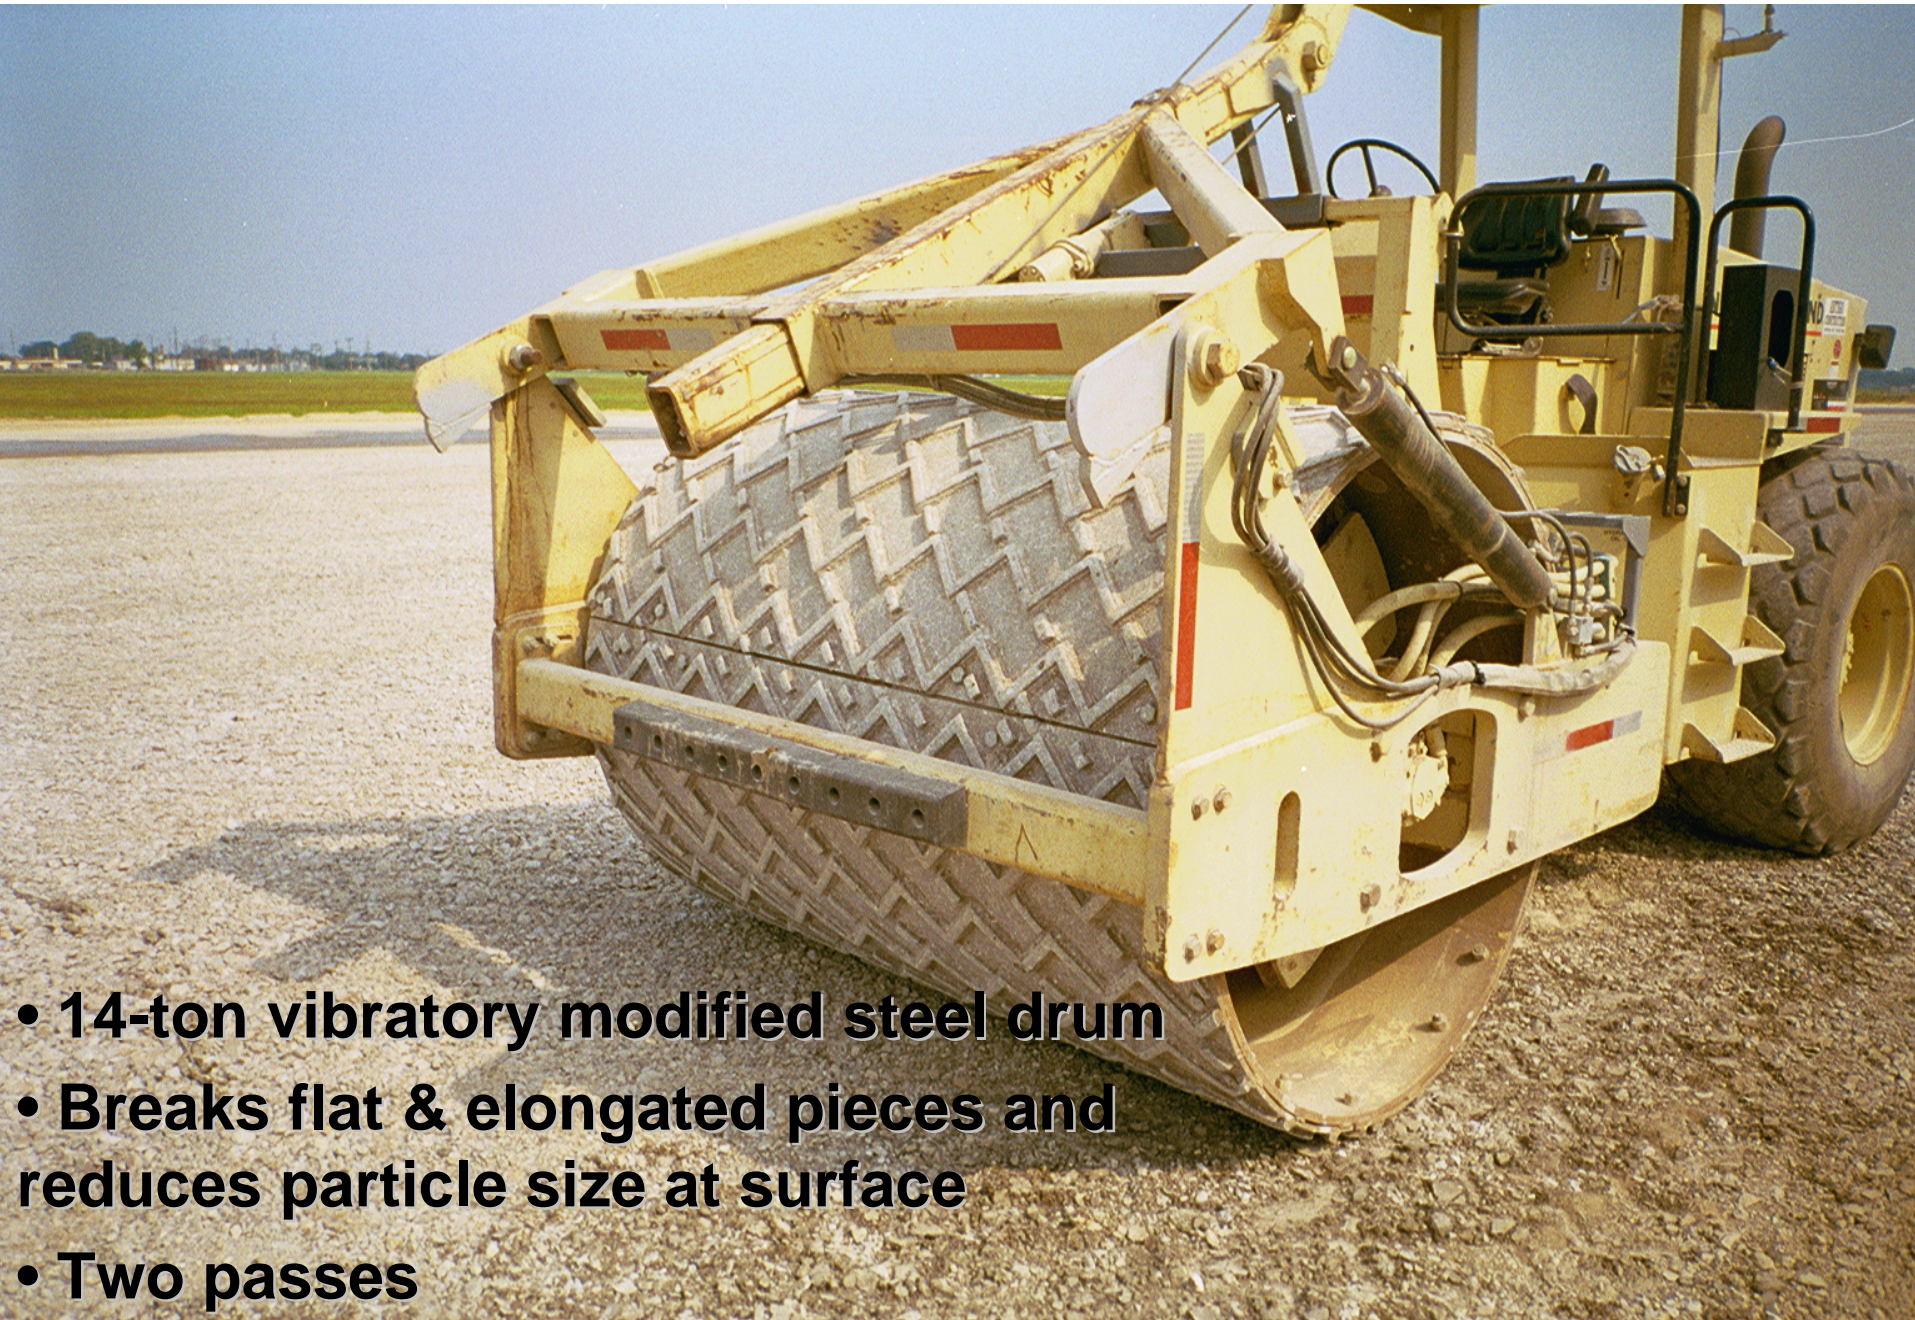
# Z-grid Roller at Selfridge

- 14-ton vibratory modified steel drum
- Breaks flat & elongated pieces and reduces particle size at surface
- Two passes

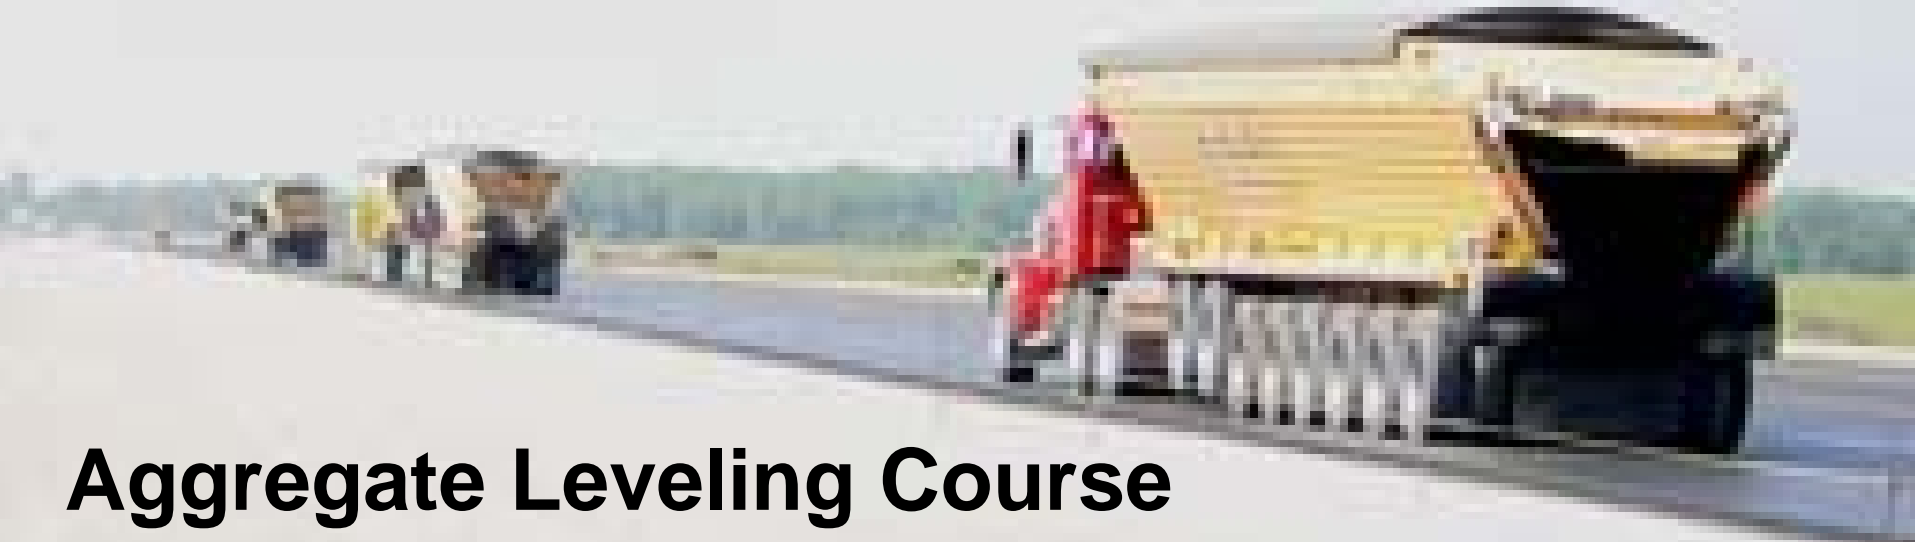
# Leveling Course and Paving at Selfridge

## Aggregate Leveling Course

- Only necessary for grade and profile changes
  - Can't fine grade rubblized surface
- Variable 4-in thick layer

## HMA Overlay

- 7-in thick
- Placed in three lifts

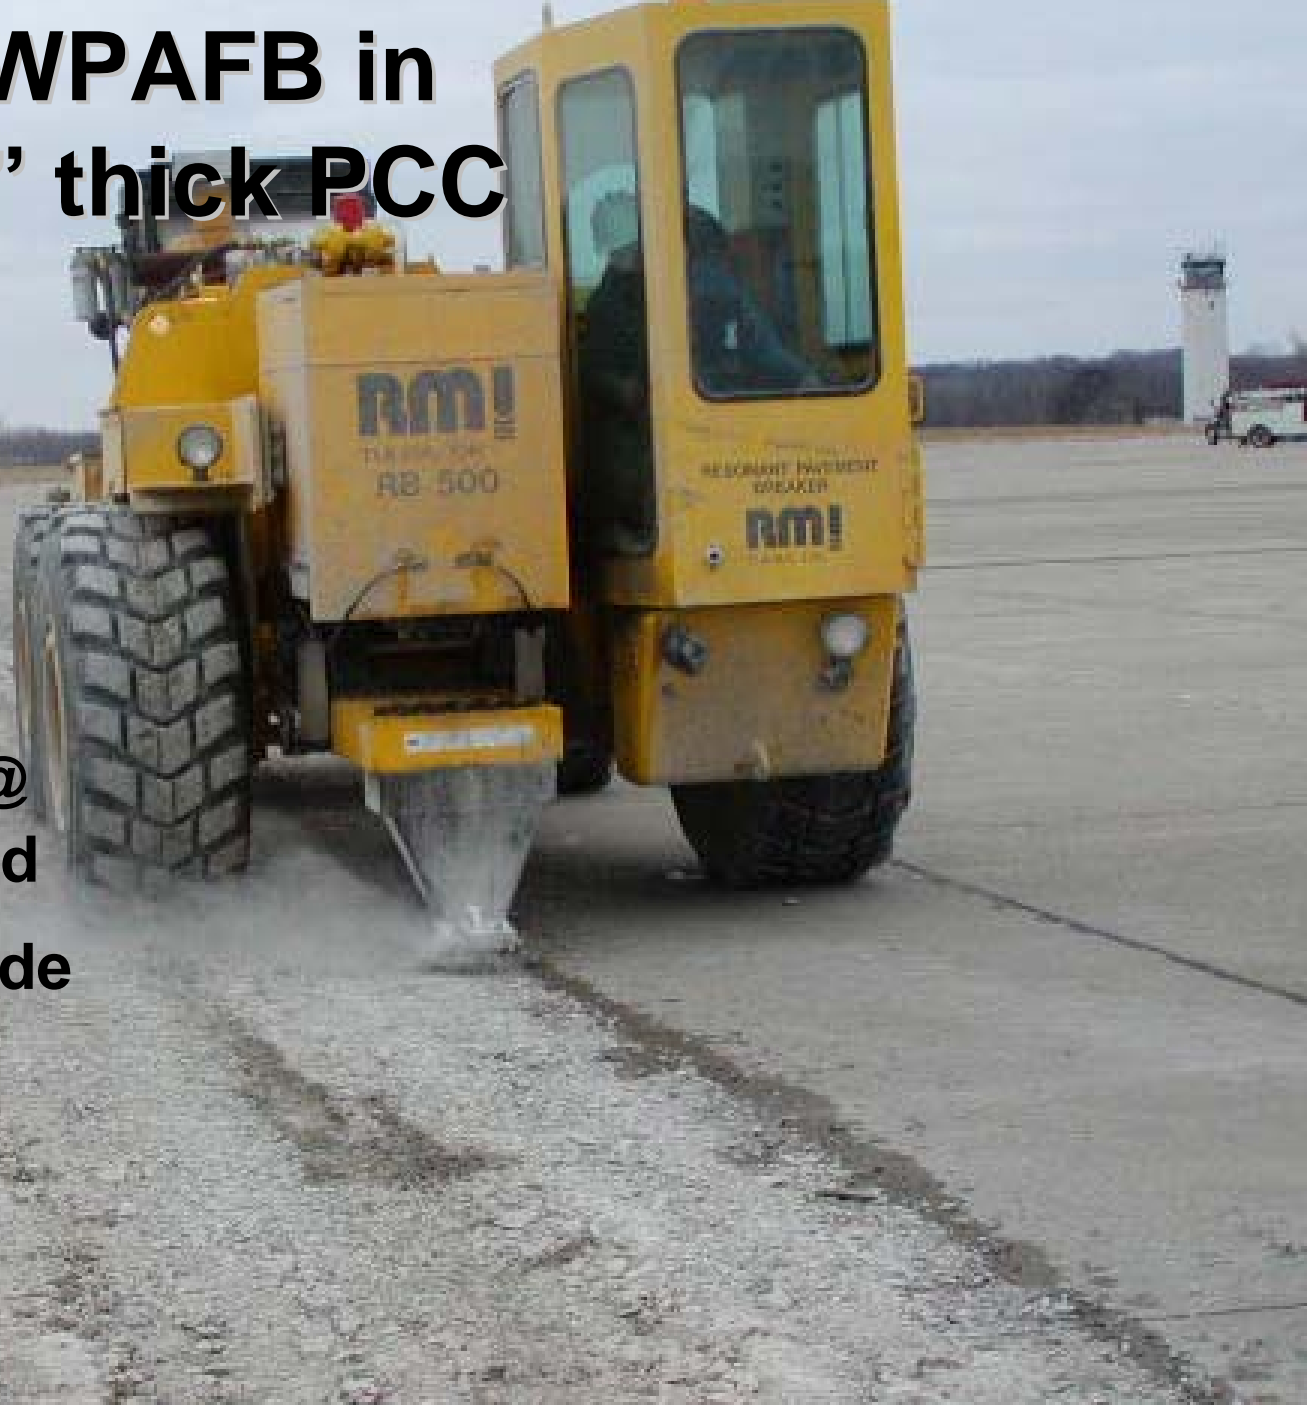
# RB-500 at WPAFB in 2002 w/ 26" thick PCC

- 2000 lbf blows @  
44 cycles/second
- < 1 inch amplitude
- 9-12 inch wide  
passes

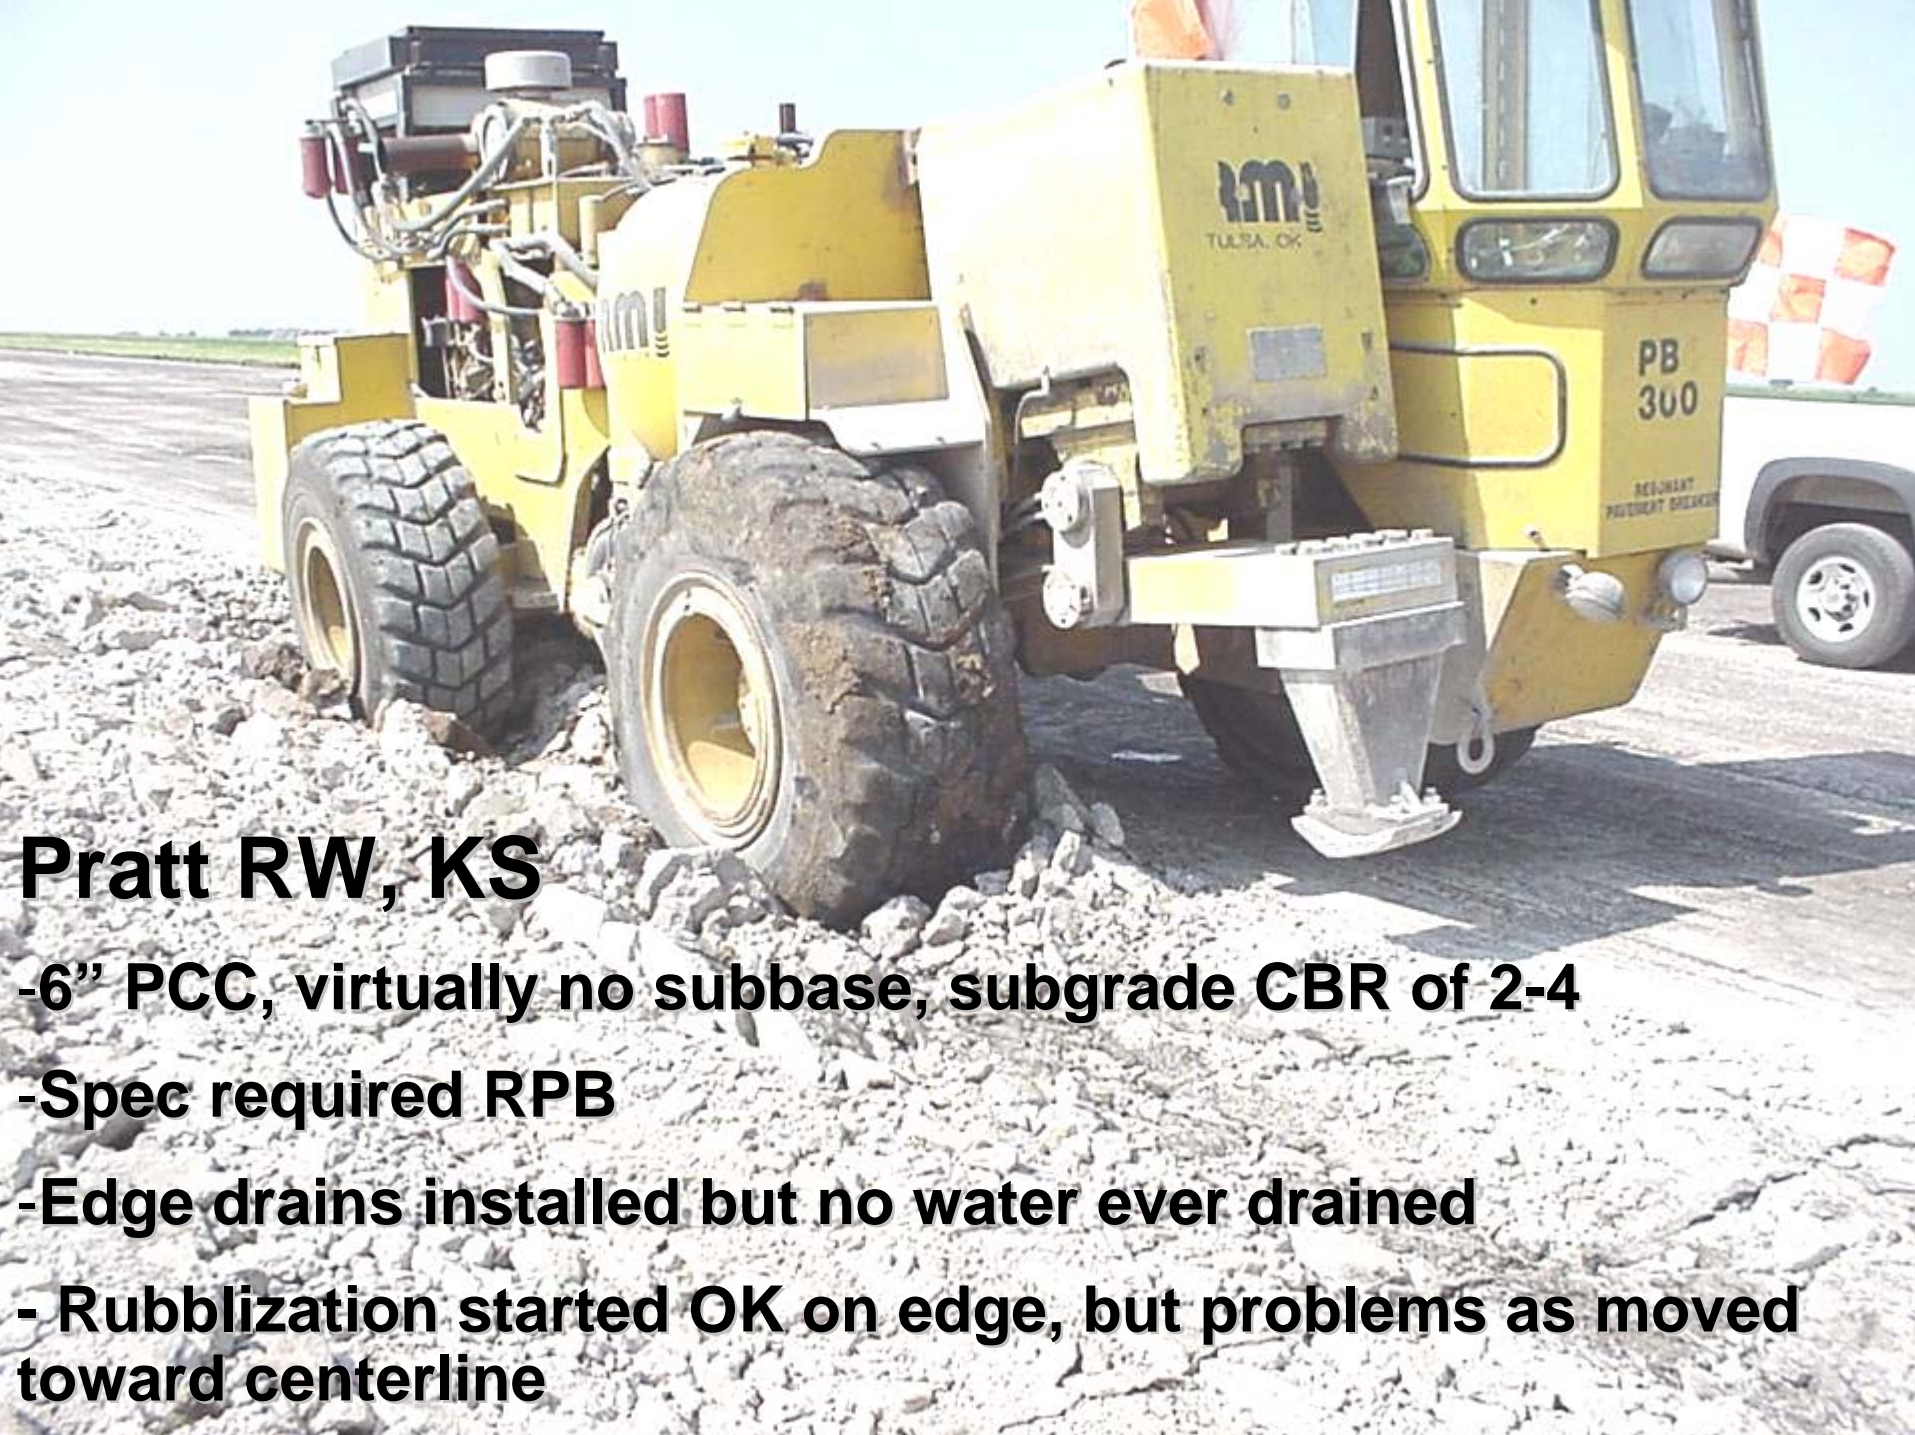
## **Pratt RW, KS**

- 6" PCC, virtually no subbase, subgrade CBR of 2-4**
- Spec required RPB**
- Edge drains installed but no water ever drained**
- Rubblization started OK on edge, but problems as moved toward centerline**

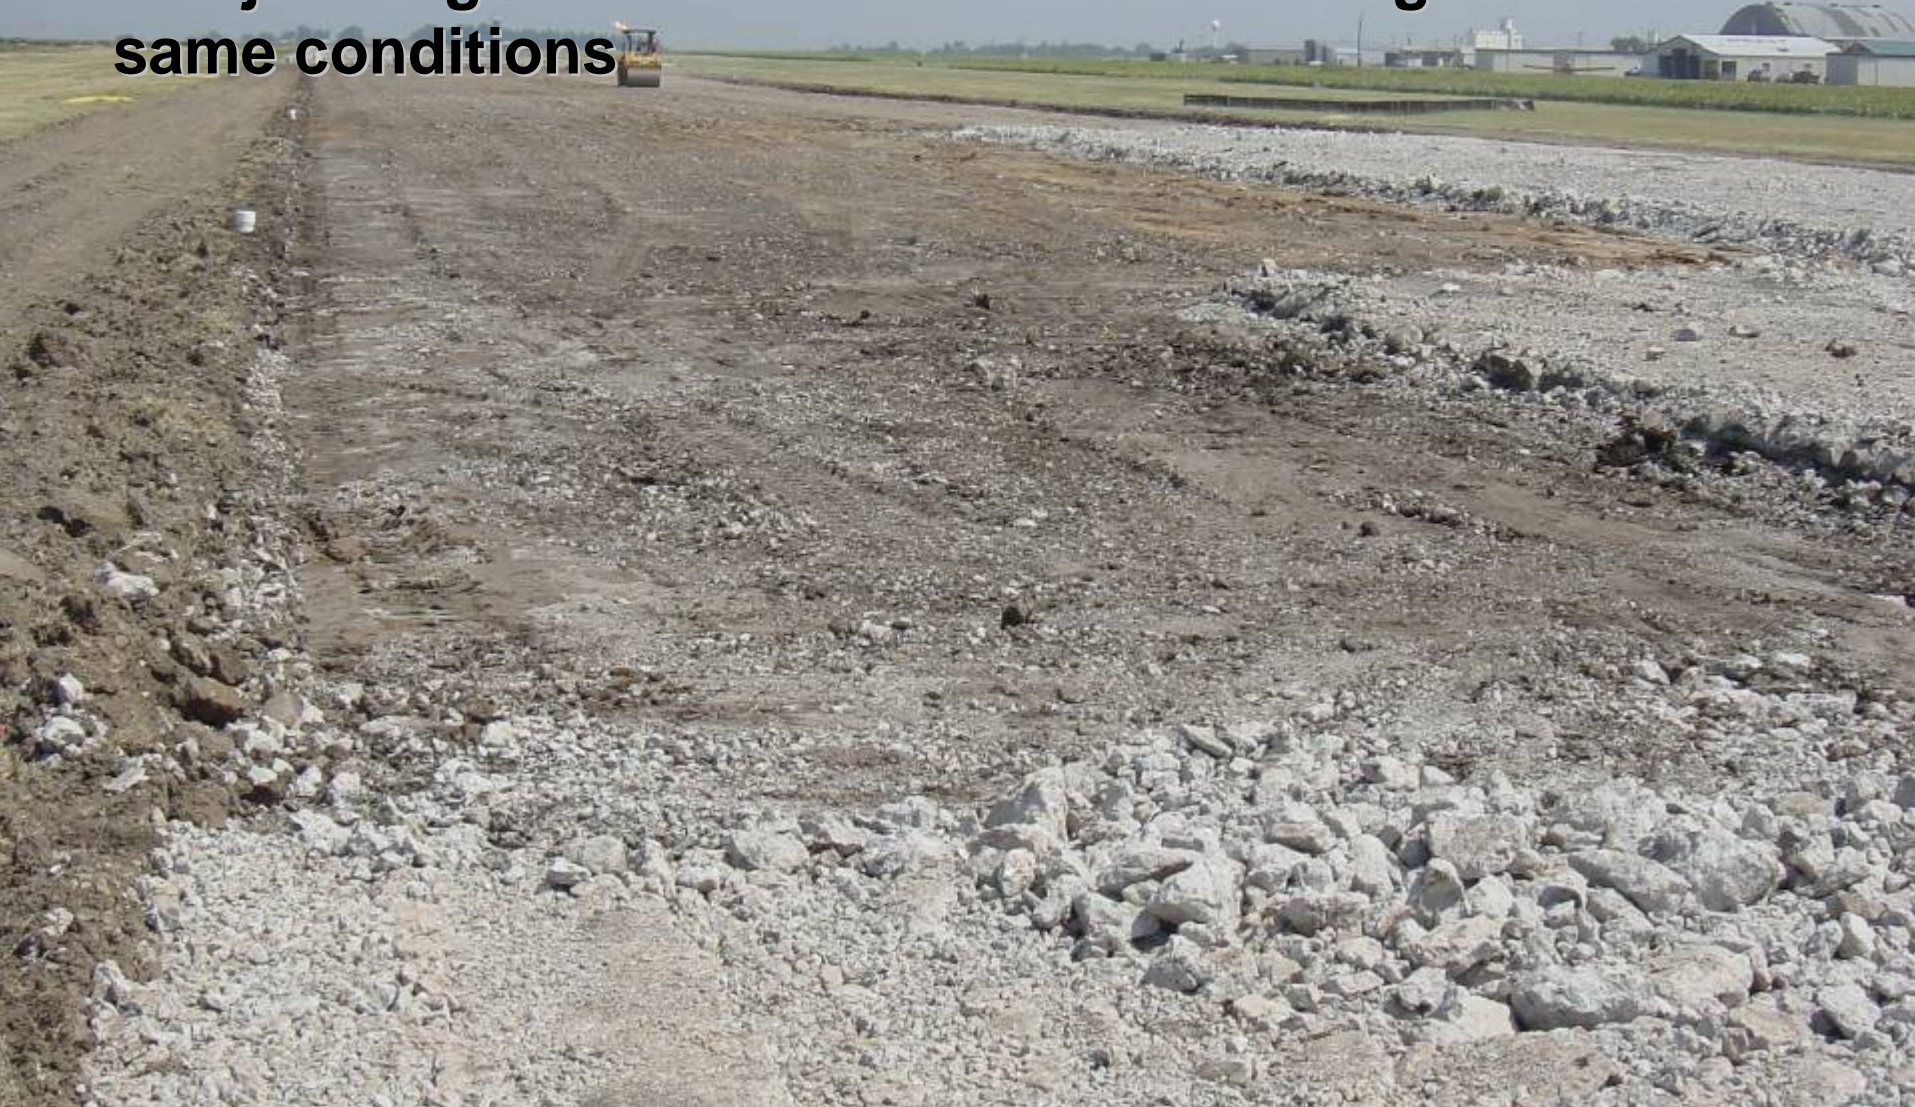
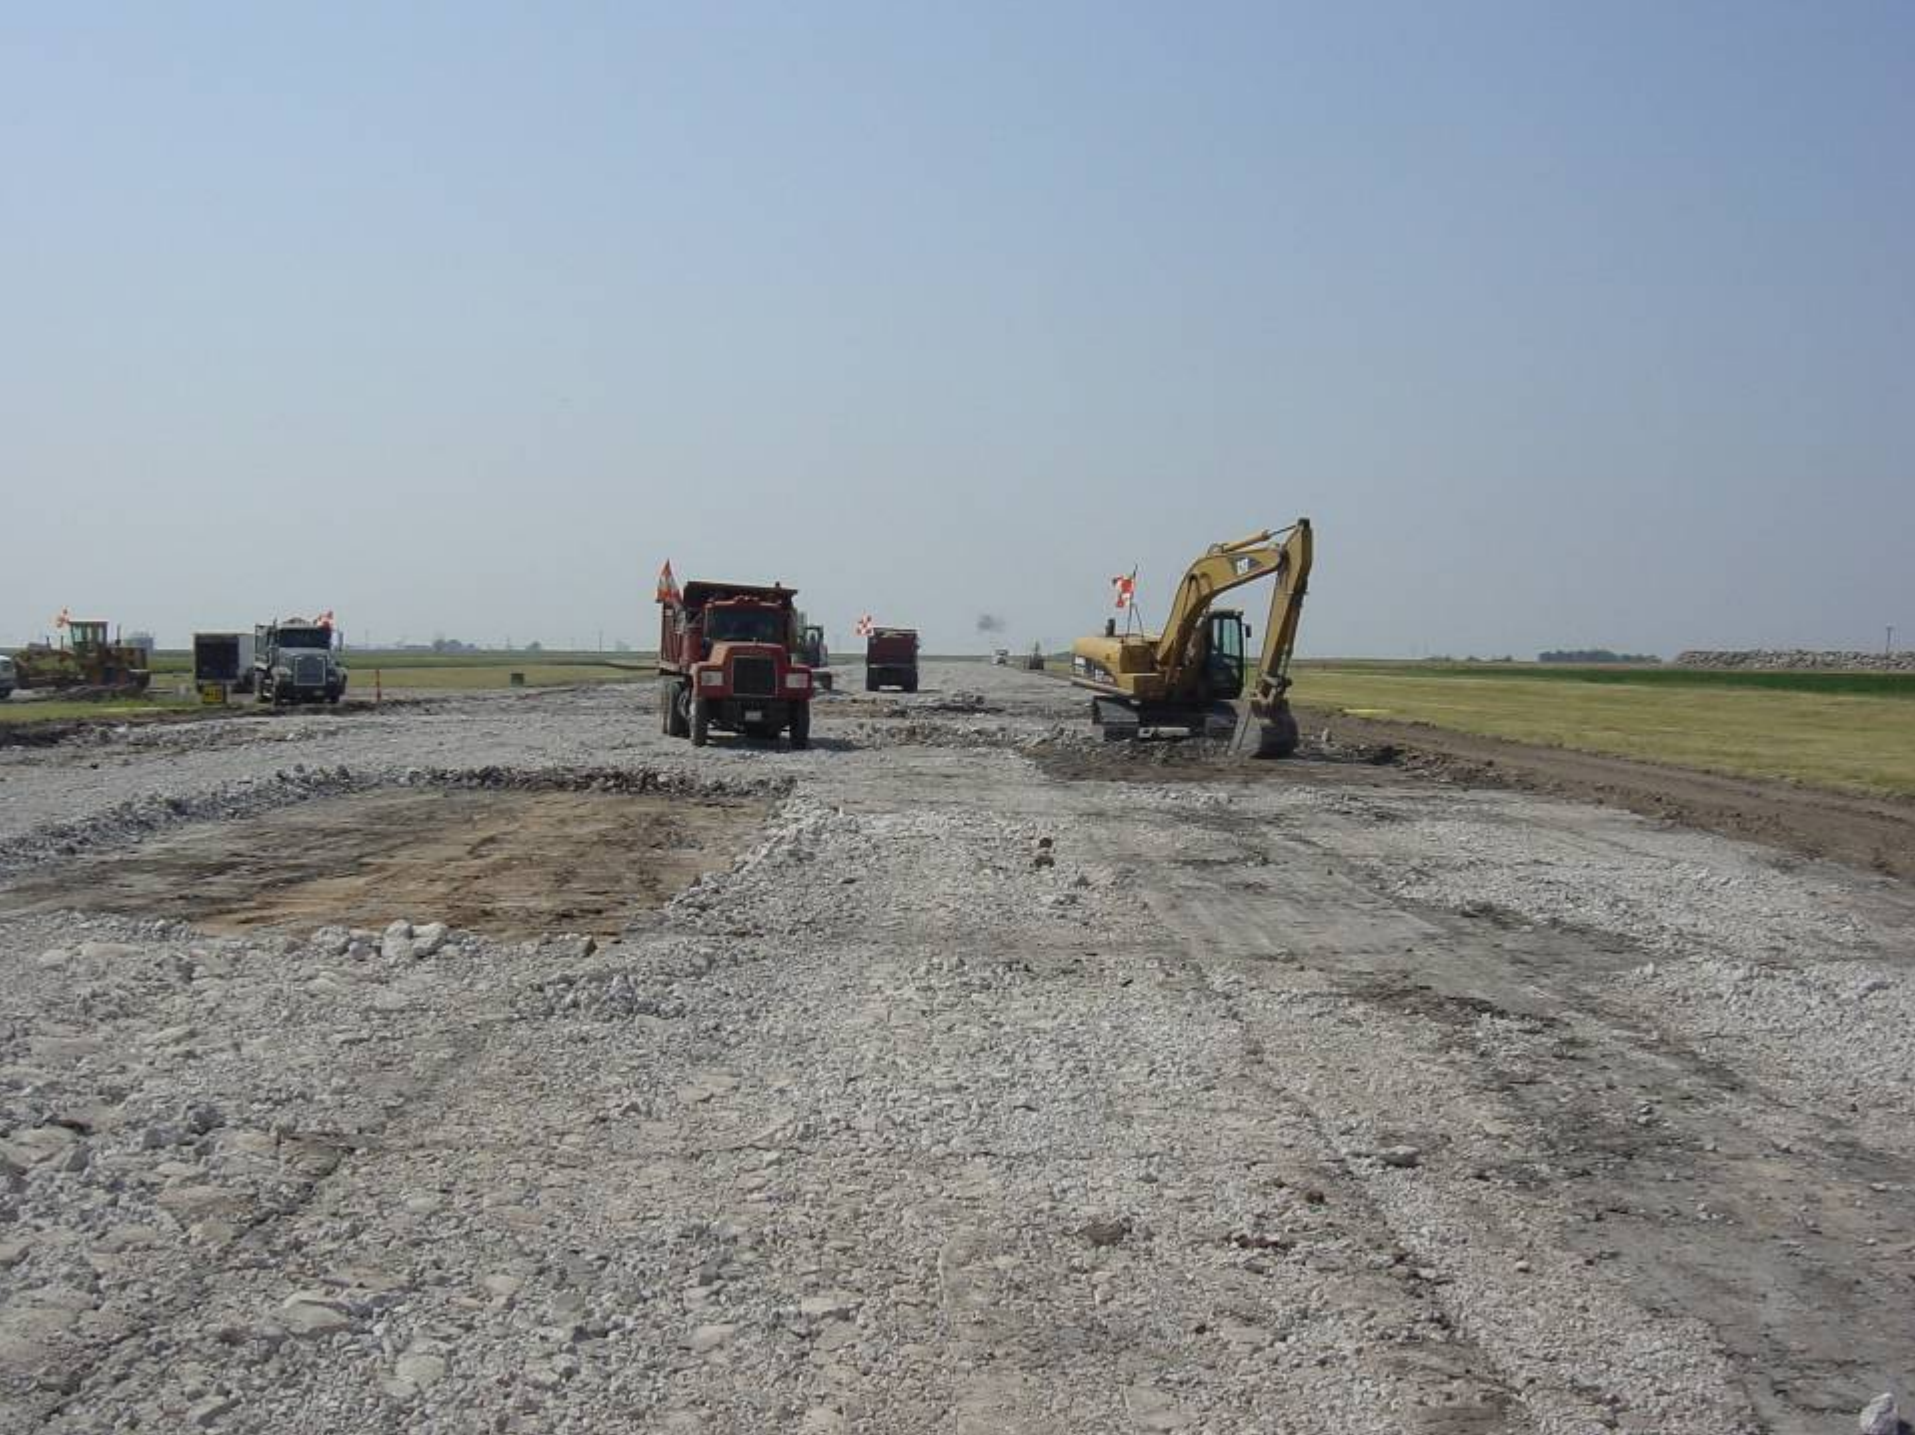
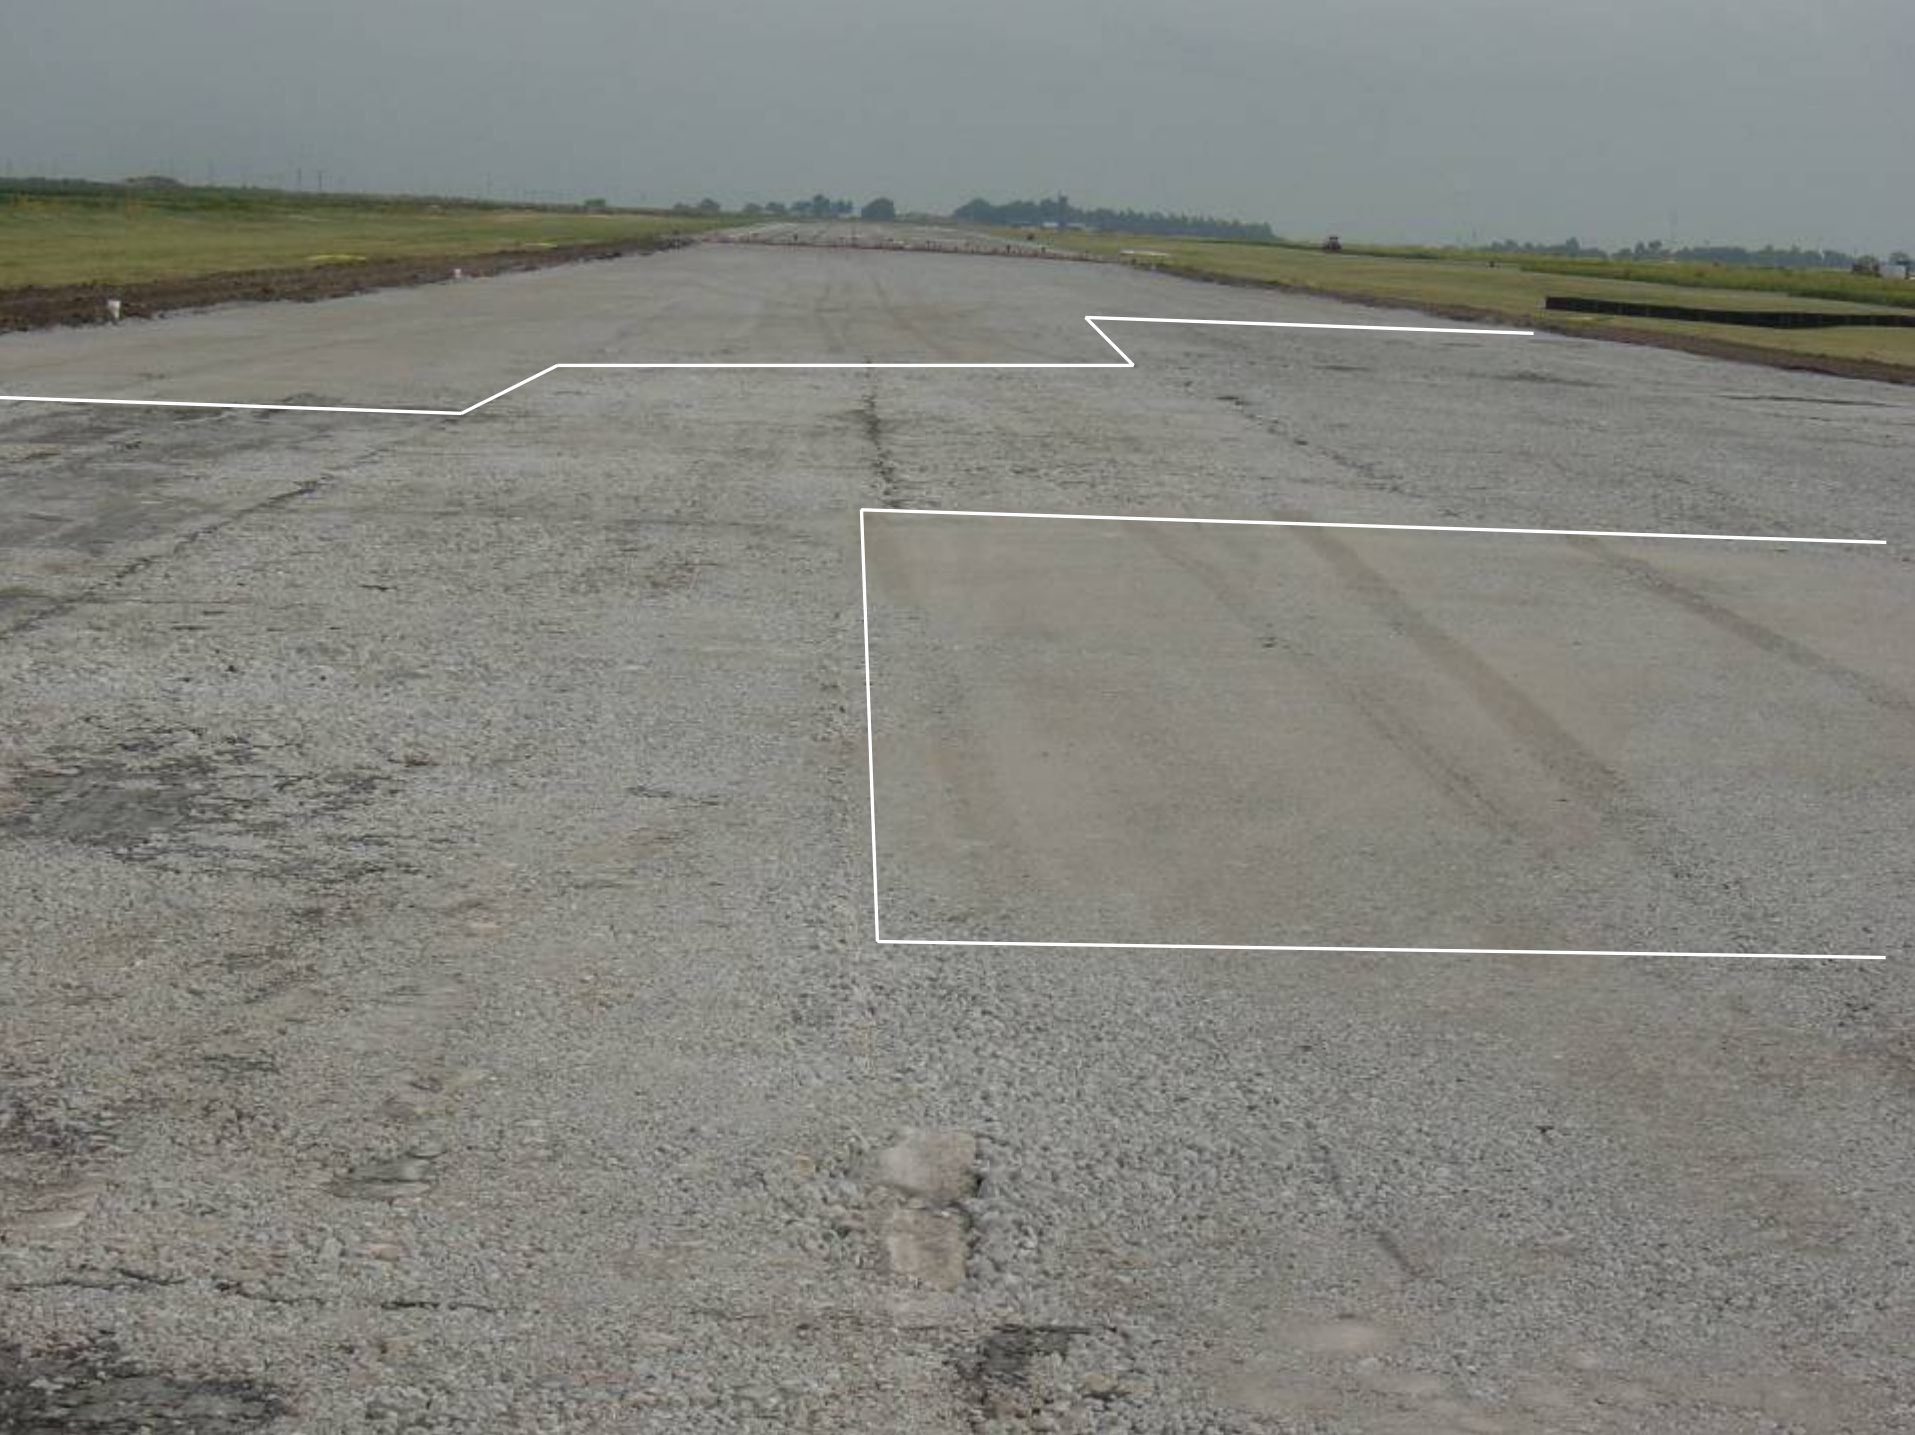
# Pratt RW

**-45% of first phase required full depth patching**

**-Project engineer said he would rubblize again under same conditions**
