*Findings and Recommendations  
from AAPT 04-01, Developing  
Rubblization Guidelines for  
Airport Pavements*

Mark Buncher, Ph.D., P.E.  
SWIFT Conference in Toronto, CA  
Sept 17th, 2009

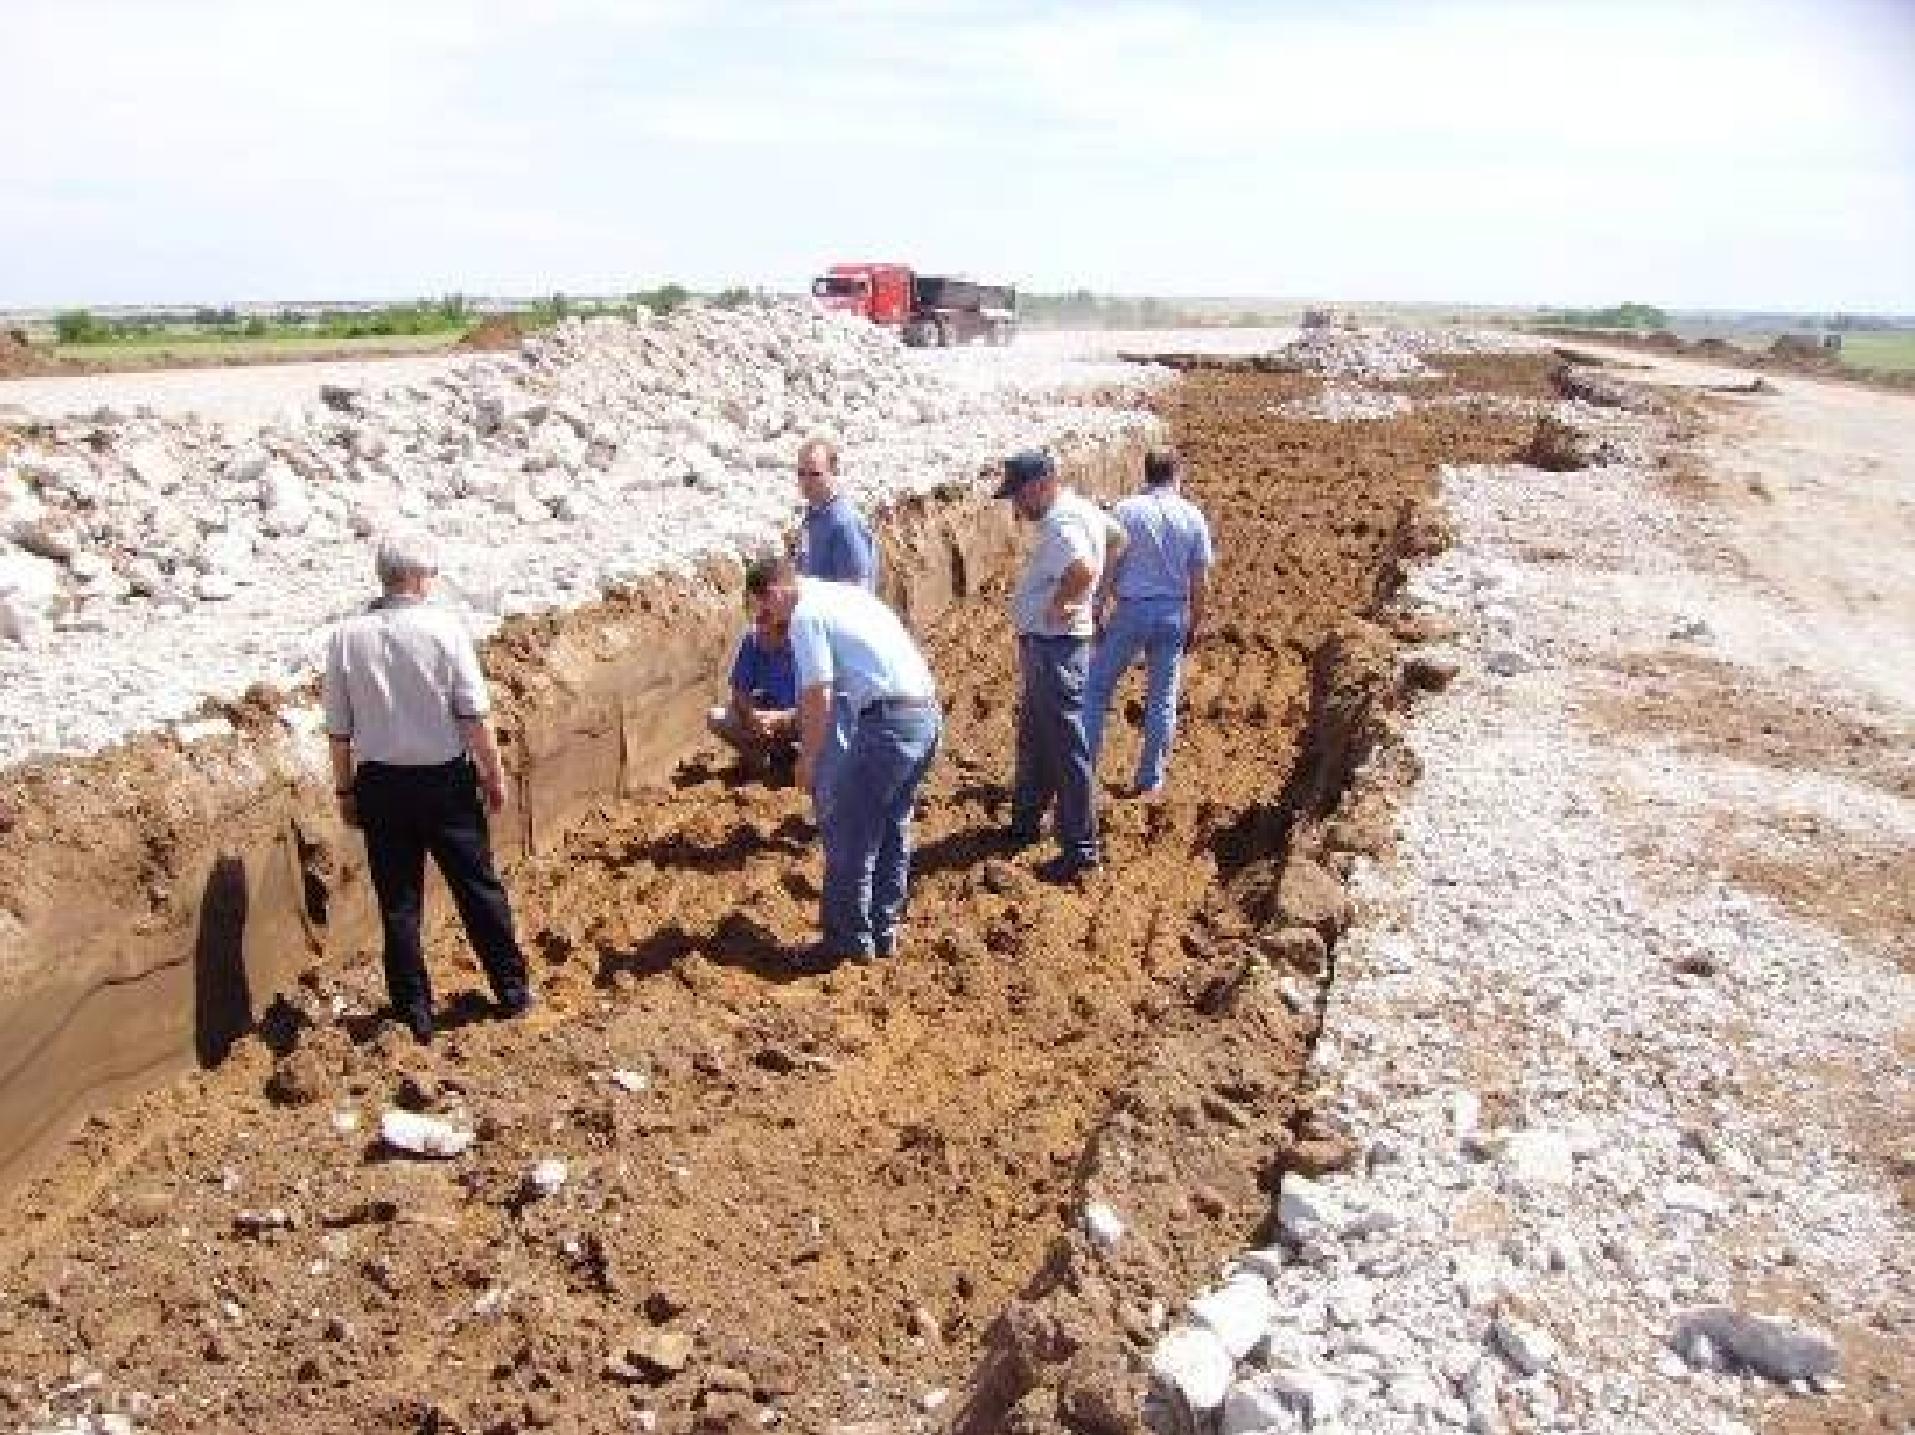
# **Kegelman Auxillary Field, OK**

- **5"-6.5" PCC, 0-4" sand subbase, clay subgrade**
- **RPB required**
- **Poor drainage and "couldn't afford" edge drains**
- **No punch-thrus but excessive rutting (>2")**
- **30% of project had full depth patches (2-4' in subgrade)**

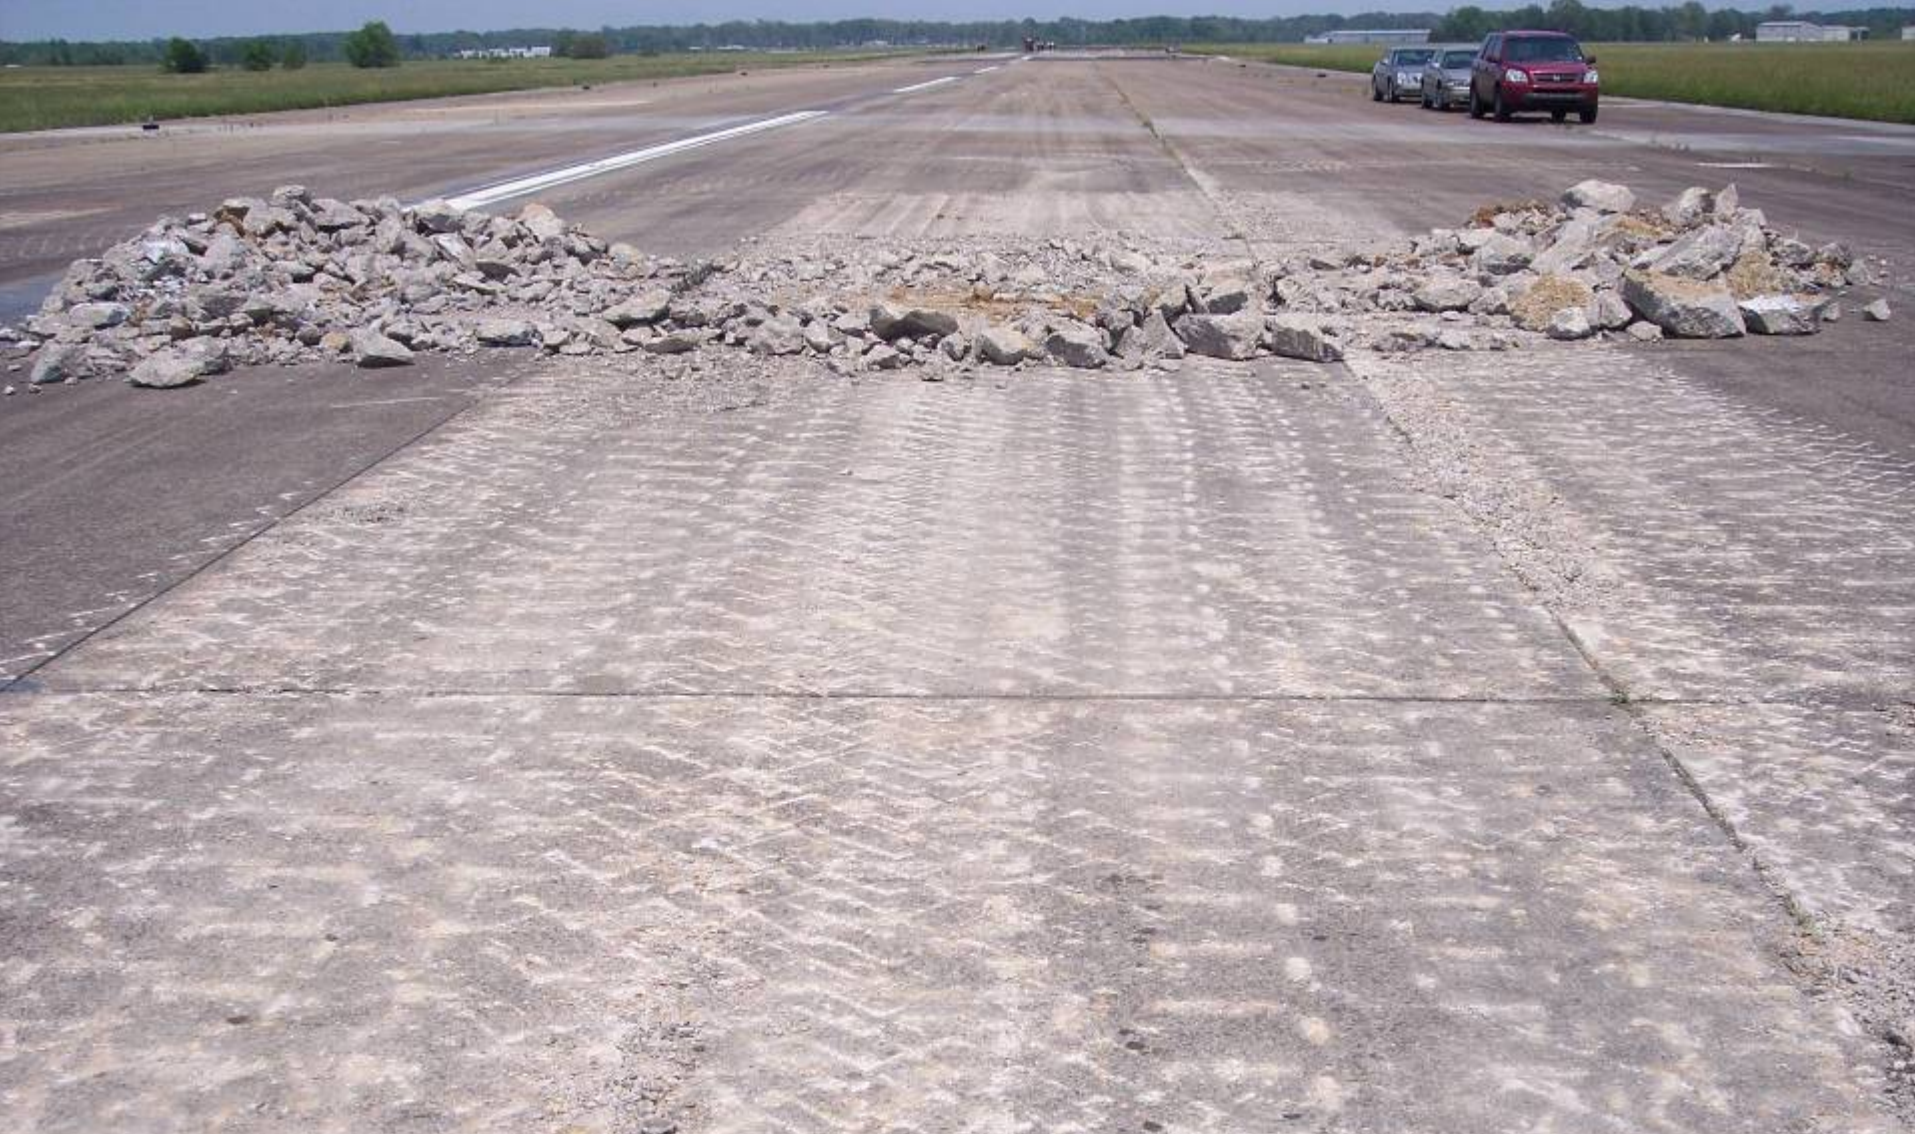
**MHB “Modified” Rubblization Process (low drop ht – 16”, large spacing – 10”) Produced Acceptable Surface, But Did Not Meet Criteria**

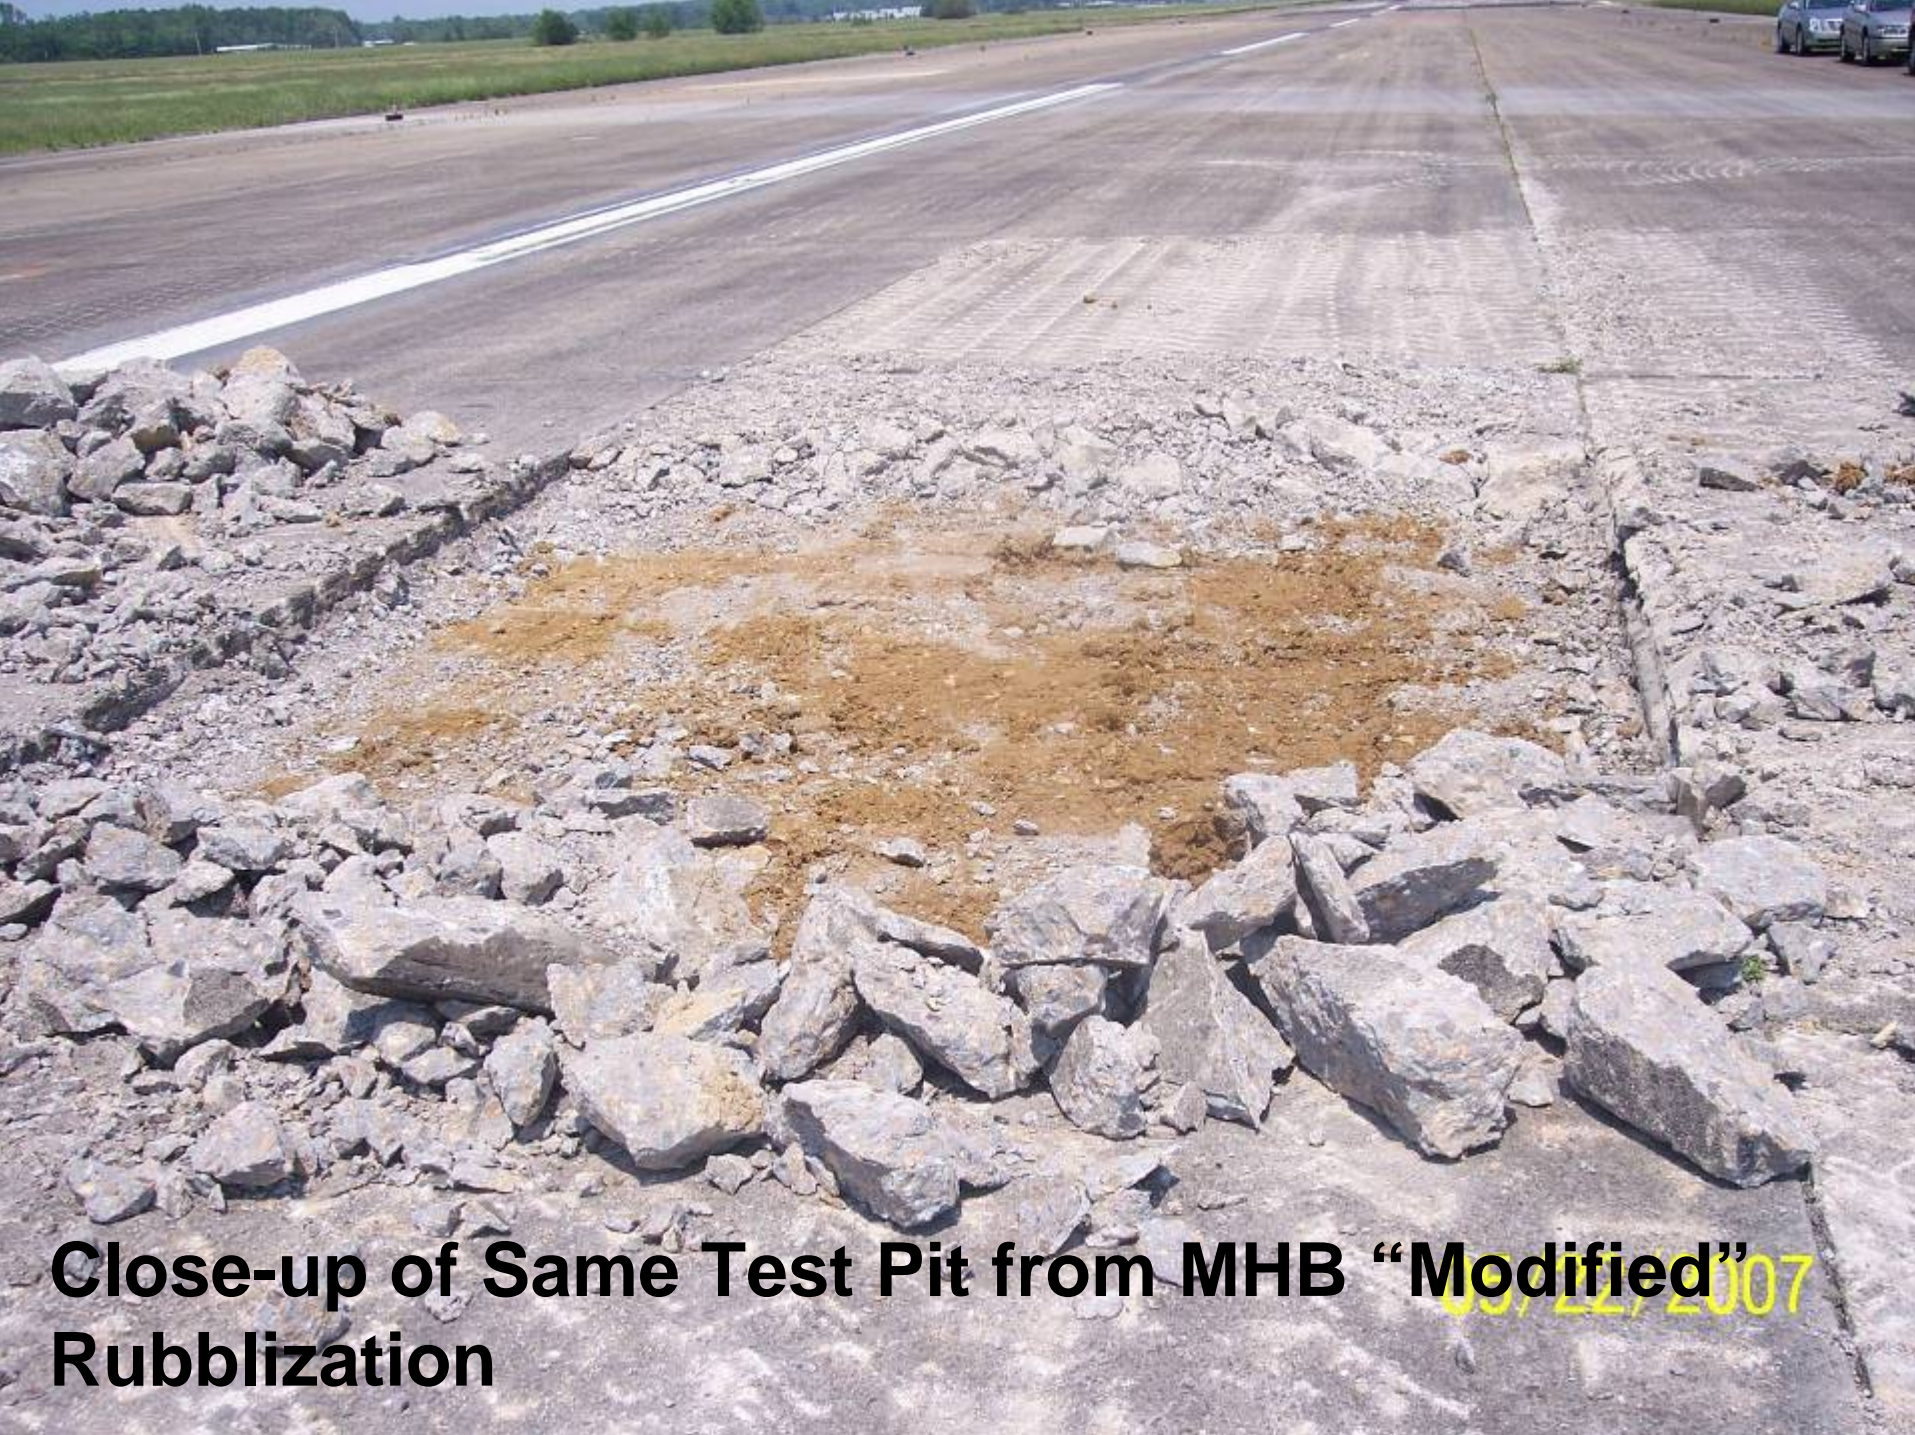
**Close-up of Same Test Pit from MHB “Modified”  
Rubblization**

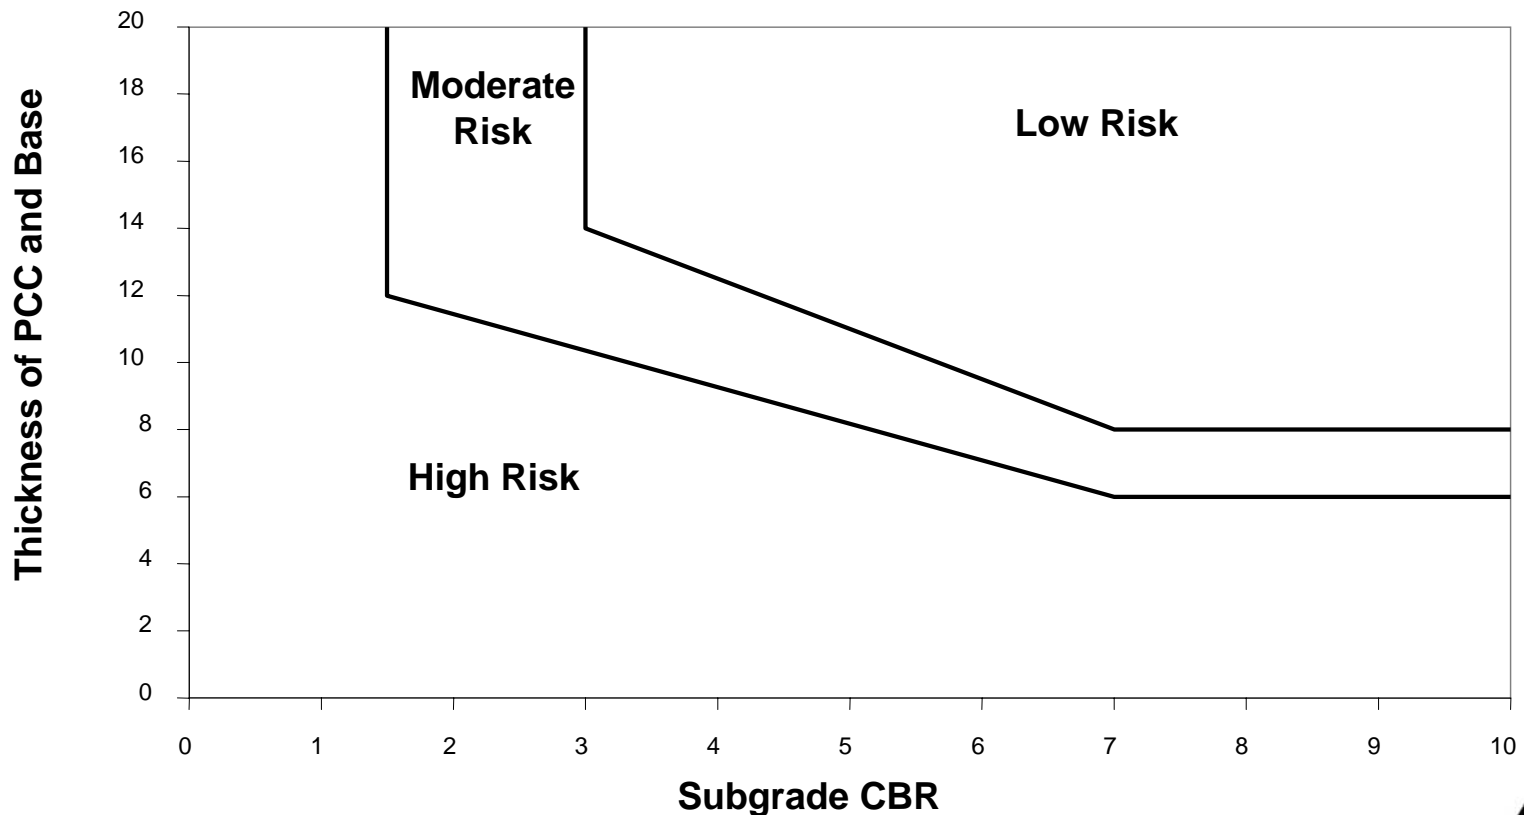
# Assessing Risk to Aid in Project Feasibility Guidance

**Assessing risk of having inadequate structural support for effective rubblization (resulting in inconsistent breakage, large and shifting PCC particles, punch-thus or rutting from construction equipment).**

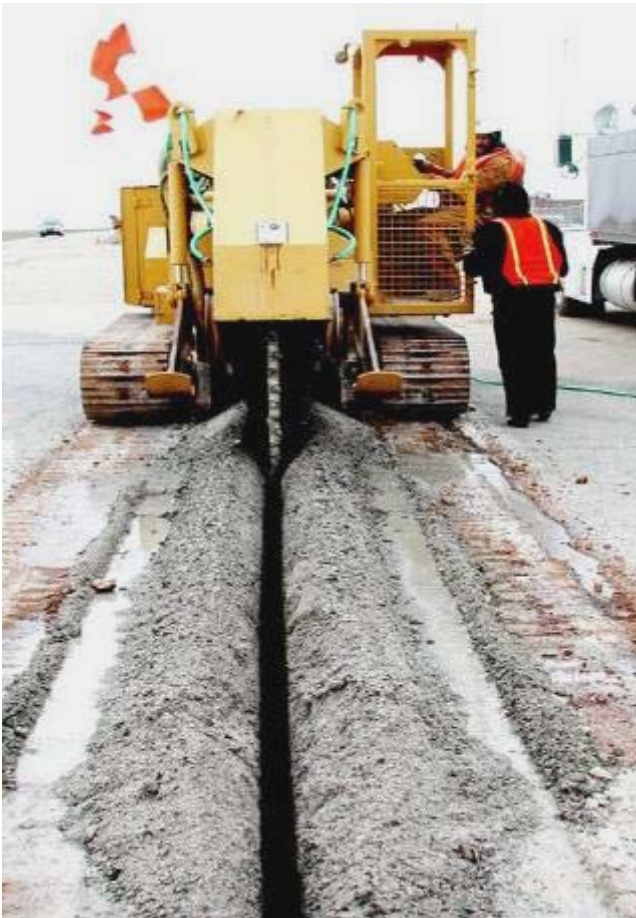
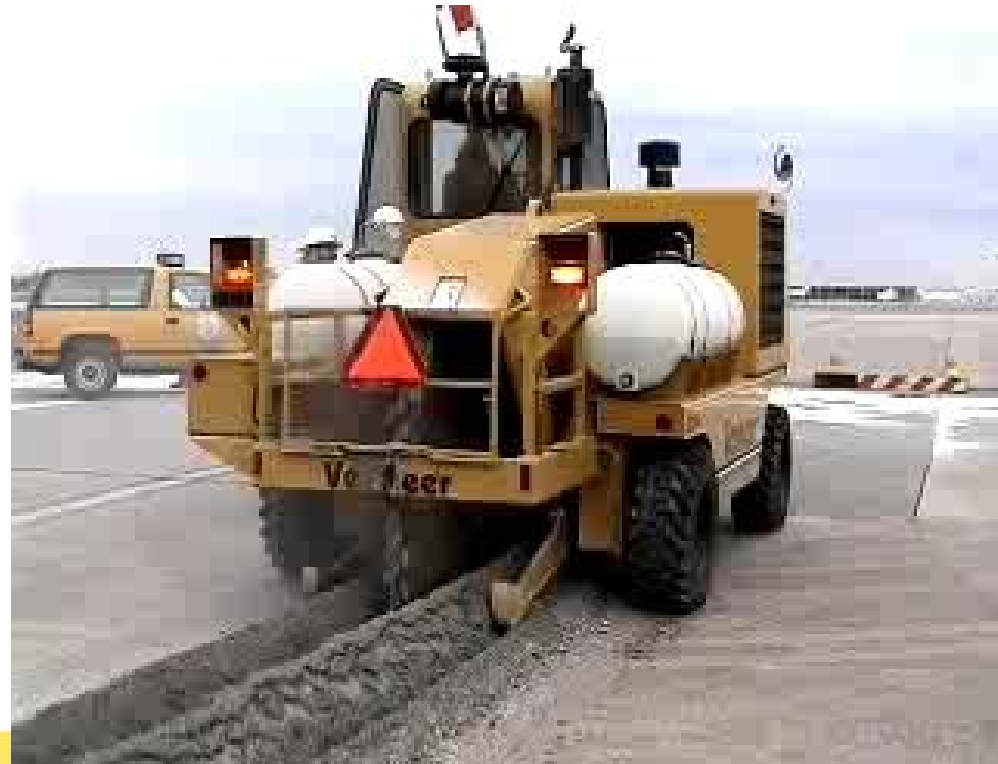
# Isolate Adjacent Pavements Not To Be Rubblized

**Protect structural integrity of adjacent pavement with:**

- wheel saw relief trench, or
- two parallel diamond blade saw cuts
