Runway Concrete Slab Replacement in Record Time at YVR

Lincoln Chan, P.Eng.
Principal Project Manager, Associate

Project Overview

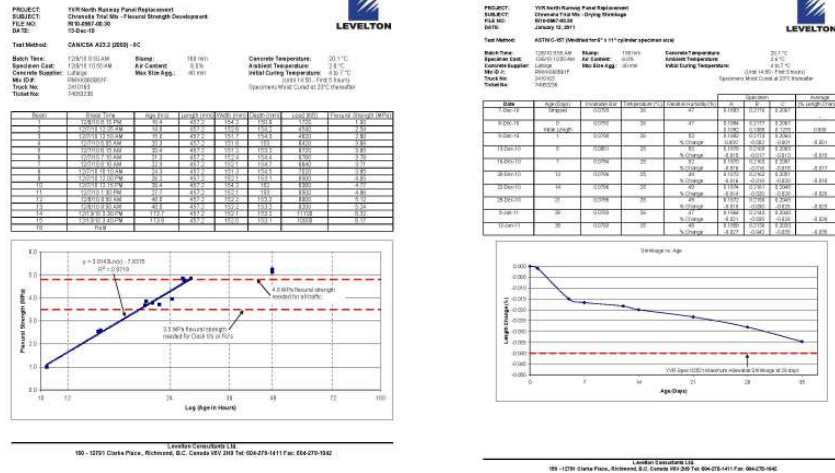
First Trial

- First trial performed at Lafarge Kent Street batch plant on December 6, 2010
 - Air content: 6%
 - Slump: 180mm
 - Moist cured at 23°C after 5th hour
 - Flexural Strength: 3.5MPa at ~20hrs & 4.8MPa at ~26hrs
 - Drying Shrinkage: -0.028% at 28 days
 - Issue: segregation

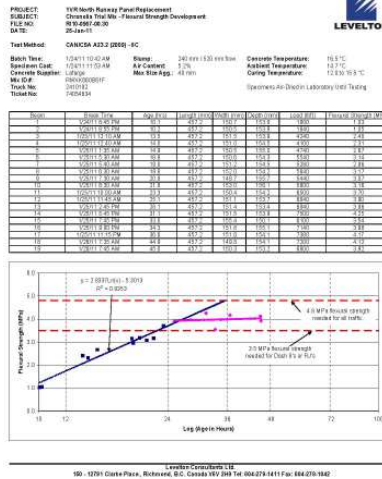
Second Trial

- Second trial performed at Levelton's laboratory on January 24, 2011 to simulate 30 – 40 mins of transit time
 - Air content: 5.2%
 - Slump: 240mm
 - Air-dried in laboratory until testing
 - Flexural Strength: 3.5MPa at ~23hrs & levelled off at 4.1MPa after ~36hrs
 - Issue: possible phenomenon known as "accelerator burn-out" of cementing materials (lack of supplementary water during air-dry conditioning in laboratory until testing)

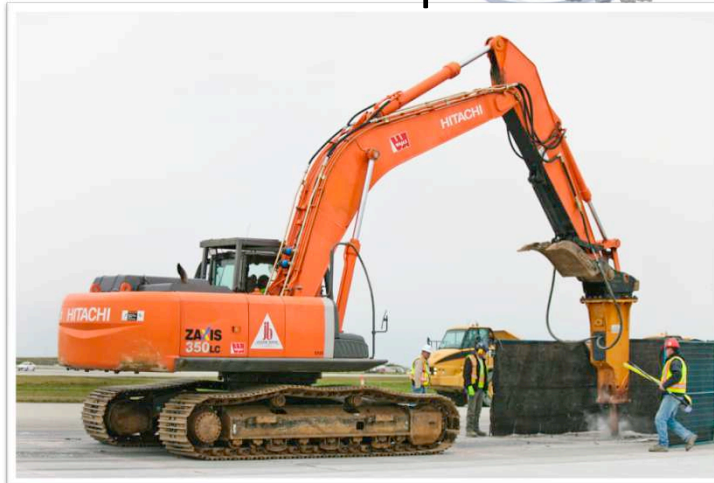
Time 20:10 • (Area A) • PCC Demolition with Hydraulic Hammer

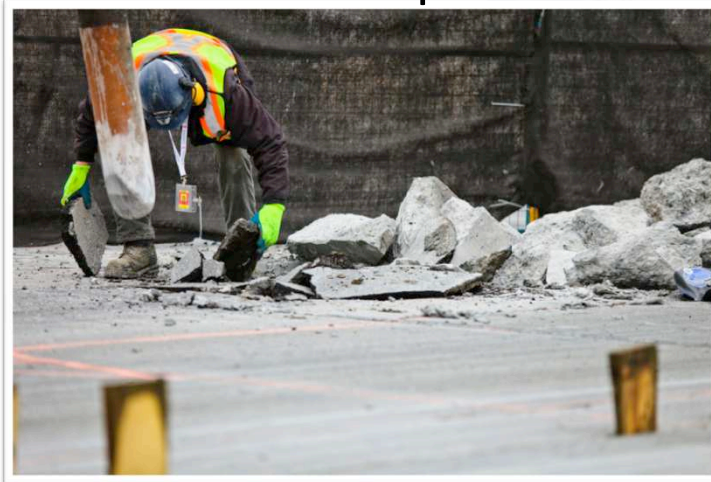
Time 20:20 • (Area A) • Separation of Asphalt Patches from PCC

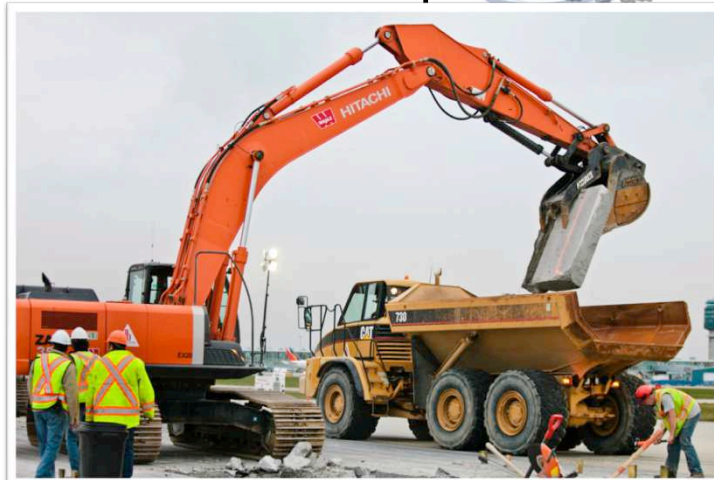
Time 20:35 • (Area A) • Removal of 2.5m x 2.0m PCC Slabs with 2nd Excavator

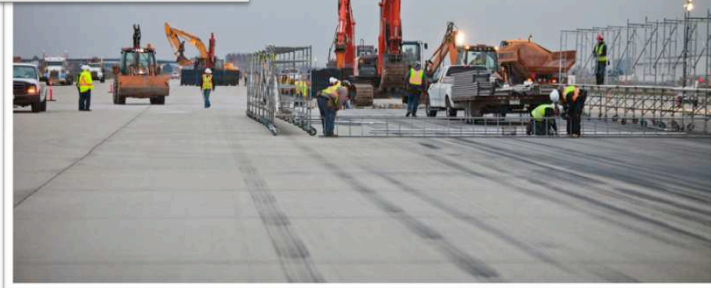
Time 20:50 • (Area A) • 10.5m Tent Structure

- Distinct crews and crew superintendent for each activity
- Mock-up to simulate worse case scenarios
- Double sawcut panel edges and relief cut (3 x 3 matrix) one day before runway closure
- 10.5m wide temporary tent structure on wheels for inclement weather and ensure curing environment
- Placement of PCC by line pump and triple roller screed
- Heat and wet curing
- Second batch plant on standby

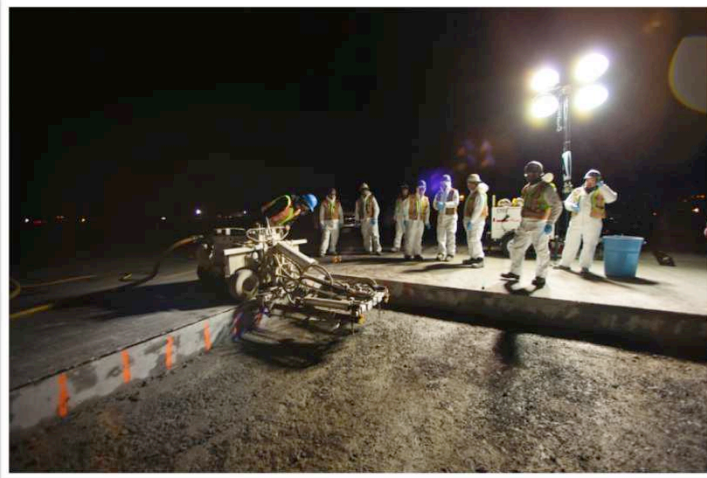
Time 21:40 – 02:00 • (Area A) • Gang-drilling PCC for Dowel Placement
(30mins Ahead of Schedule)

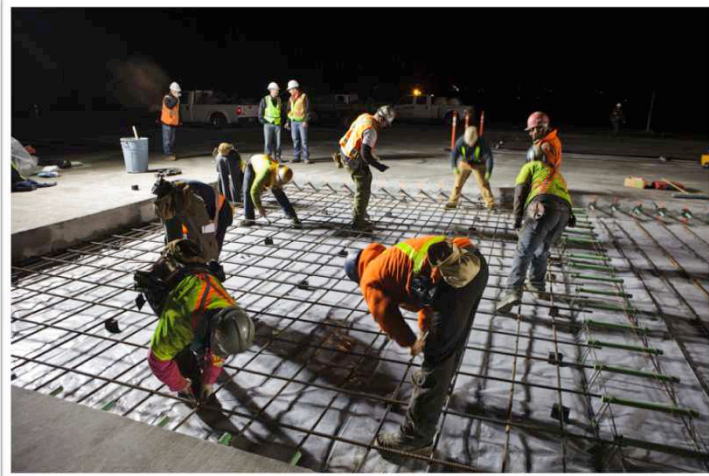
Time 23:15 – 02:30 • (Area A) • Rebar Placement
(On Schedule)

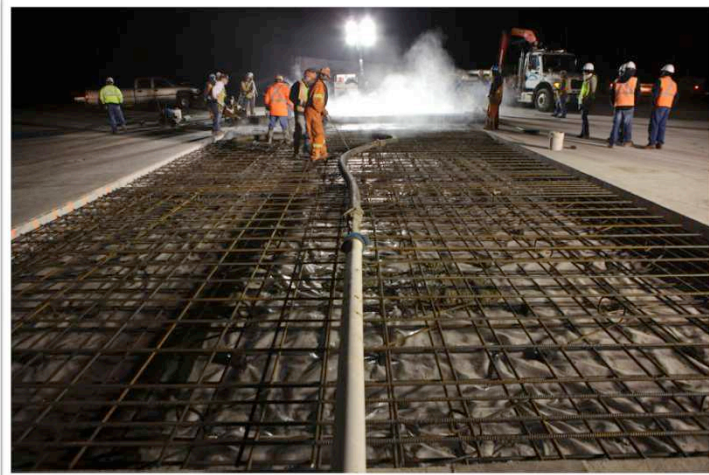
Time 03:00 – 05:00 • (Area A) • PCC Placement Line Pump

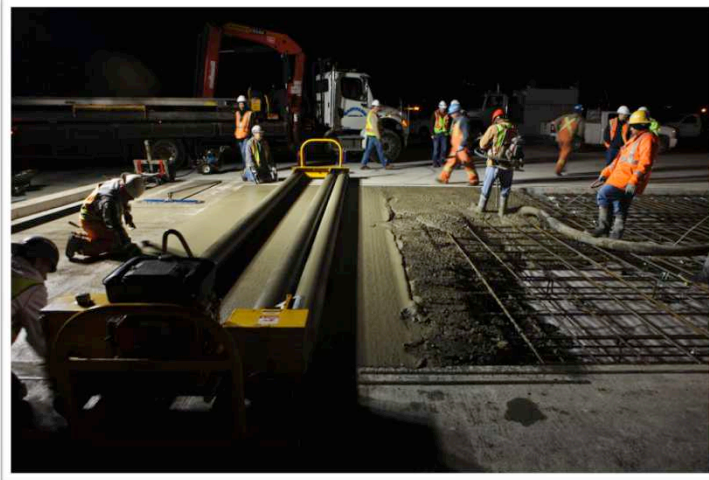
Time 03:00 – 05:00 • (Area A) • Striking off PCC with Triple Roller Screed

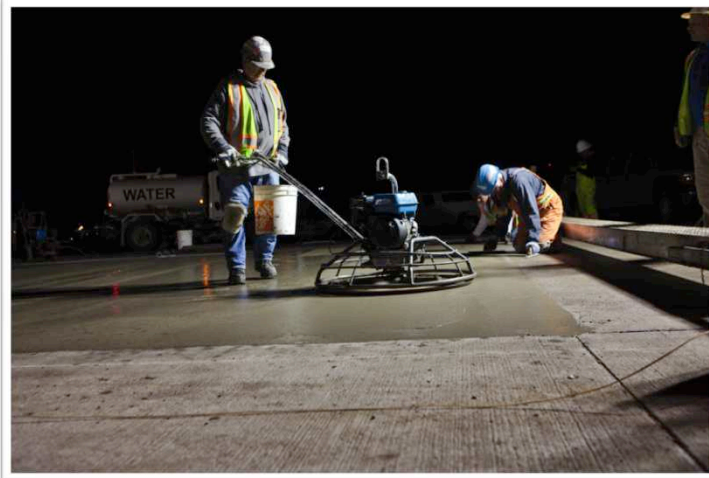
Time 04:00 • (Area A) • Power Trowel PCC to Close the Surface

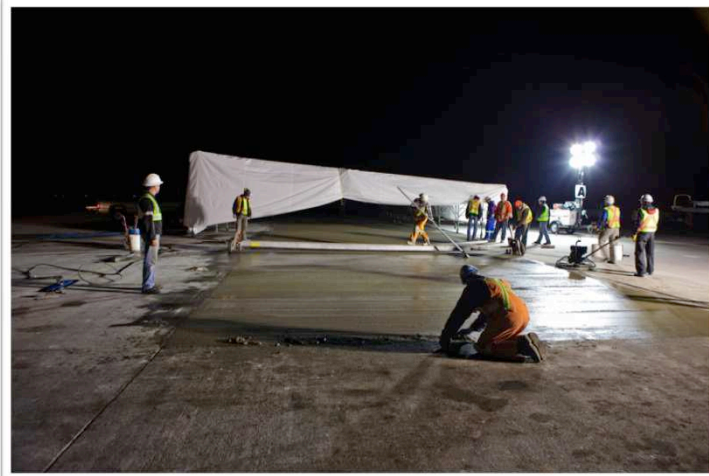
Time 05:00 • (Area A) • Rolling Tent in Place for Curing
(On Schedule)

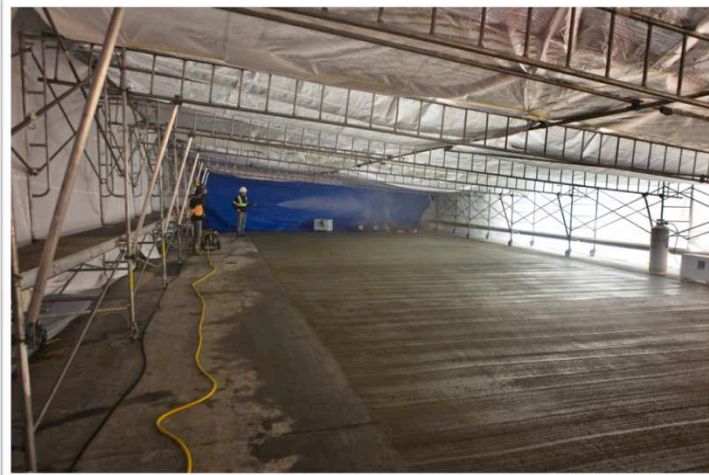
Time 05:30 • (Area A) • Wet Curing at 20-25°C
(On Schedule)

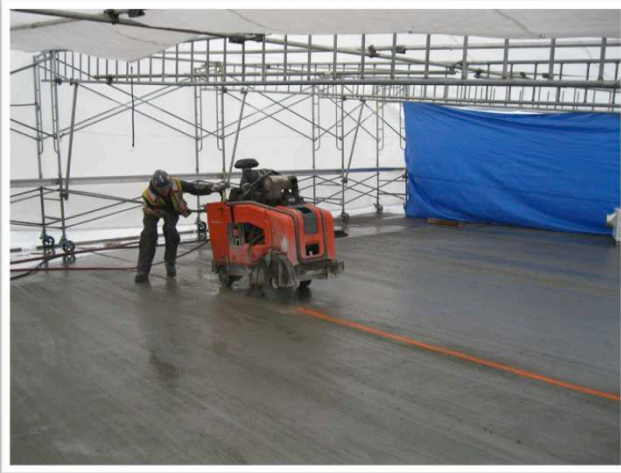
Time 06:15 • (Area A) • Green Cutting of PCC

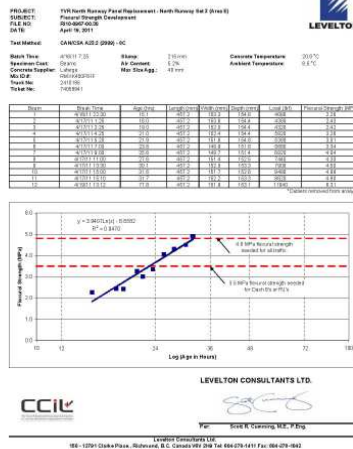
Flexural Strength Results

4.8MPa (700psi) fr after 32hrs (at 15:00 on April 17, 2011)
(Runway Opened 13 hours Ahead of Schedule)
