# Pavement Distress Investigation

## at Toronto Pearson International Airport

**Presenter: Mohammed Kamala – Englobe, Kevin Chee – GTAA**  
**Date: Sept 9, 2019**  
**Location: 2019 SWIFT - Vancouver**

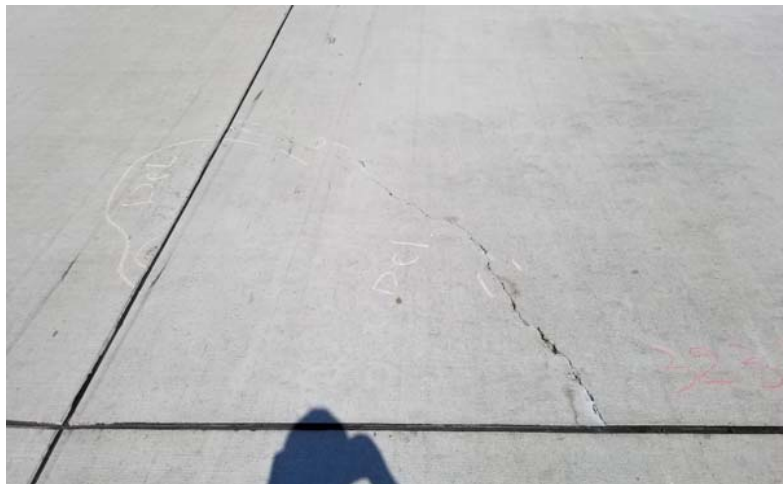
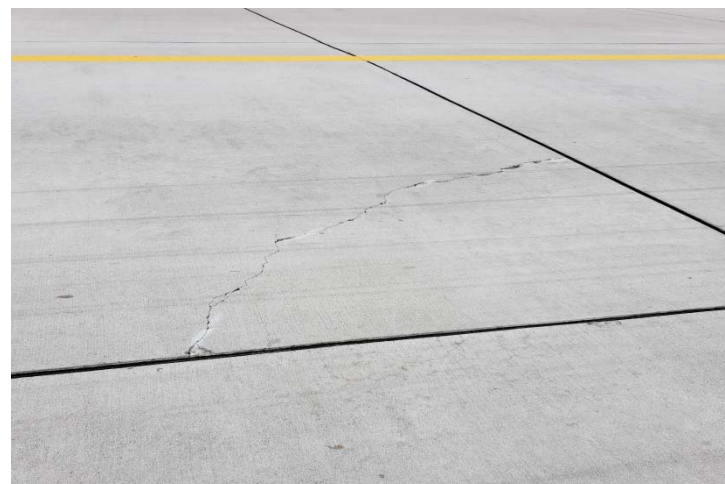
## Field Data Collection - Corner break

1. Cement stabilized base strength exceeded the specified 6.5 MPa @ 28 days resulting in significant residual curling and subsequent corner cracking.
2. Localized loss of support under concrete slab.

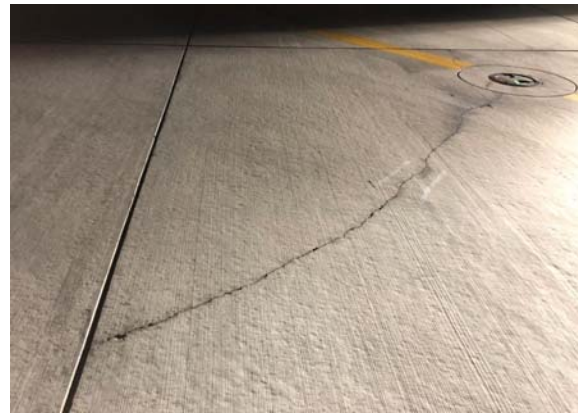
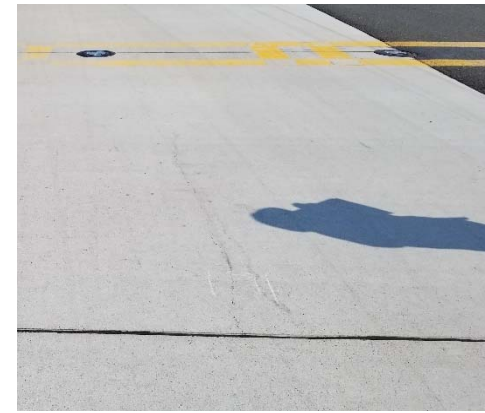
## Field Data Collection - Longitudinal, Transverse & Diagonal Cracking

1. Varied levels of support under the concrete pavement causing differential deflections.
2. Loss of support under the concrete pavement.
3. Possible late or improper sawing of control joints (for low severity)

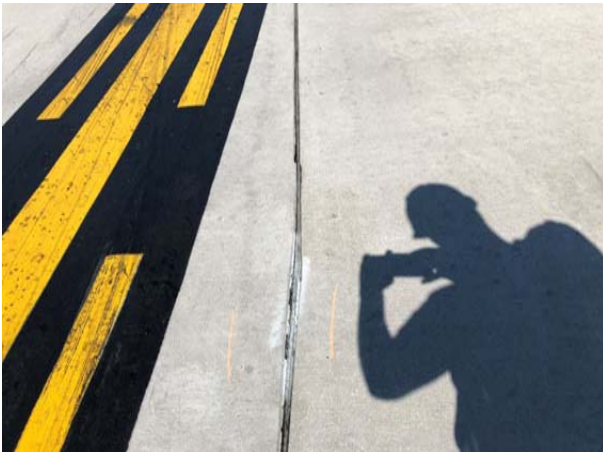
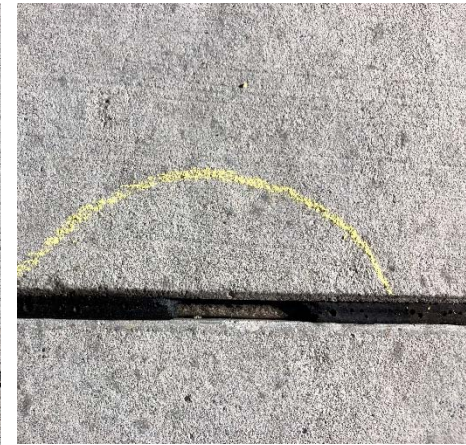
## Field Data Collection - Joint seal damage

1. Improper installation of joint sealant)

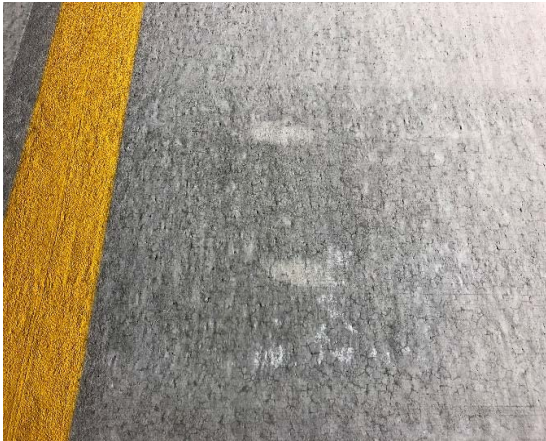
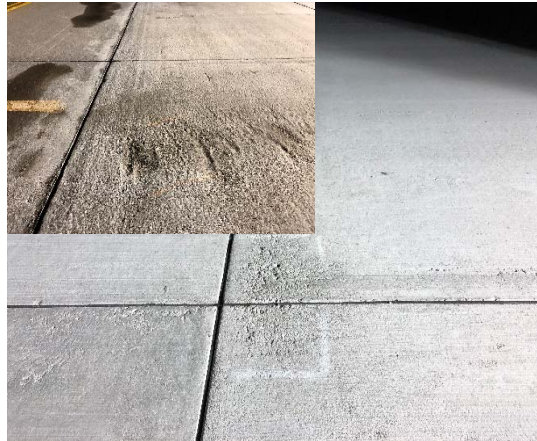
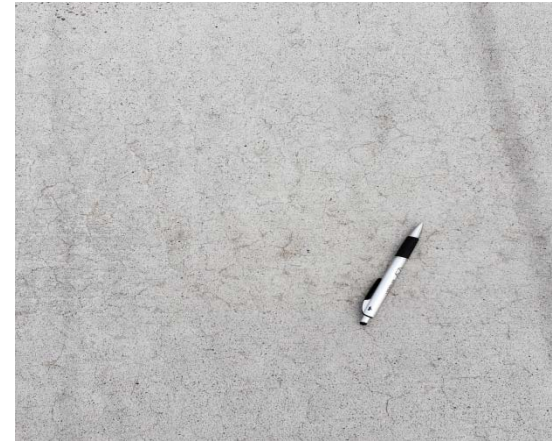
## Field Data Collection - Scaling, Map Cracking & Mortar flaking

1. High water-cementitious ratio or surface concrete and / or poor curing practices
2. Excessive and early drying out of the surface of concrete due to hot temperatures and/ or windy conditions and late application of curing compound

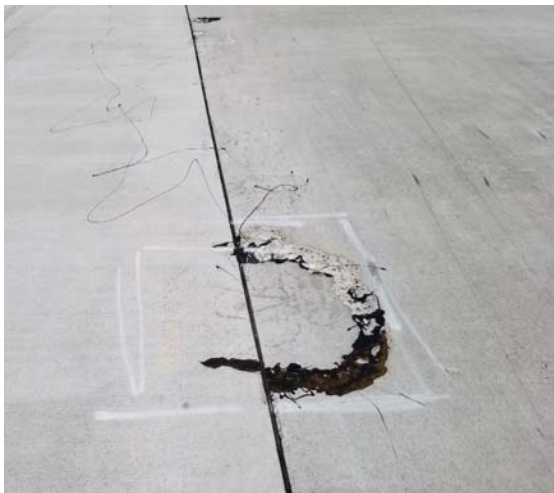
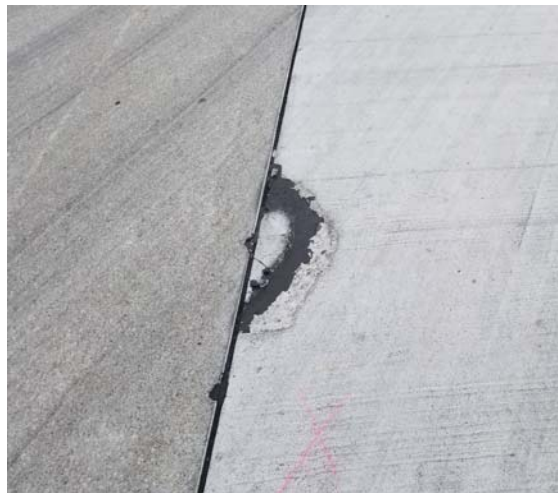
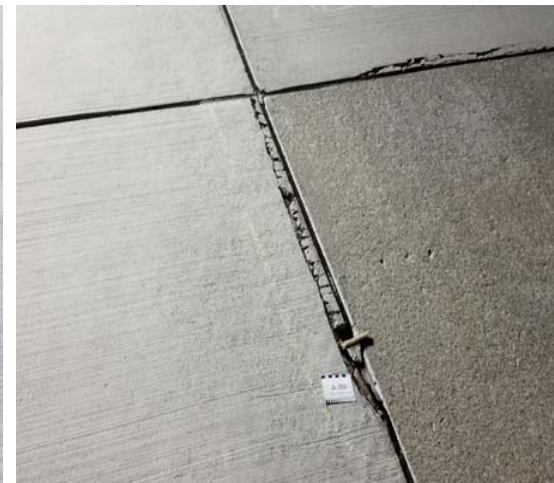
## Field Data Collection - Joint spalling

1. Joint sides are weaker due to loss of moisture during the curing period (curing compound may not have been reapplied after saw cutting).

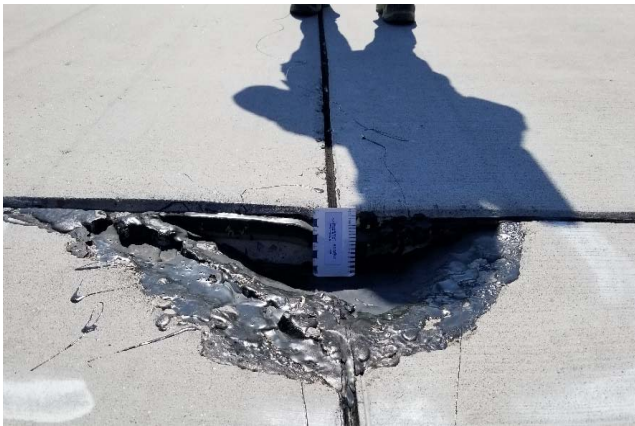
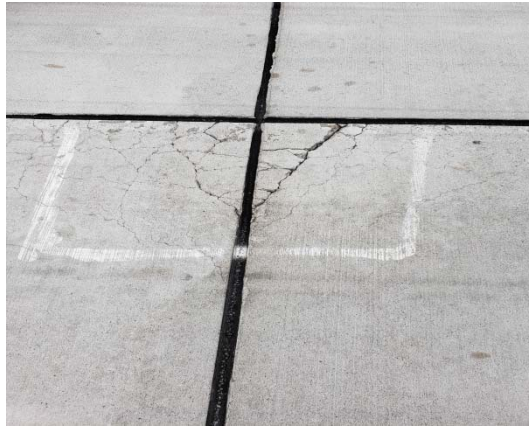
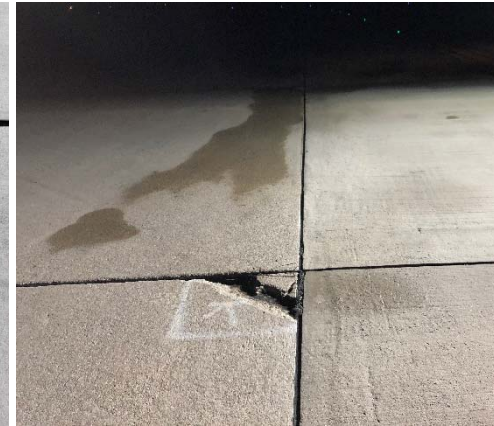
## Field Data Collection - Corner spalling

1. Excessive curling and / or warping due to high moisture differential and / or high-water content.
2. Weaker concrete at corner side joints due to improper curing that spalls off over time.

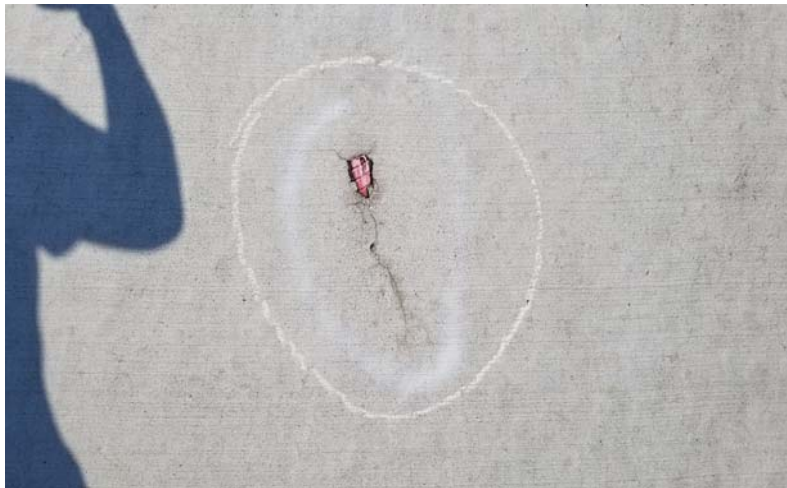
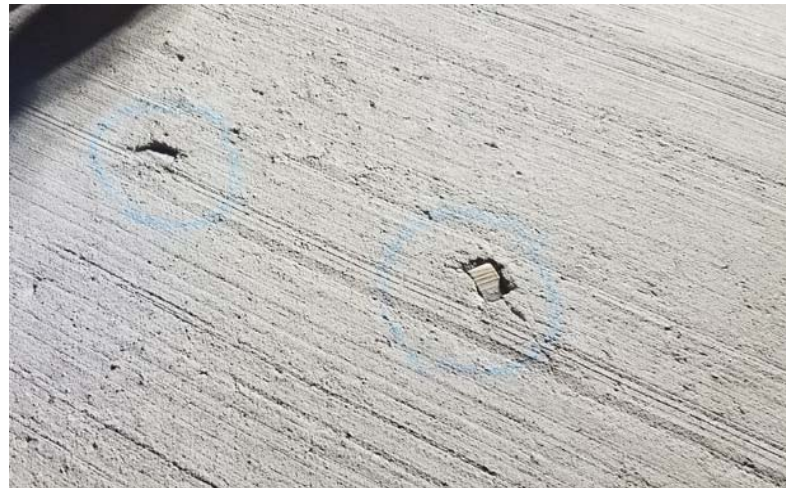
## Field Data Collection - Wood, Plastic & Metal

1. Poor housekeeping failing to remove garbage from pour area.
2. Possible displacement of dowel basket which surfaced during construction

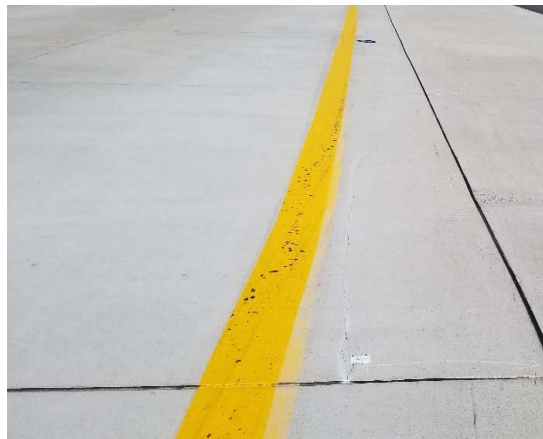
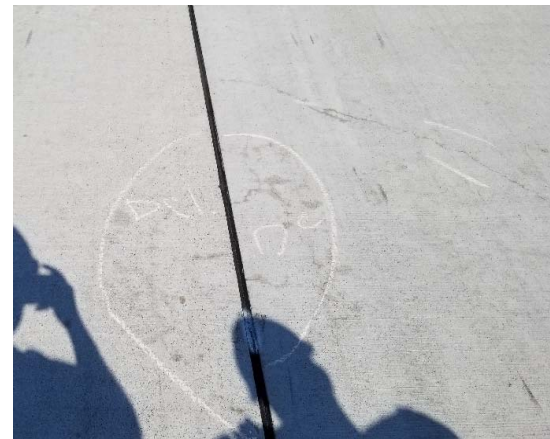
## Field Data Collection - Concrete Delamination

1. Improper protection of concrete during inclement weather or possibly due to weight of protective tarps and anchor systems.
2. Premature sealing of the concrete surface.
3. Leaving excess concrete along the longitudinal joint of a previously poured lane.
