Pavemetrics

SWIFT 2011 - Laser Crack Measurement System (Barcelona Airport survey)

Vision Technology for Inspection of Transportation Infrastructures

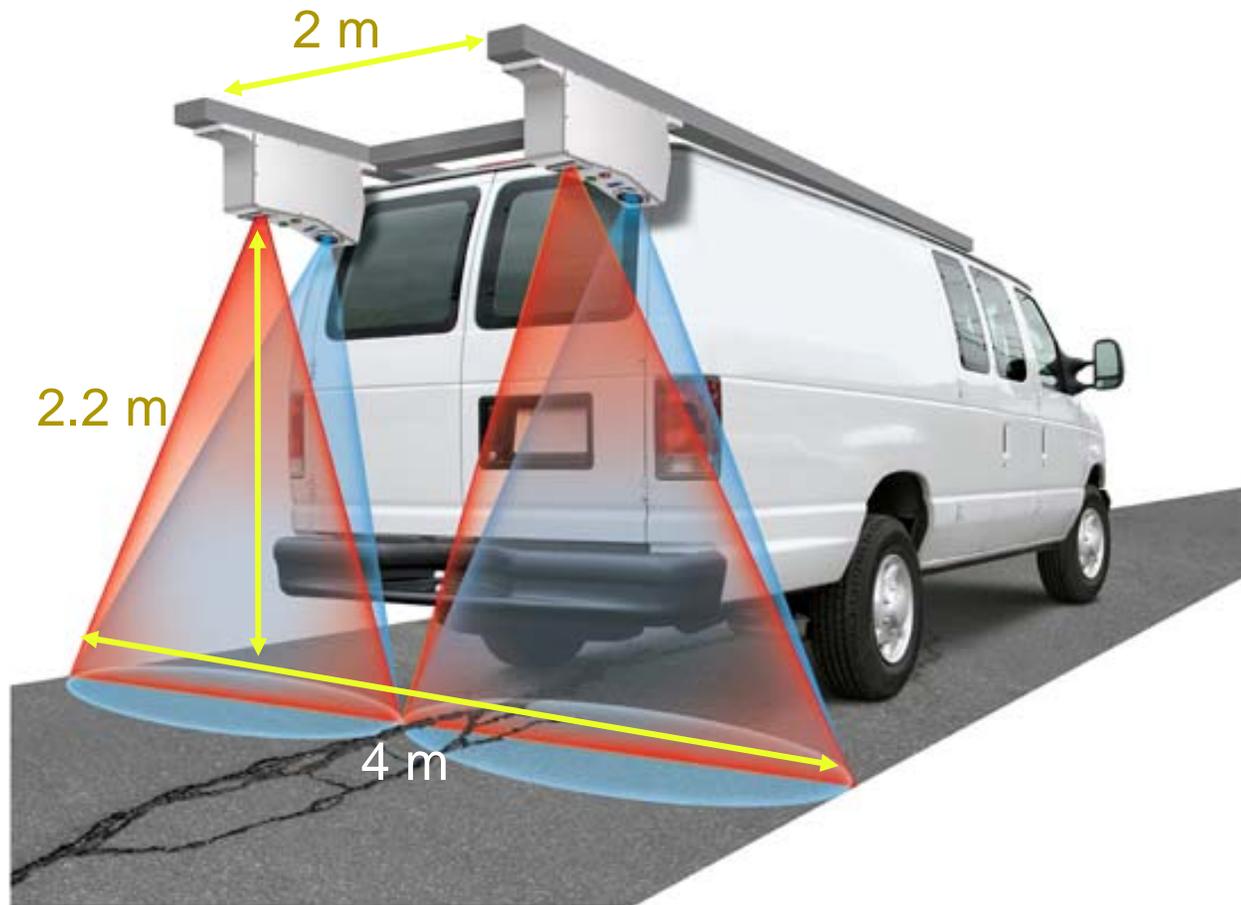
Laser profiling (principle)

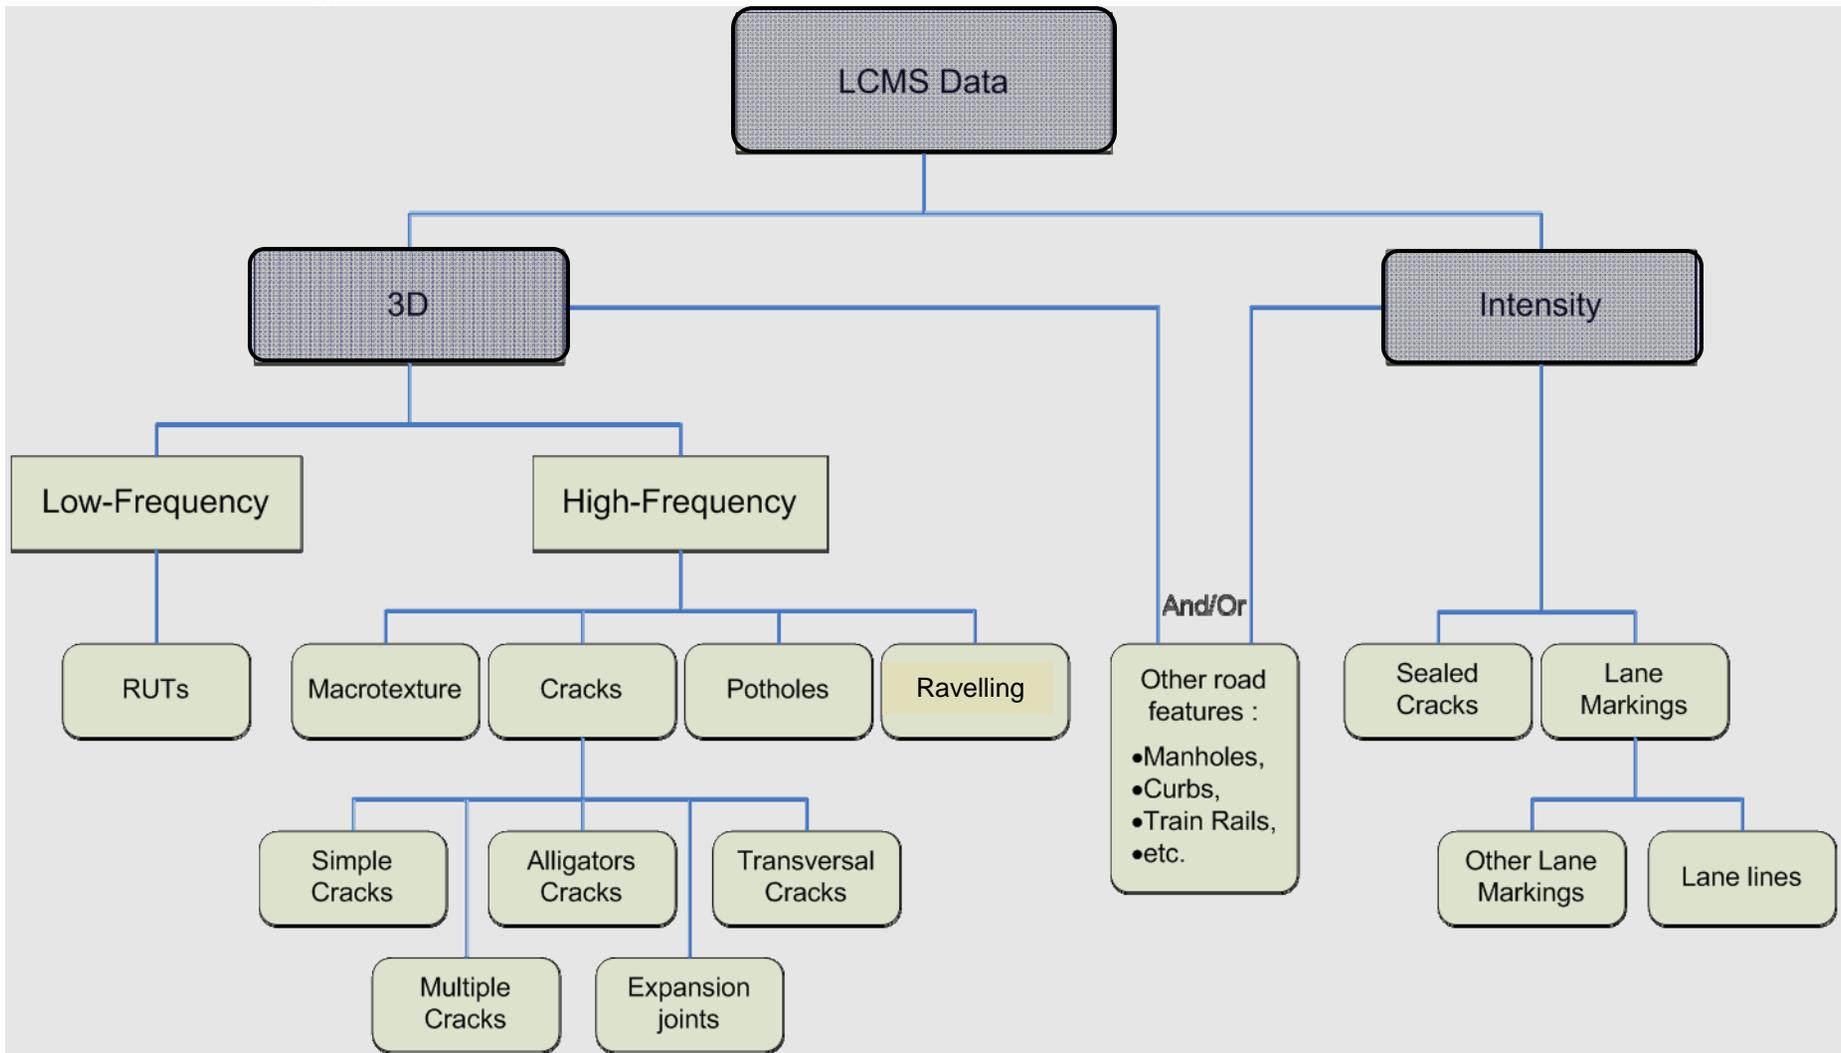
LCMS Specifications

Acquisition Rate	11,200 profiles/s
Range Accuracy	0.5mm
Lateral Resolution	1mm (FOV = 4m)

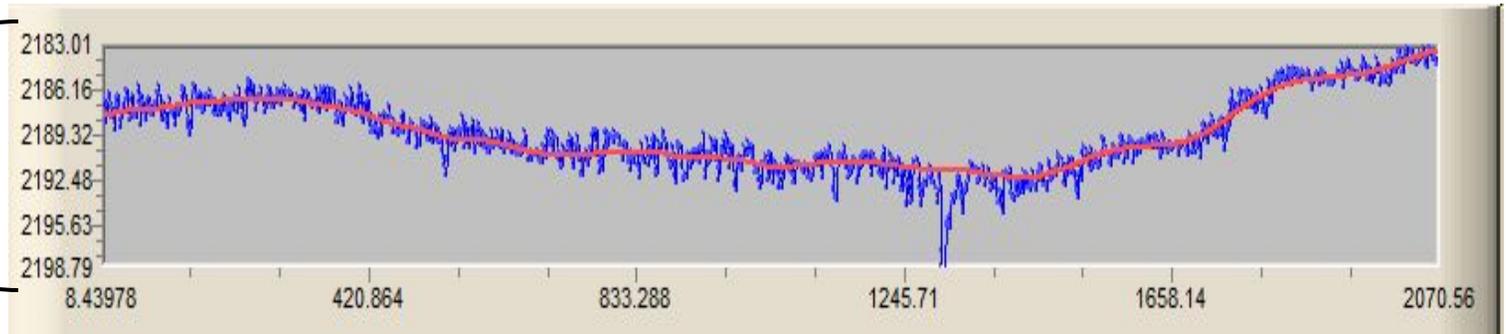
Single Road Profile (2 meter)

Distance
between Sensor
and ground
(in mm)

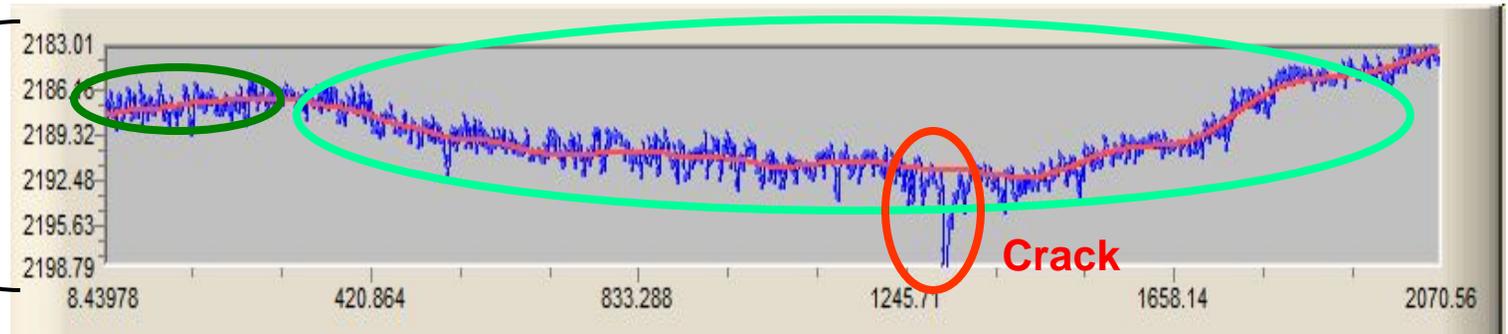
Single Road Profile (2 meter)

Macro-texture

Rut

Distance
between Sensor
and ground
(in mm)

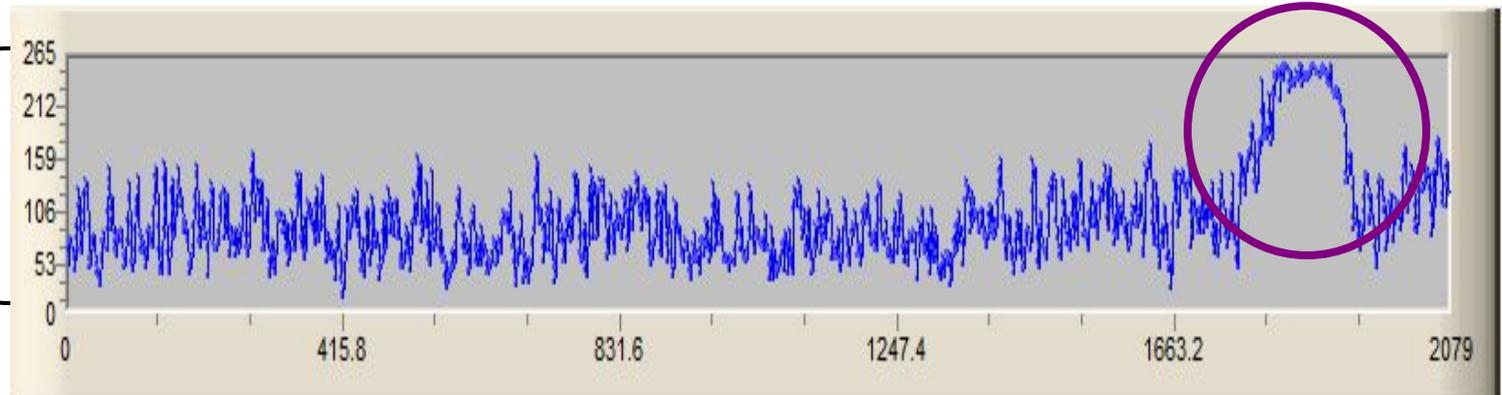
Laser intensity
(black = 0,
white = 255)

Right Lane
Marking

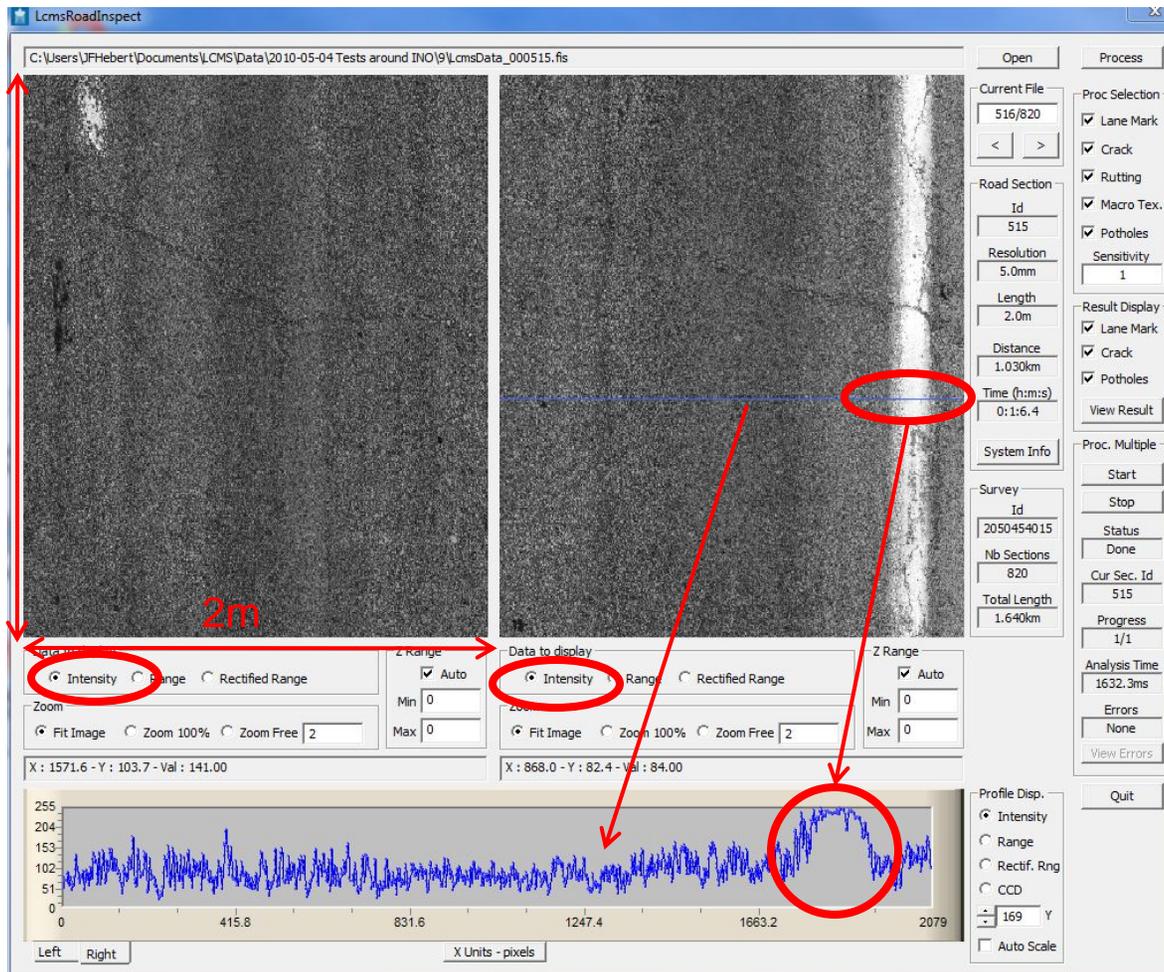
Road Section: Intensity Data

400 road profiles captured every 5 mm = 2m road section

Definition:
A Road Section is a set of profiles merged together.

Intensity:

- Depends on the reflective properties of the surface.

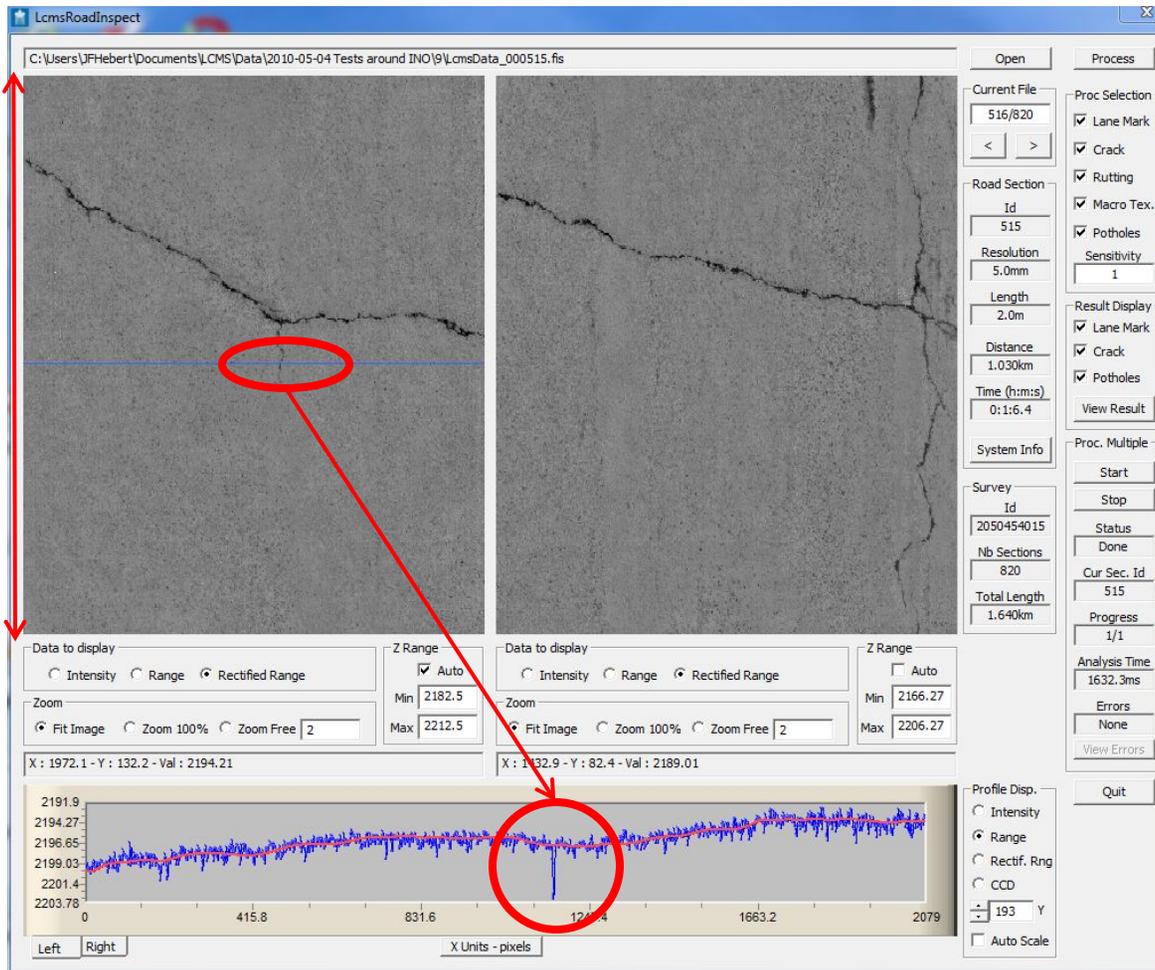
Road Section: Range Data

400 road profiles captured every 5 mm = 2m road section

Range:

- Gives the distance to the ground.

Mapping to 2D Viewer:

- Darker points = further away
- Gray points = on-surface
- White points = closer

Cracks:

- Notch in the profile
- Appear darker in range image

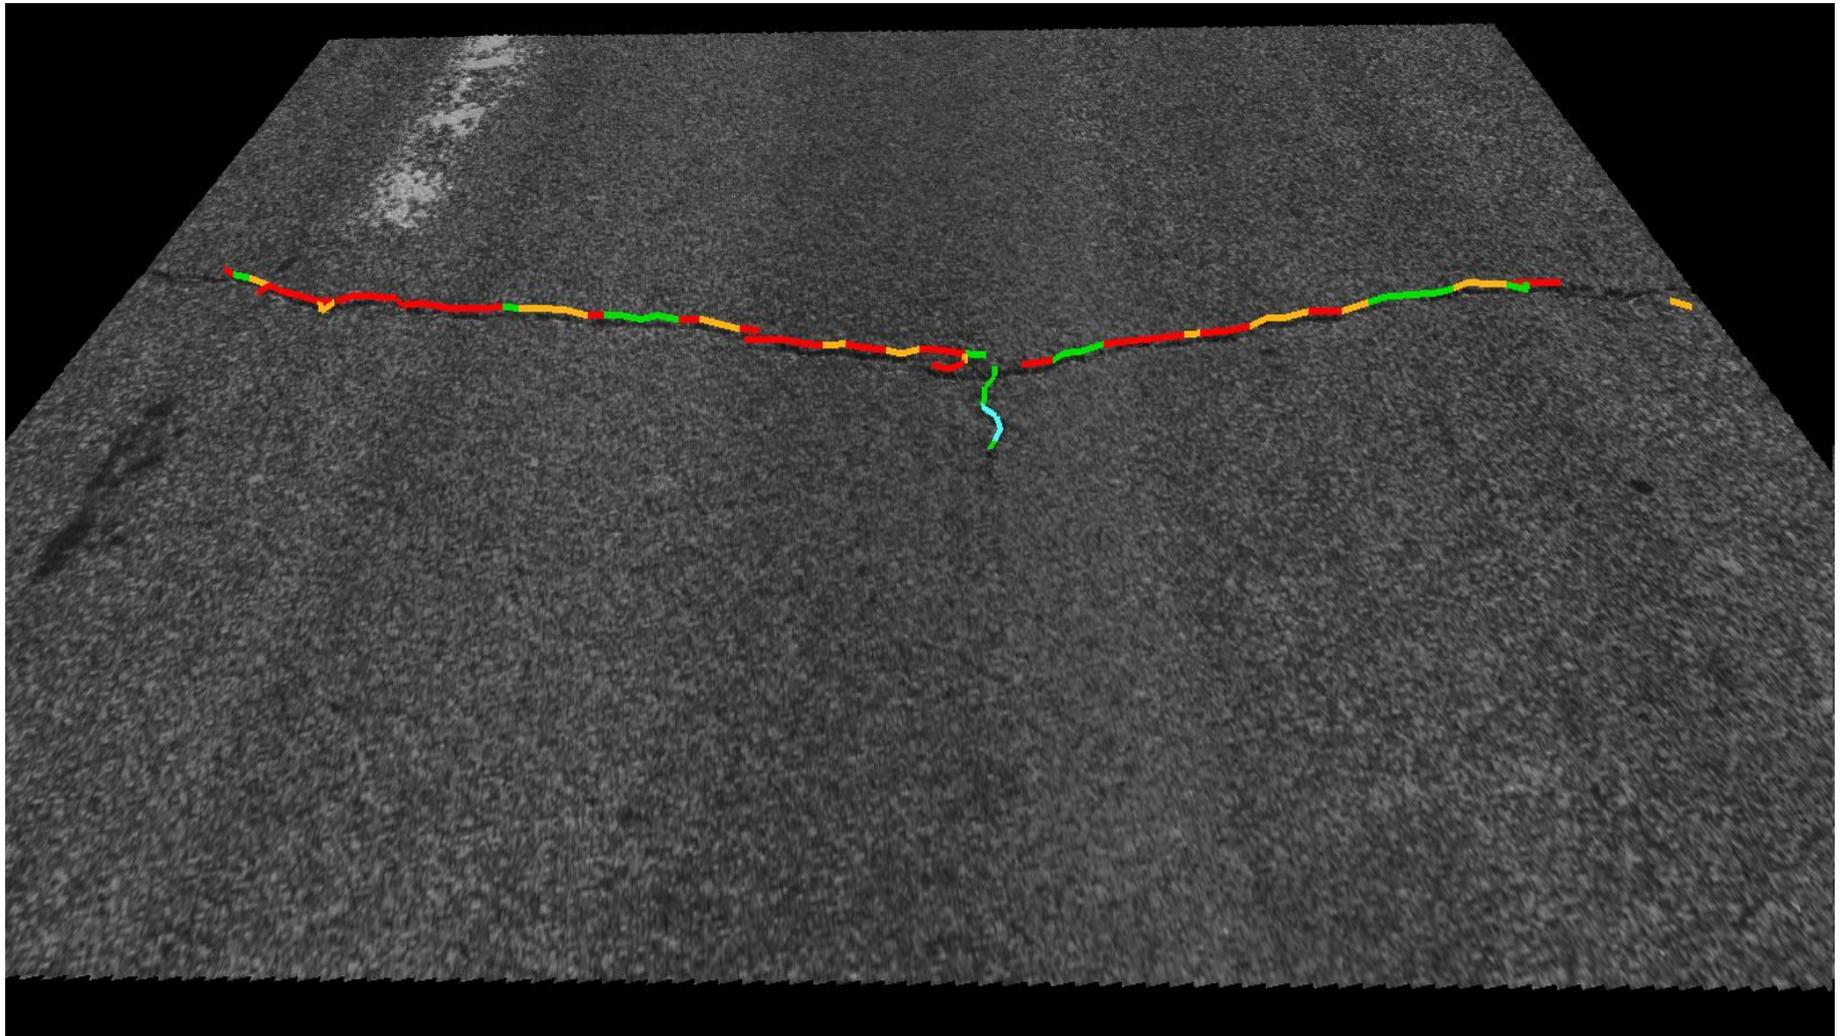
Automatic Crack Detection Length, Type, Severity

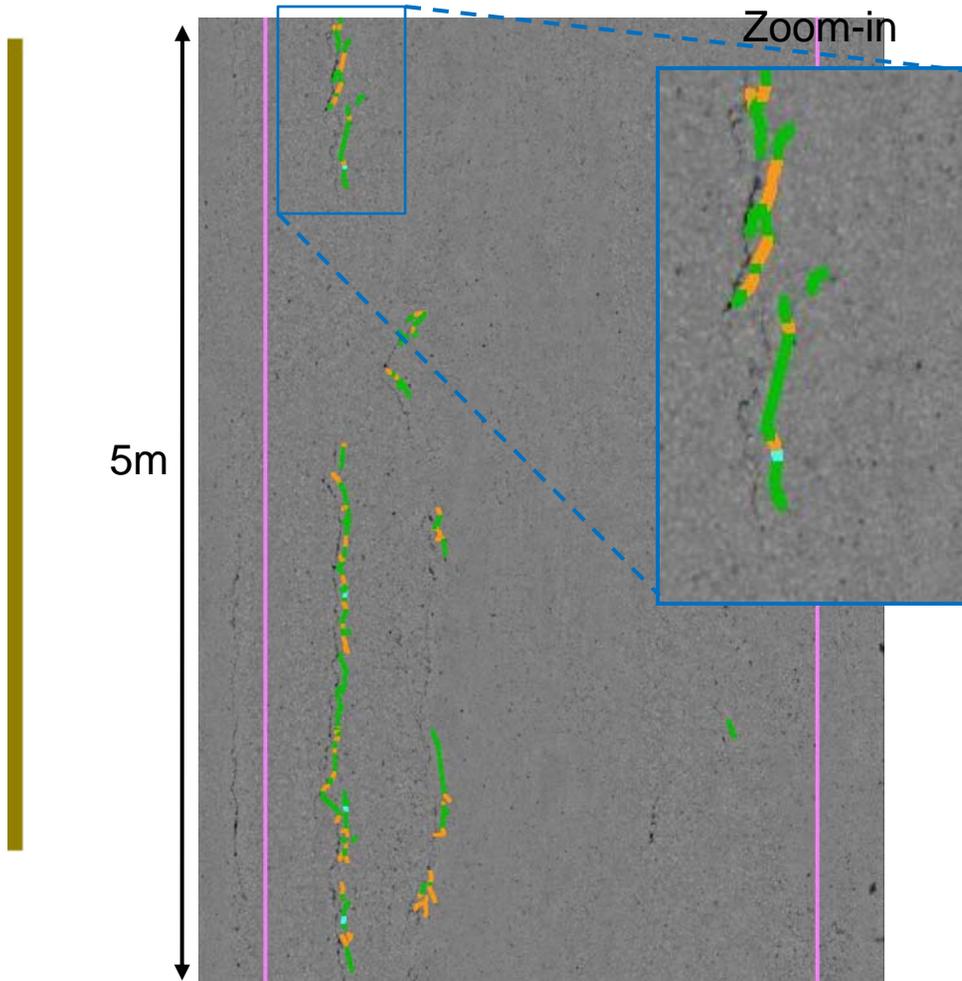
Crack example: 8695m

(Osaka data file 1739.jpg)

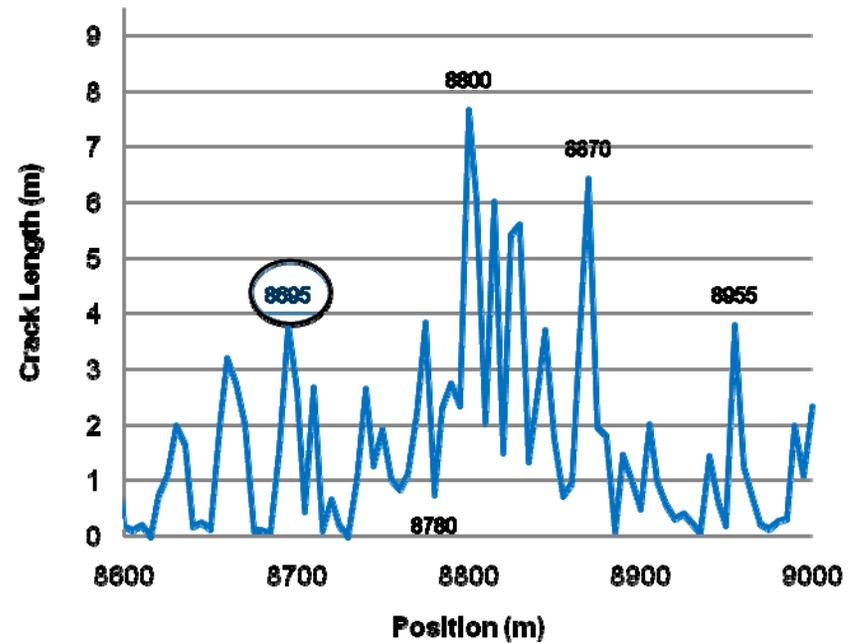
Crack length (per road section) between 8.6km and 9.0 km for Osaka Data
(files 1720.jpg-1800.jpg)

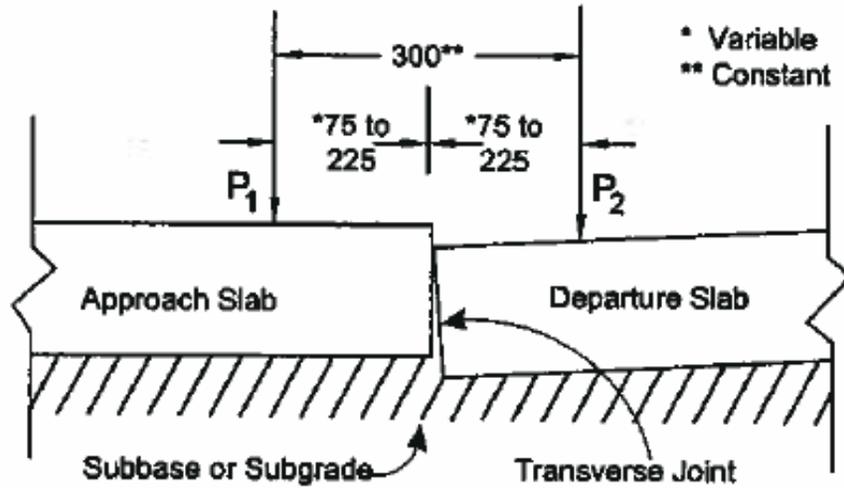
Joint detection and faulting

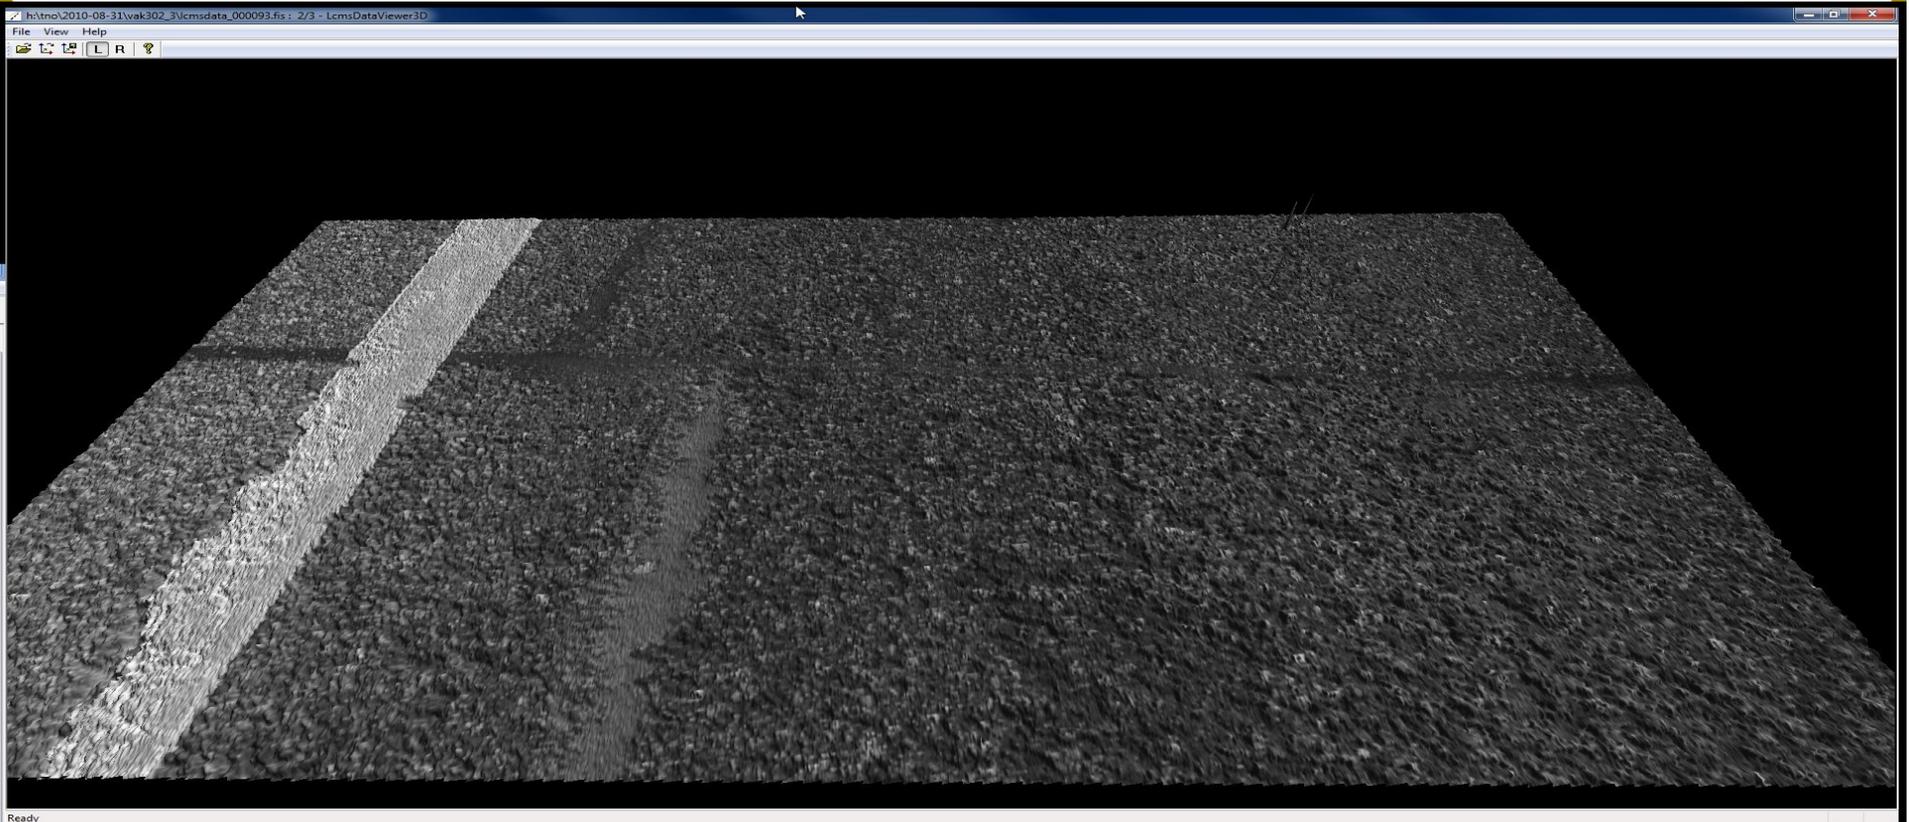
Raveling Index (RI)

- Raveling spots (loss of aggregate) are identified from the 3D range images.
- The volume of the missing aggregate spots are measured per surface area.

$$RI = V_{ravelling} / A_{Total}$$

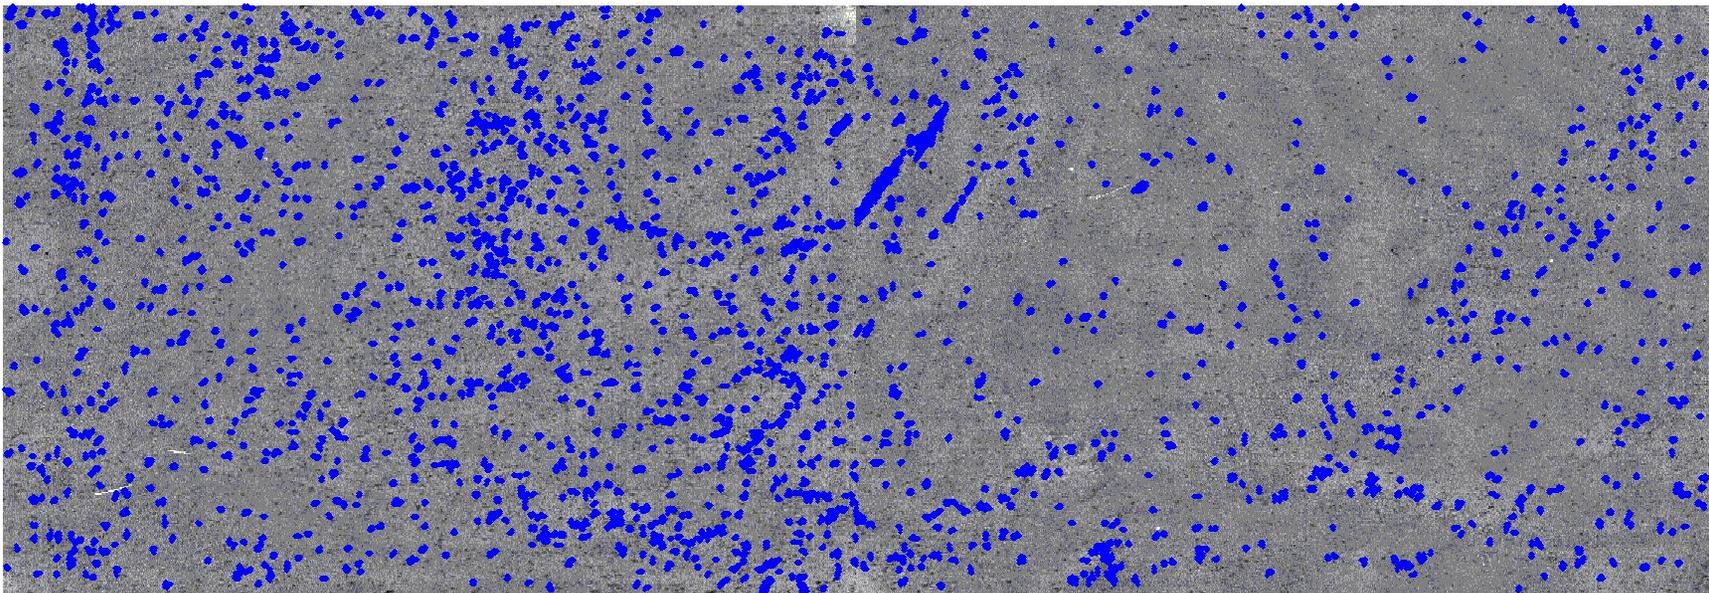
Aggregate loss detection

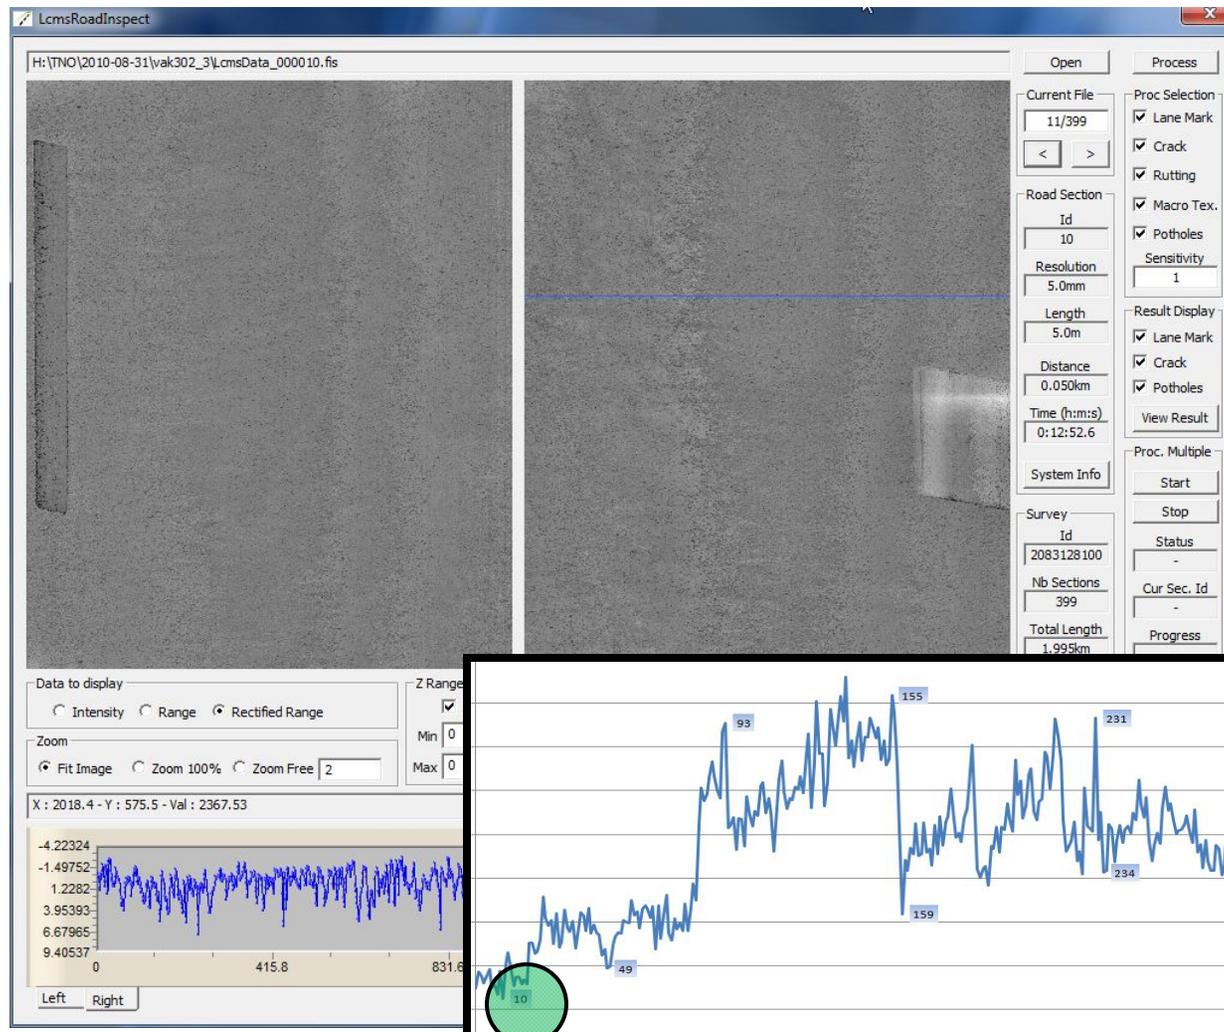
RI - Road test - Porous Asphalt in the Netherlands

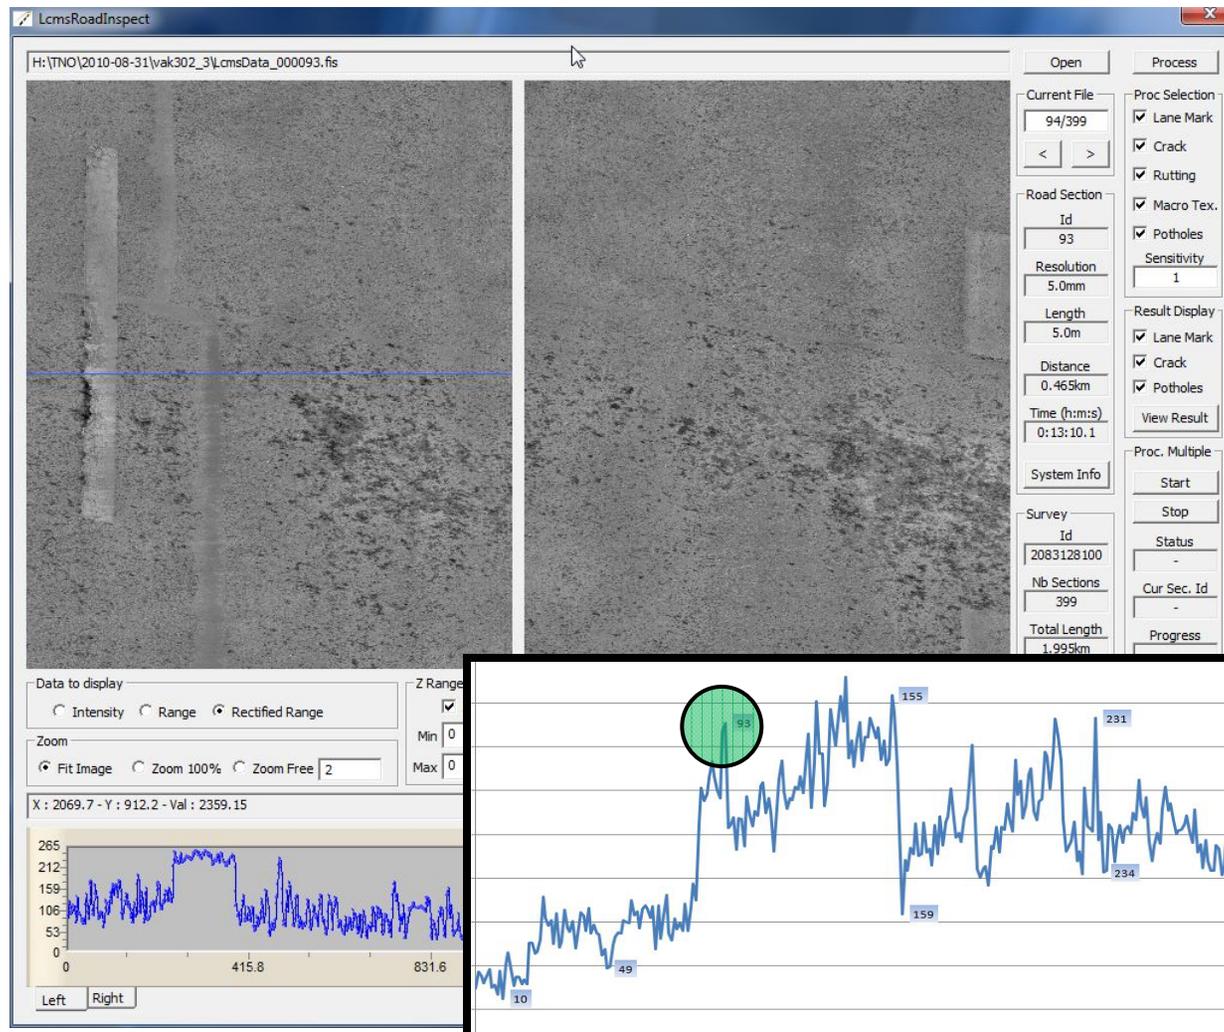
Road Section #93 : Transition between Ravelling and new pavement (Range)

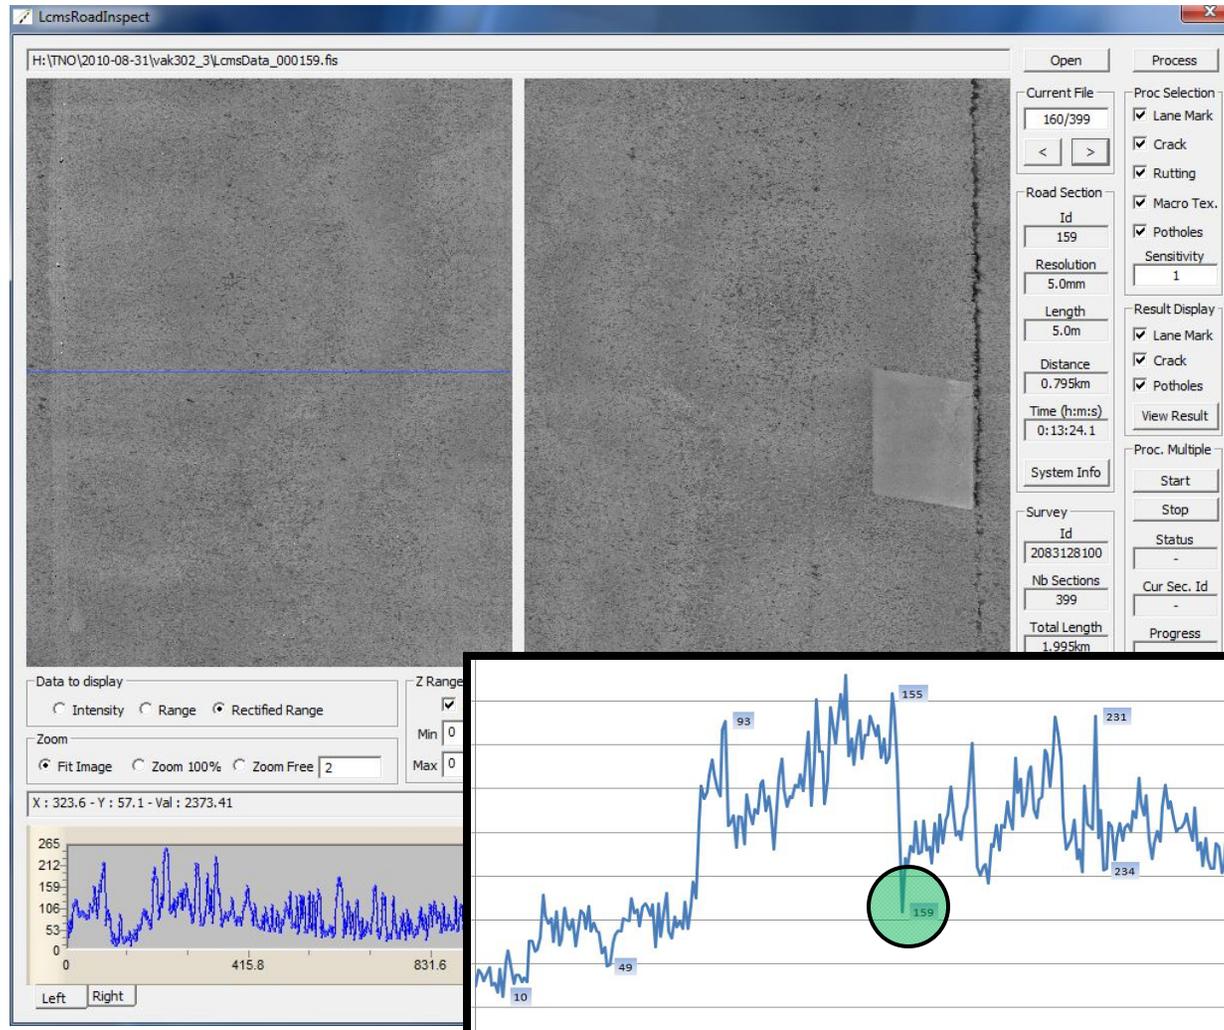
Road Section #159 : Smooth texture

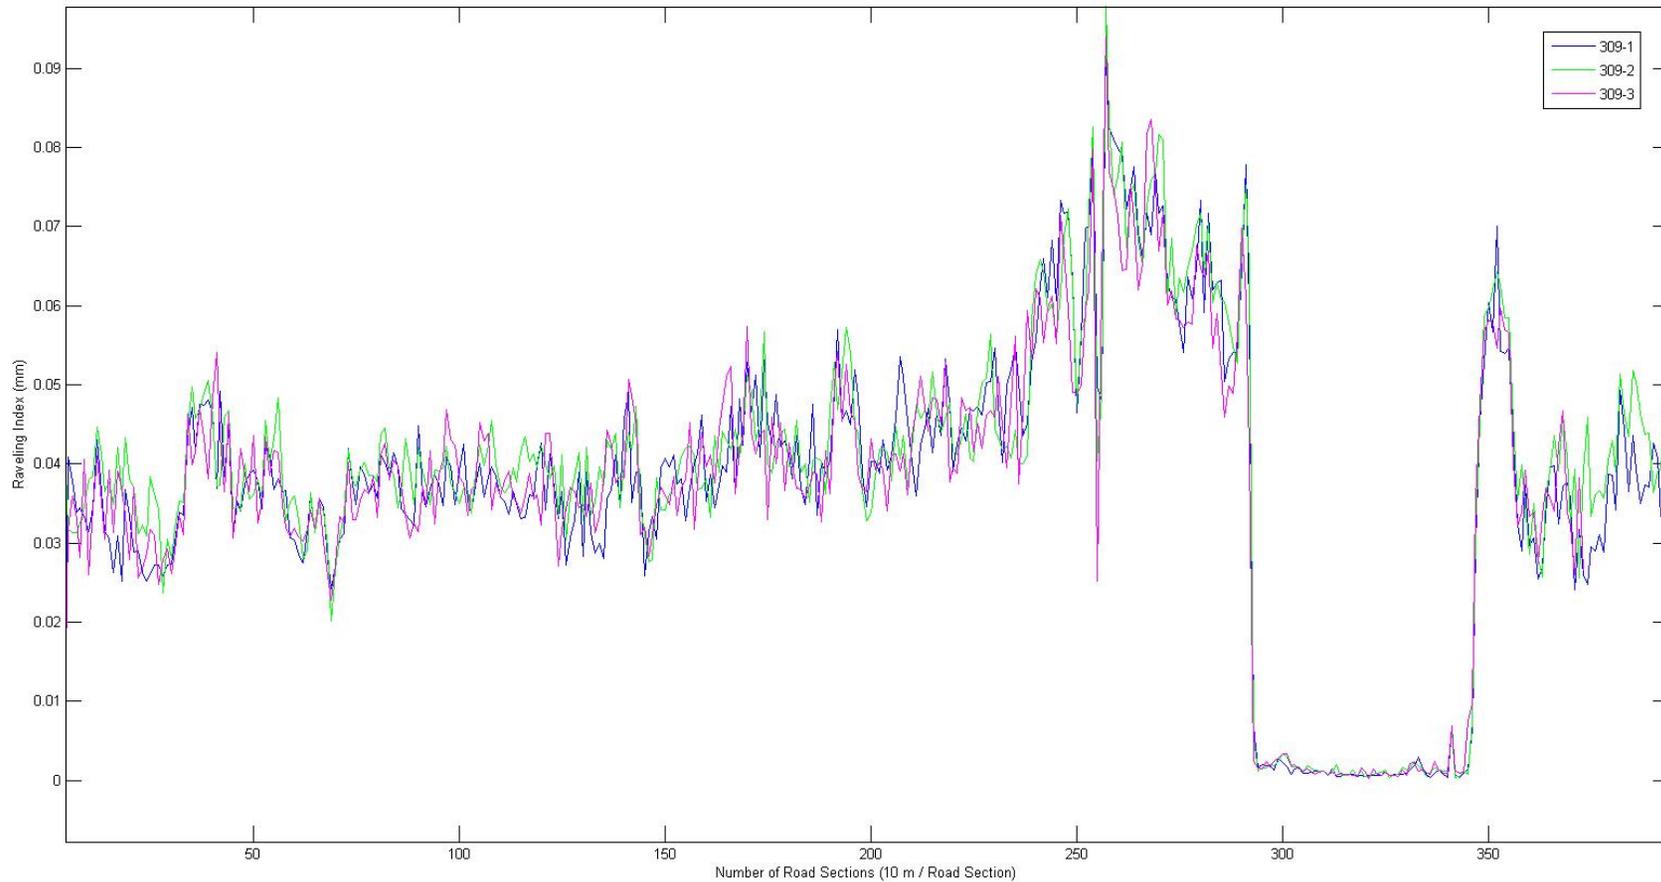
Ravelling Index - Repeatability (Porous asphalt Netherlands)

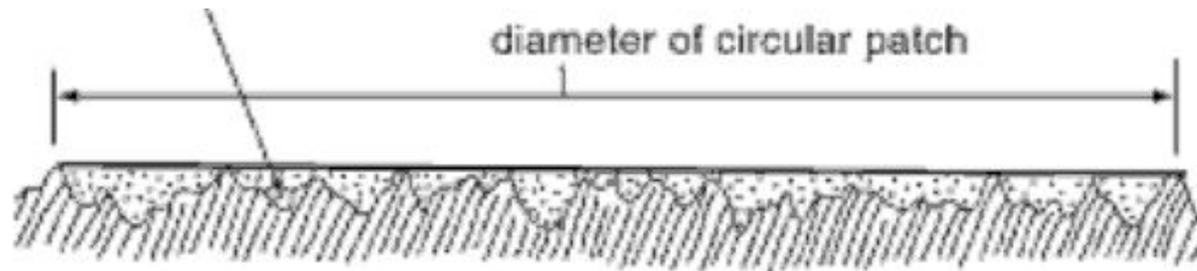
Macrotexture - RPI

Digital Sand Patch Method

RPI - Road Porosity Index = (Volume under the surface – Ravelling - Cracks) divided by a surface area

$$RPI = \frac{Vol_{air\ void} - Vol_{ravelling} - Vol_{cracks}}{Area_{Total}}$$

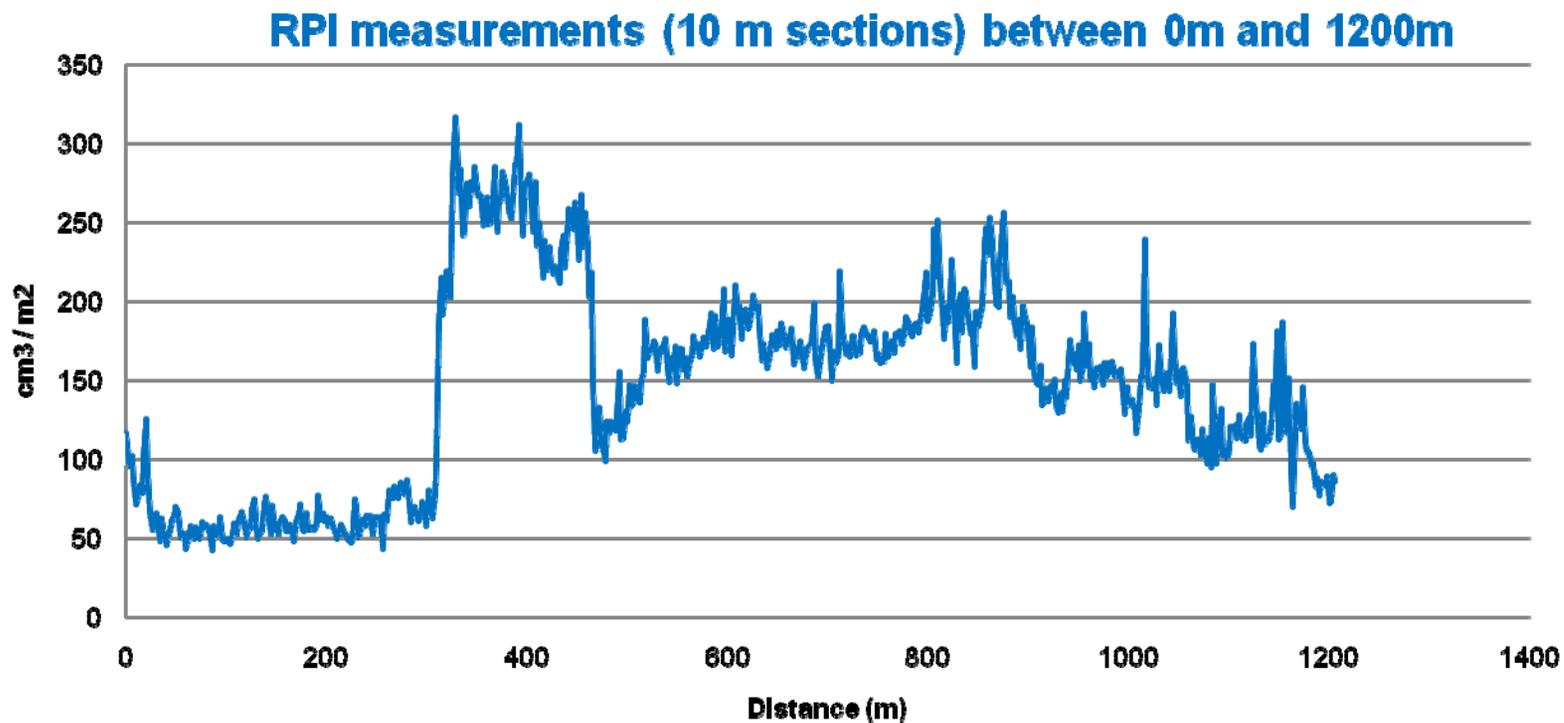
RPI – Road Test (Québec)

- This test section is interesting because it involves different types of pavement surfaces: Smooth, Very rough and Rough.

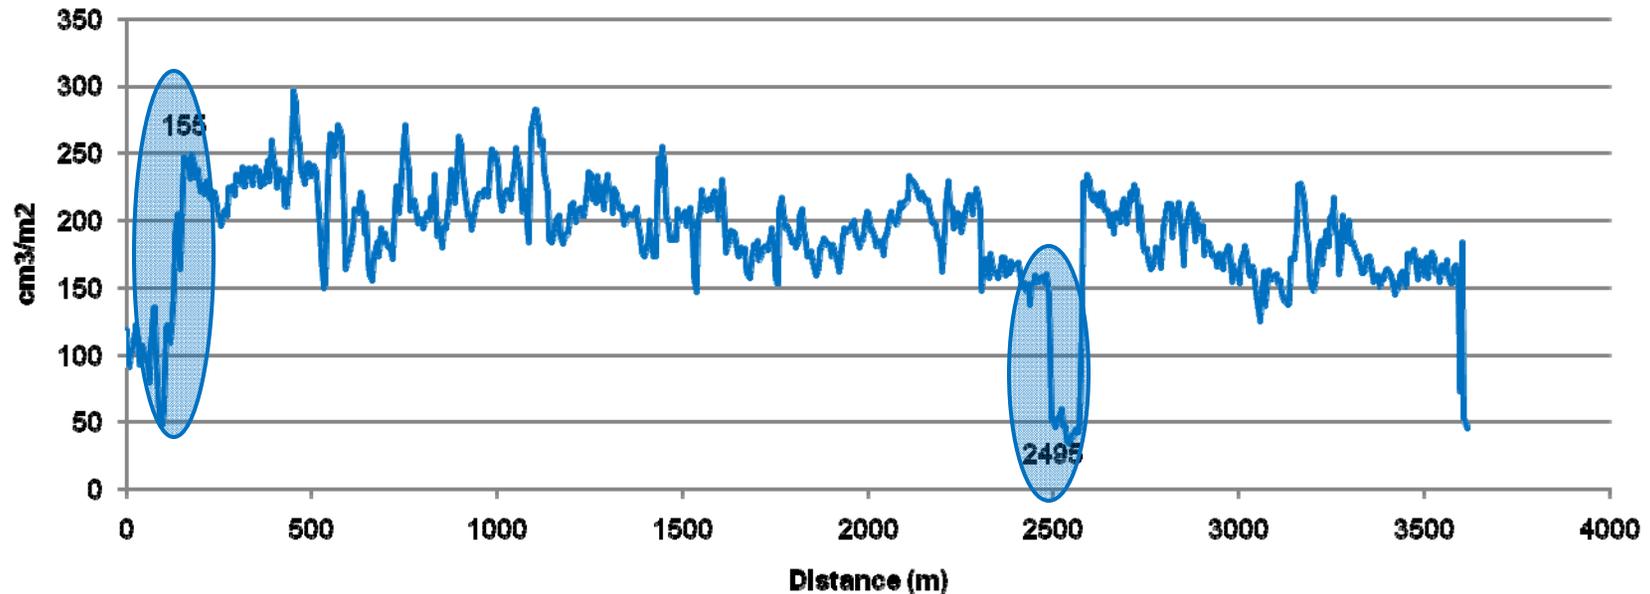
- RPI is a good indicator for texture transition.
- Abrupt asphalt texture transition at **155m**, from Smooth to Very Rough.
- Another asphalt texture transition at **2495m** (Rough to Smooth)

RPI per 5m road section for Lane #5

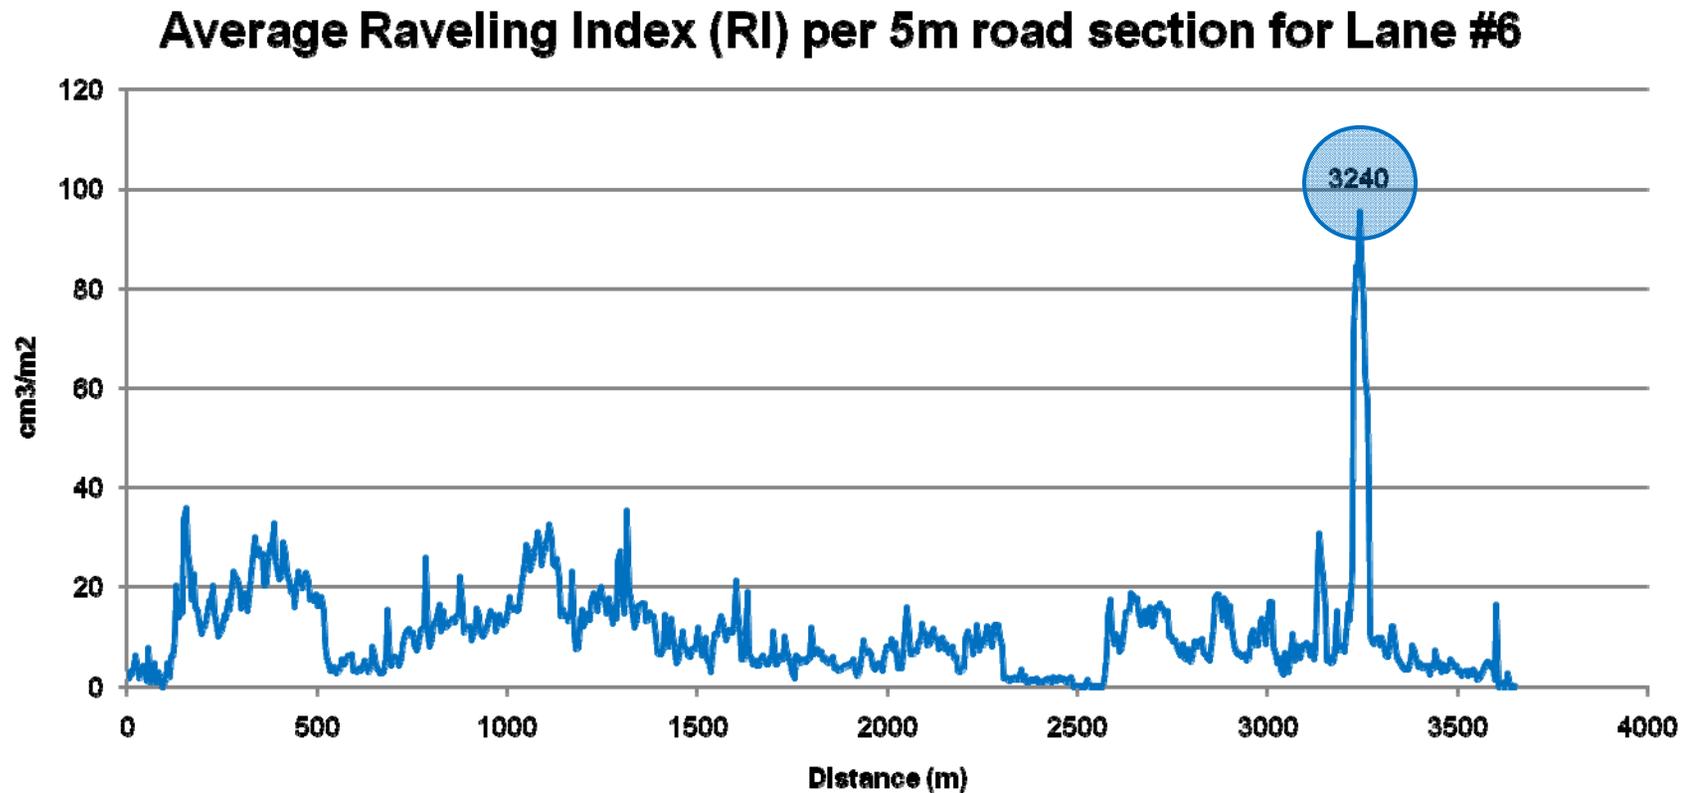
- Raveling index (RI) for Lane #6 shows a problem at distance 3240m
