Pavemetrics

SWIFT 2011 - Laser Crack Measurement System (Barcelona Airport survey)

Vision Technology for Inspection of Transportation Infrastructures

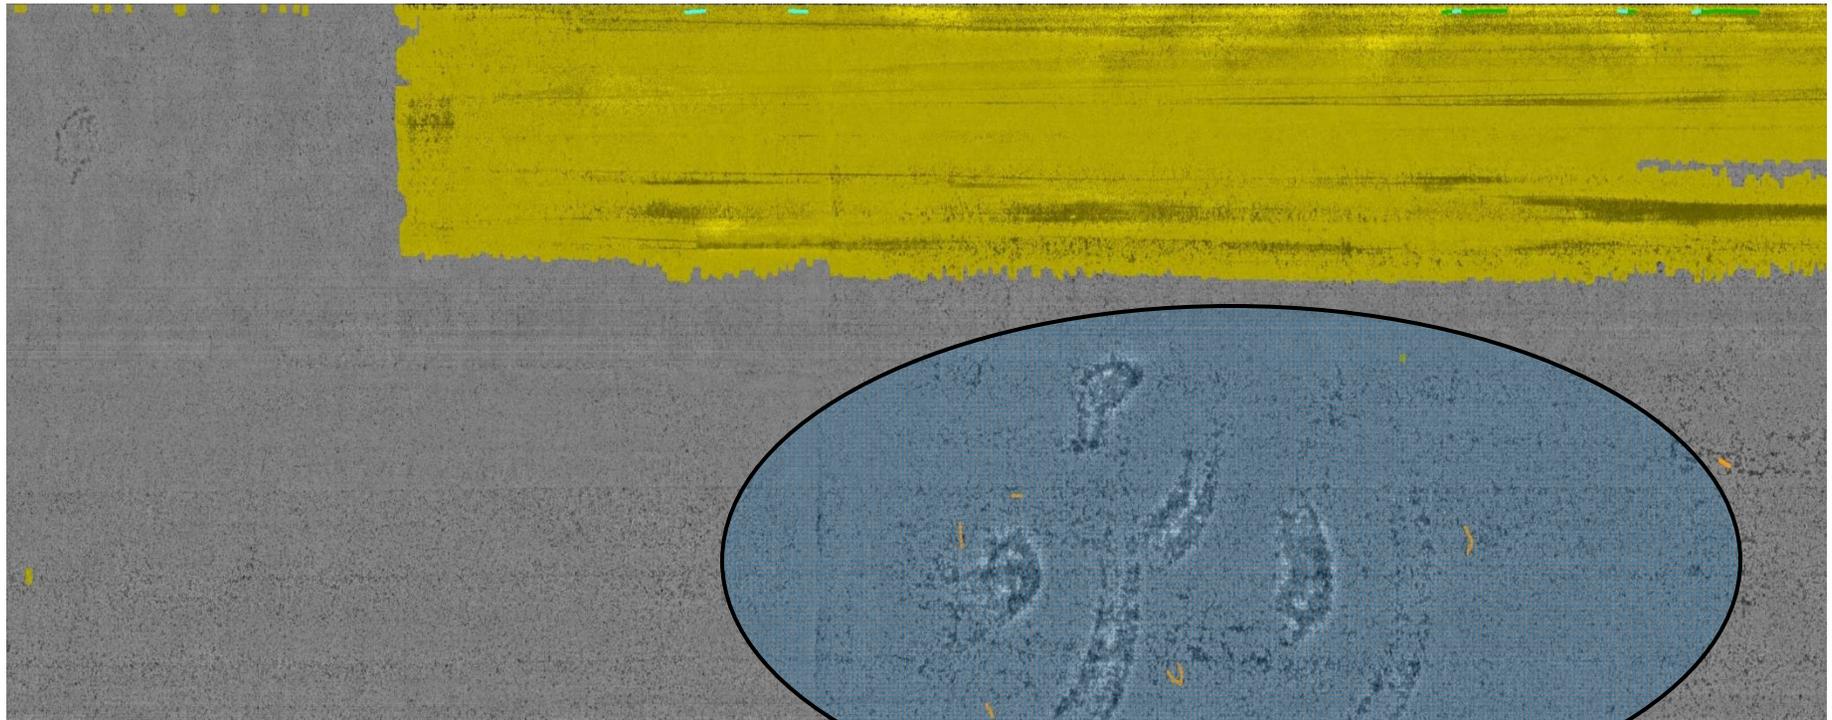
3D Range Images (3230m to 3250m)

Severe raveled section

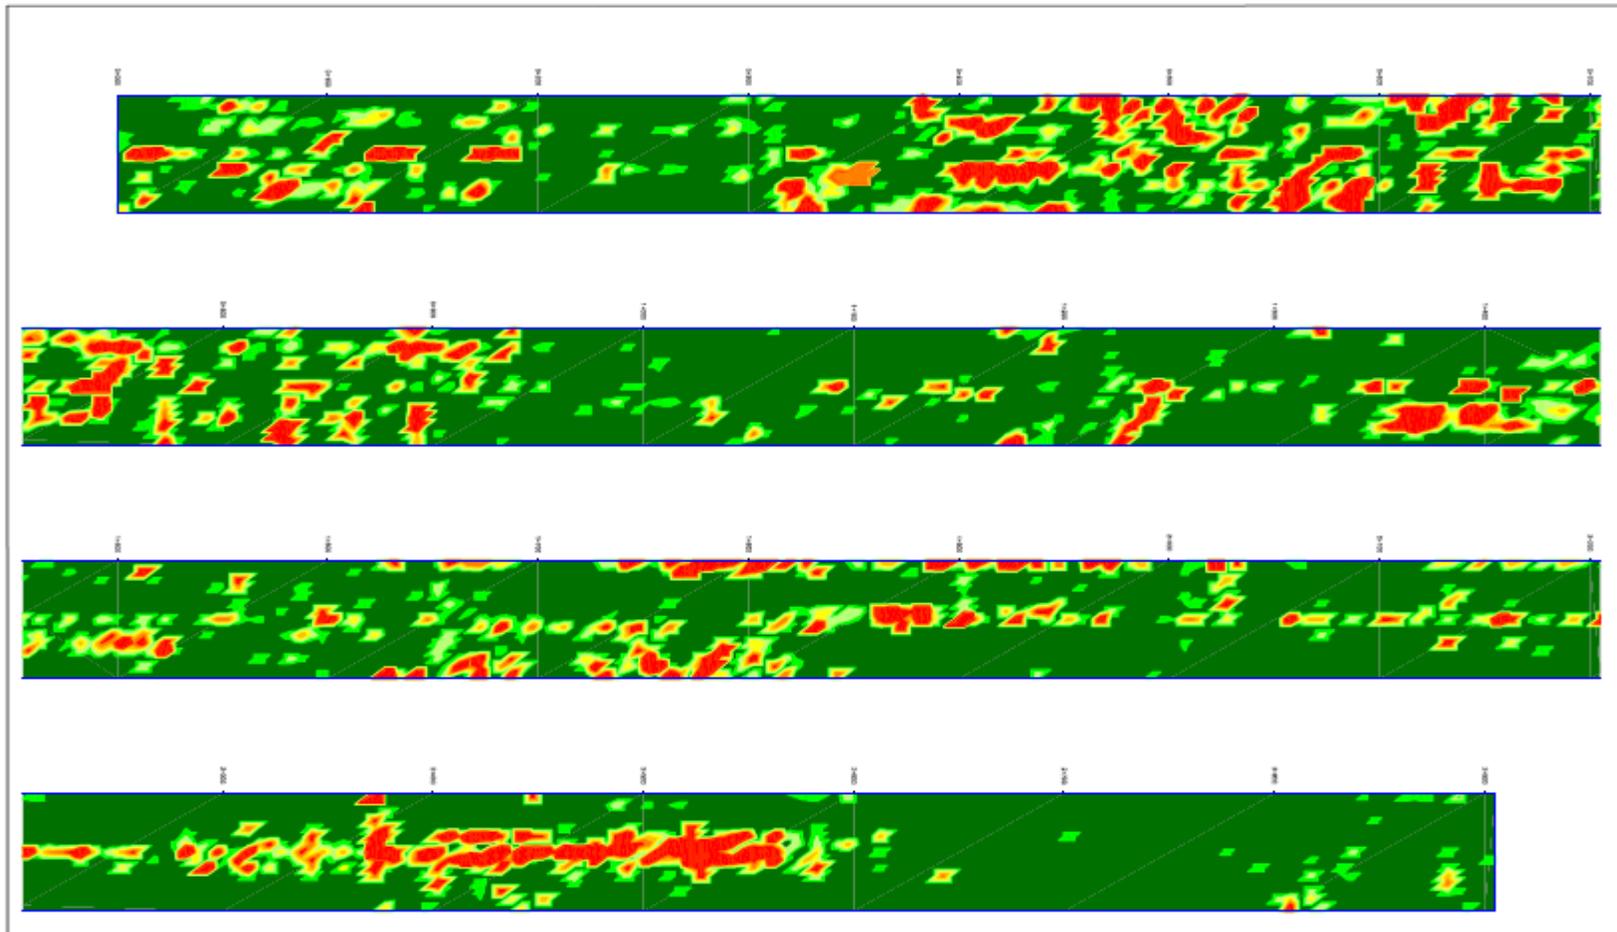
Barcelona - Cracking

MEDICIÓN CON EQUIPO LÁSER DE FISURACIÓN

Parámetro auscultación: **FISURACIÓN TOTAL**

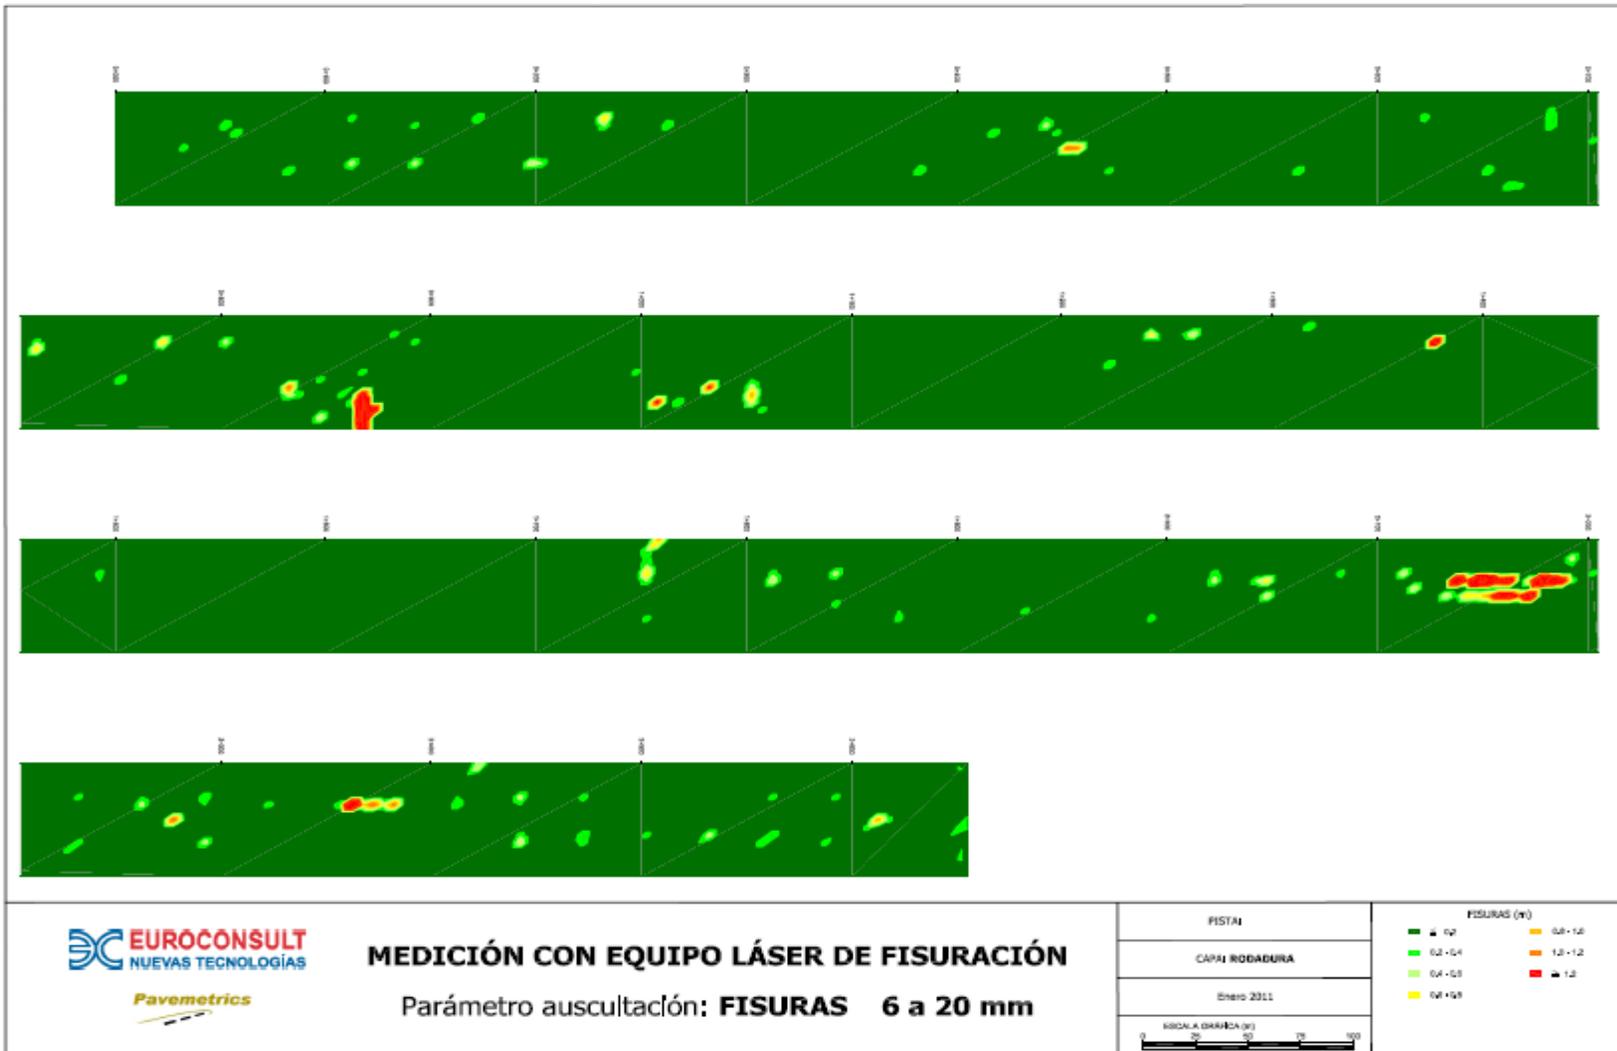
Barcelona - Cracking (6mm+)
