# DESIGN AND CONSTRUCTION OF A DE-ICING FACILITY FOR A SMALL AIRPORT ENVIRONMENT

Myron Thiessen, P.Eng., M.Sc. Royal Canadian Air Force

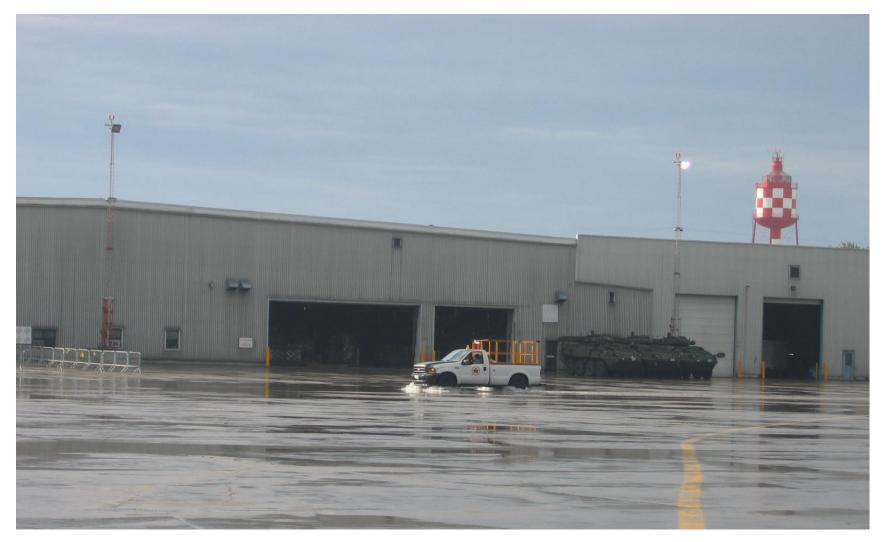
#### **Apron Flooding**

- Prior to 2007, aircraft de-icing was completed at individual parking spots
  - Done by DND staff
  - All surface runoff handled by trench drains
- For environmental reasons a decision was made to plug all trench drain outlets
  - Plugs only removed after confirmation of environmental compliance
  - Major Problems

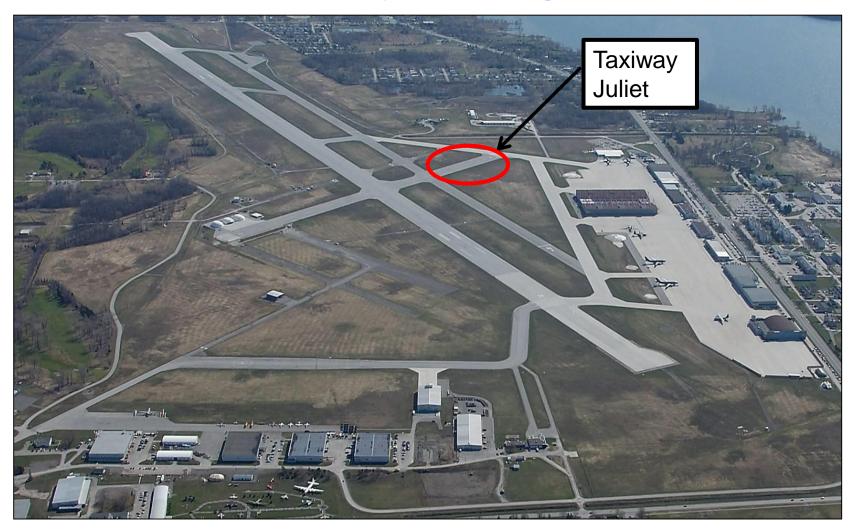
#### **Location of Temporary De-Icing Pad**

- $2007 \rightarrow NE Ramp$ 
  - Reconstructed/expanded existing ramp
  - Installed isolated drainage system
  - Still flooding problems and environmental concerns
- 2008 to 2011  $\rightarrow$  Taxiway Juliet
  - Former runway (45 m wide)
  - Constructed temporary de-icing fluid collection "bowl" adjacent to the taxiway

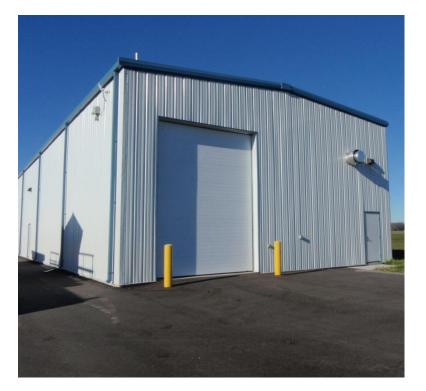
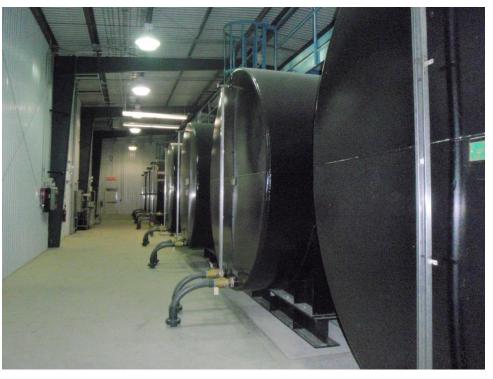
#### Waste Glycol Storage Facility

- Built in 2010
- 8 50,000L holding tanks
- Connected to Wing sewage treatment plant

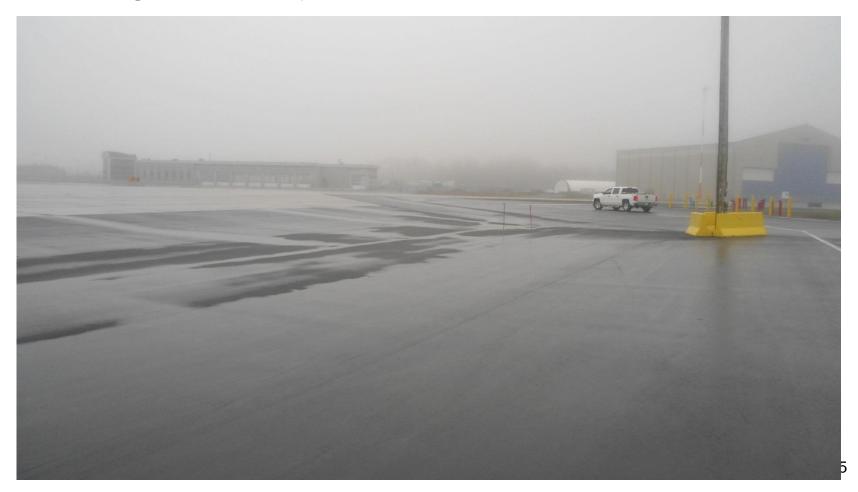
#### **Primary Containment Area**

• Storage capacity – approx. 400,000 L

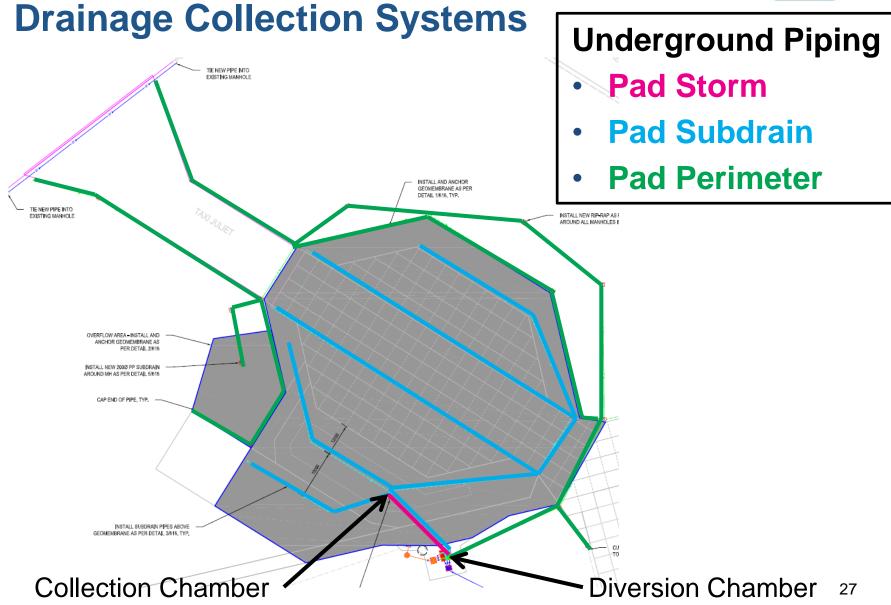
### **Drainage Collection Systems**

- 3 isolated systems
  - Pad Storm  $\rightarrow$  surface water from pad
  - Pad Subdrain → subsurface water trapped above geomembrane
  - Pad Perimeter  $\rightarrow$  storm (including overflow) and subdrains
- Custom diversion chamber
  - Separate compartments for each drainage system
  - Ability to sample and direct flow independently of each other

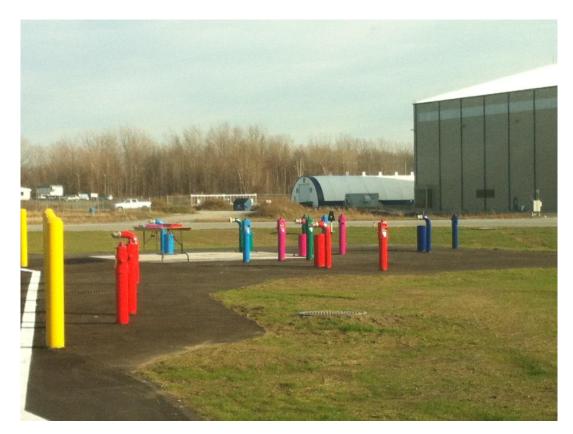
#### **De-Icing Pad Operations**

- Simplify operations  $\rightarrow$  color-coded post indicator valves

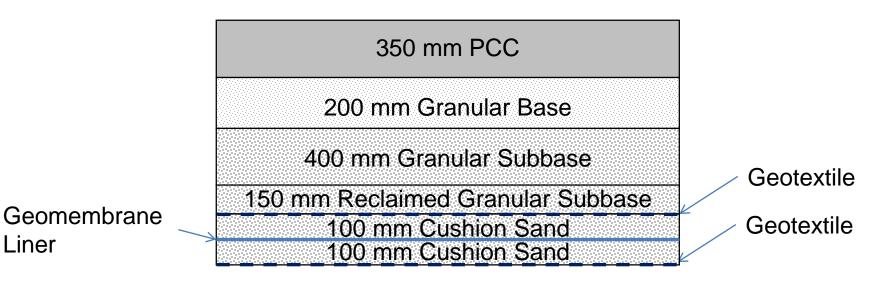
## **Pavement Design**

PCC Pavement Structure – De-Icing Pad

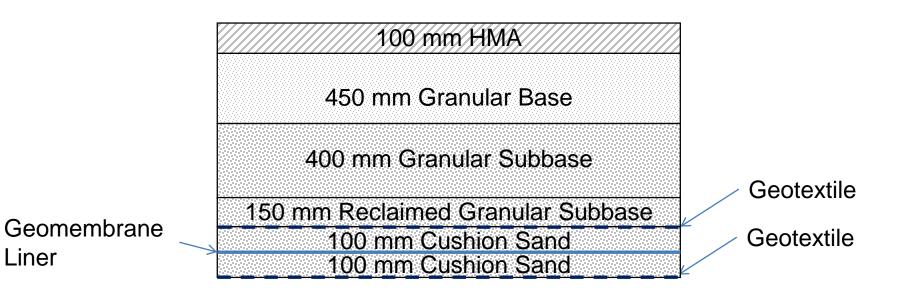
## **Pavement Design**

• HMA Pavement Structure – Perimeter Area

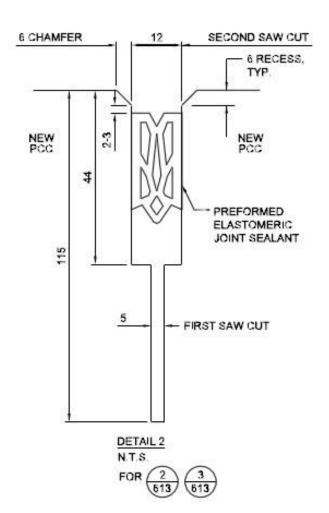
## **PCC Joint Design**

- 6 x 6 m joint spacing
- Chamfered joints
- Pre-formed neoprene joint sealant
  - First widespread use on a DND facility

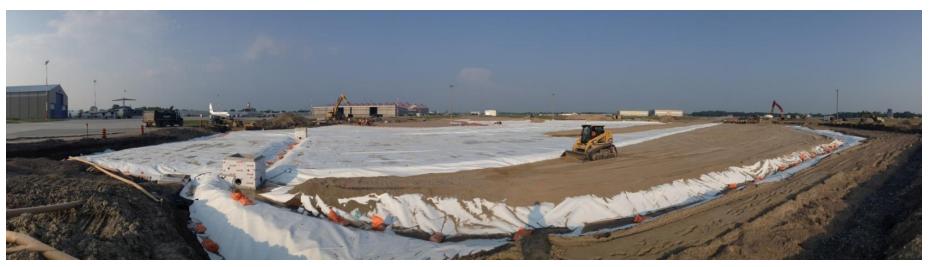
#### **Geomembrane Liner**

- Membrane  $\rightarrow$  glycol resistant polyolefin
  - Supplied in extruded sheets bonded in the factory
  - Anchored around perimeter
- Cushion sand  $\rightarrow$  only small equipment allowed

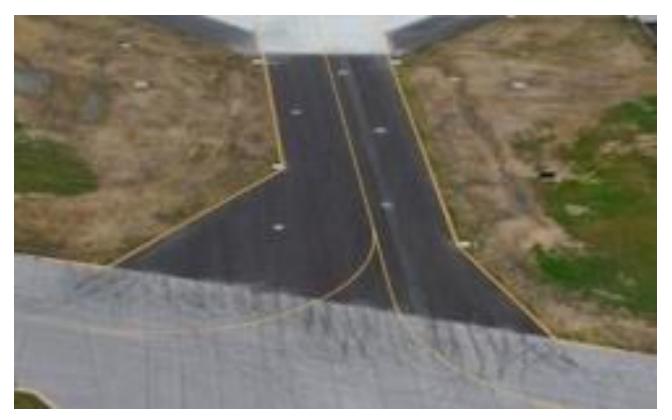
## **Asphalt Paving**

- Asphalt cement PGAC 64-28
- Echelon paving used where possible

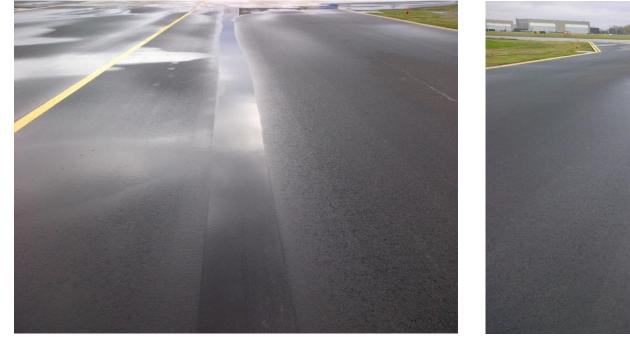
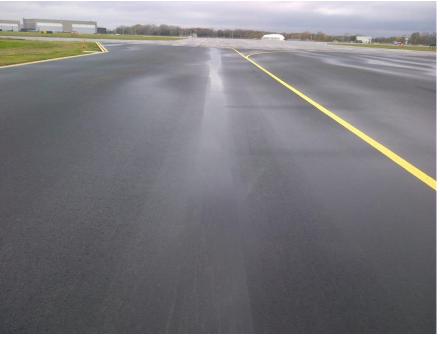
### **Asphalt Paving**

• Only significant issue  $\rightarrow$  ponding water on Juliet

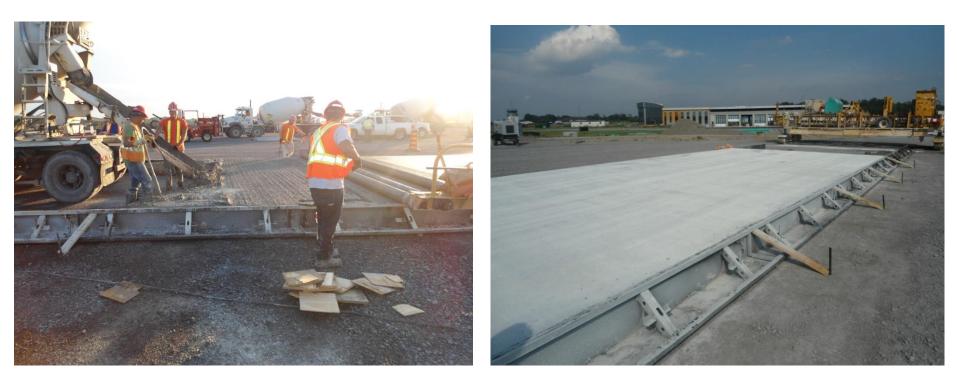
#### **Concrete Paving**

- Concrete supply  $\rightarrow$  off-site ready mix plant
- Fixed form paving  $\rightarrow$  roller screed

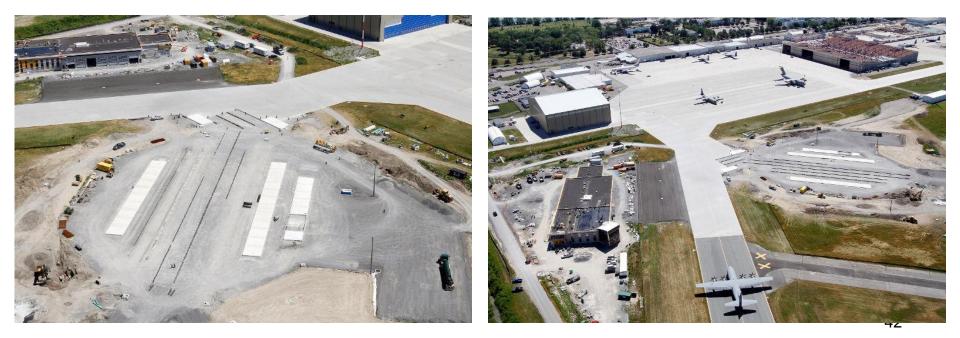
#### **Concrete Paving**

- Initial trial lane looked good at first but surface defects became evident as it cured
  - Multiple trials, mix designs, material suppliers
- Urgency of project left us in a tight spot

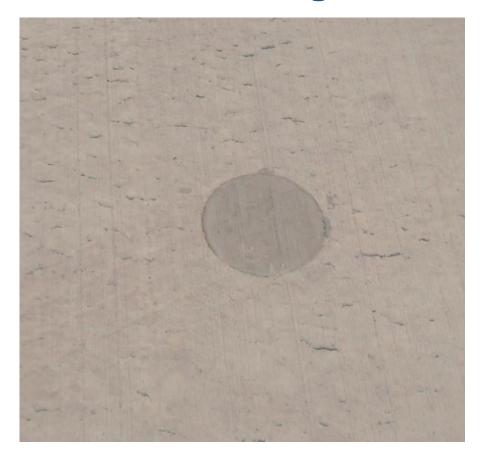
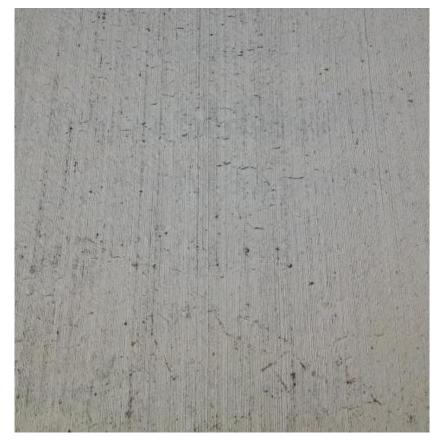
#### **Concrete Paving - Surface Defects**

- Petrographic testing confirmed microcracking around aggregates
  - Generally 5 mm, but sometimes deeper
  - Long-term durability concerns

- Considered various sealants  $\rightarrow$  unacceptable
- Diamond grinding (2014)
  - Depth approx. 5 mm
  - Replaced all neoprene joint seals
