Rehabilitation of Runway 06-24 and Holding Bay 06 at Montreal-Mirabel International Airport

SWIFT CONFERENCE – MONTREAL
September 16th, 2015

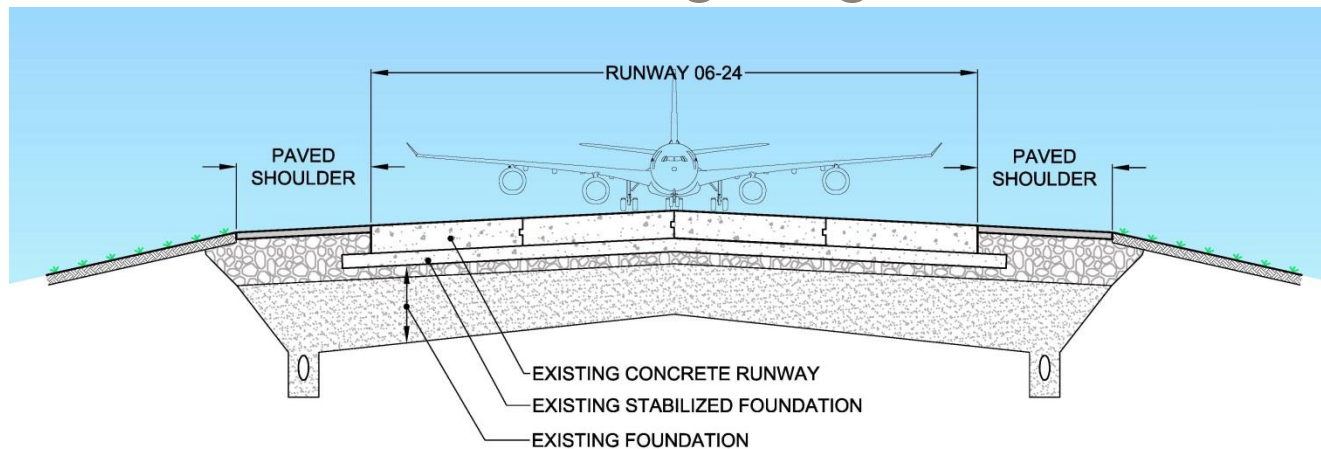
Existing Runway

Rigid pavement with cement treated base course

- 380 mm thick slabs (15")
- Key joints, undoweled
- 200 mm cement treated base course
- 100 mm crushed stone
- 500 mm sand or existing subgrade

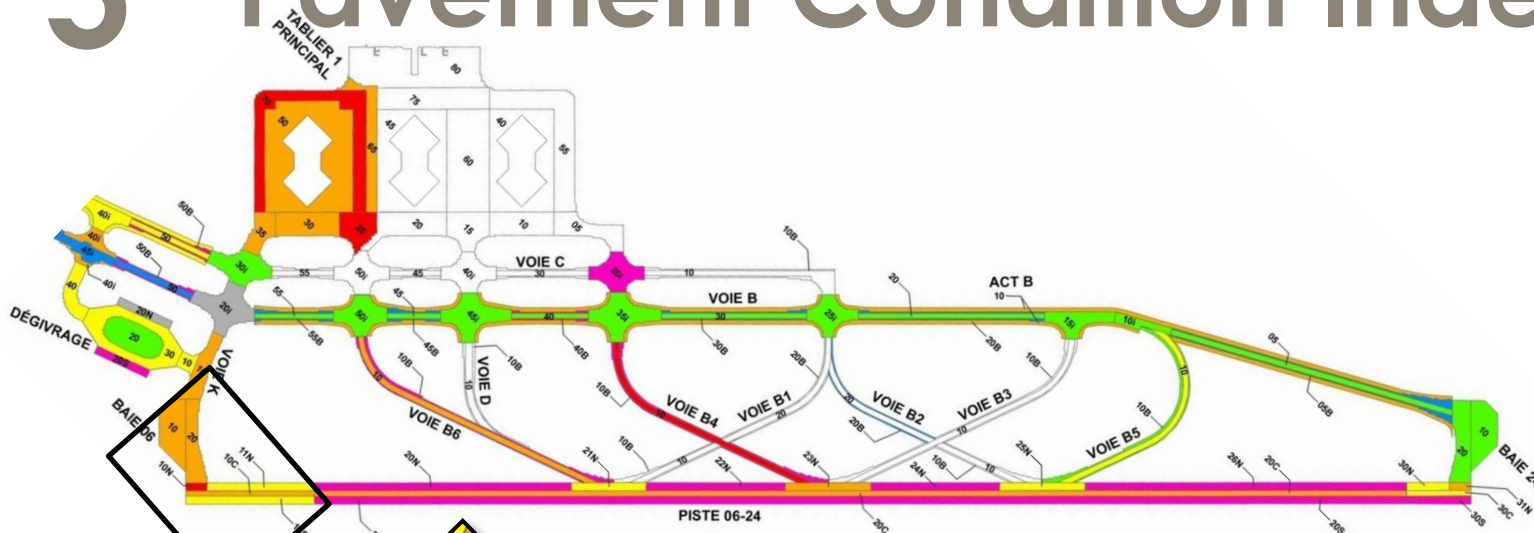
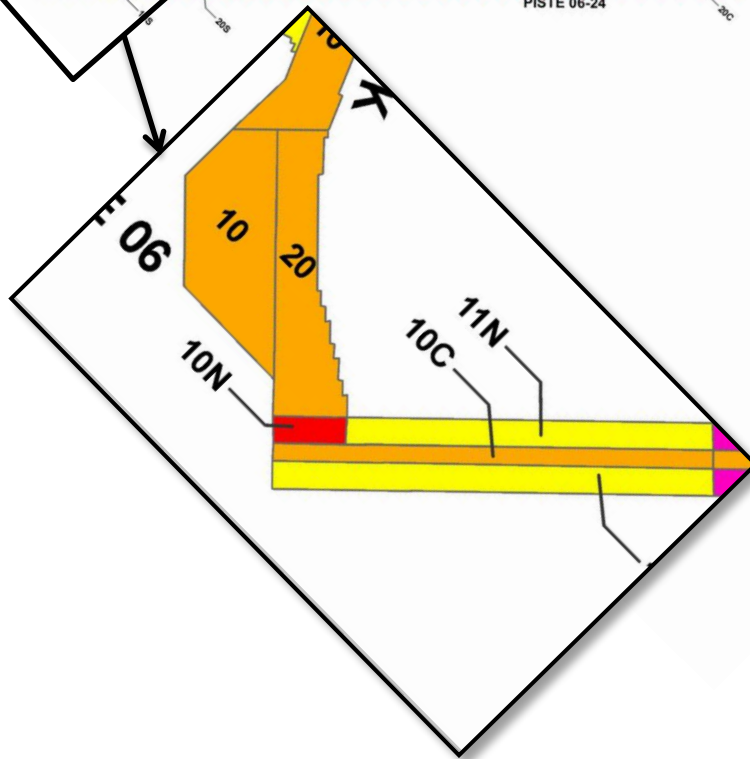
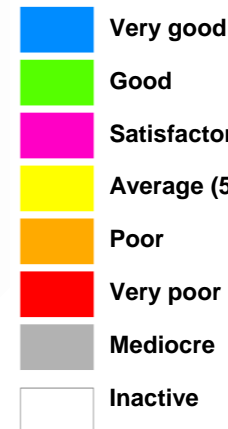
5 Pavement Condition Index

Very good
Good
Satisfactory (70 is rwy min)
Average (55 is twy min)
Poor
Very poor
Mediocre
Inactive

85 < PCI <= 100
70 < PCI <= 85
55 < PCI <= 70
40 < PCI <= 55
25 < PCI <= 40
10 < PCI <= 25
0 <= PCI <= 10

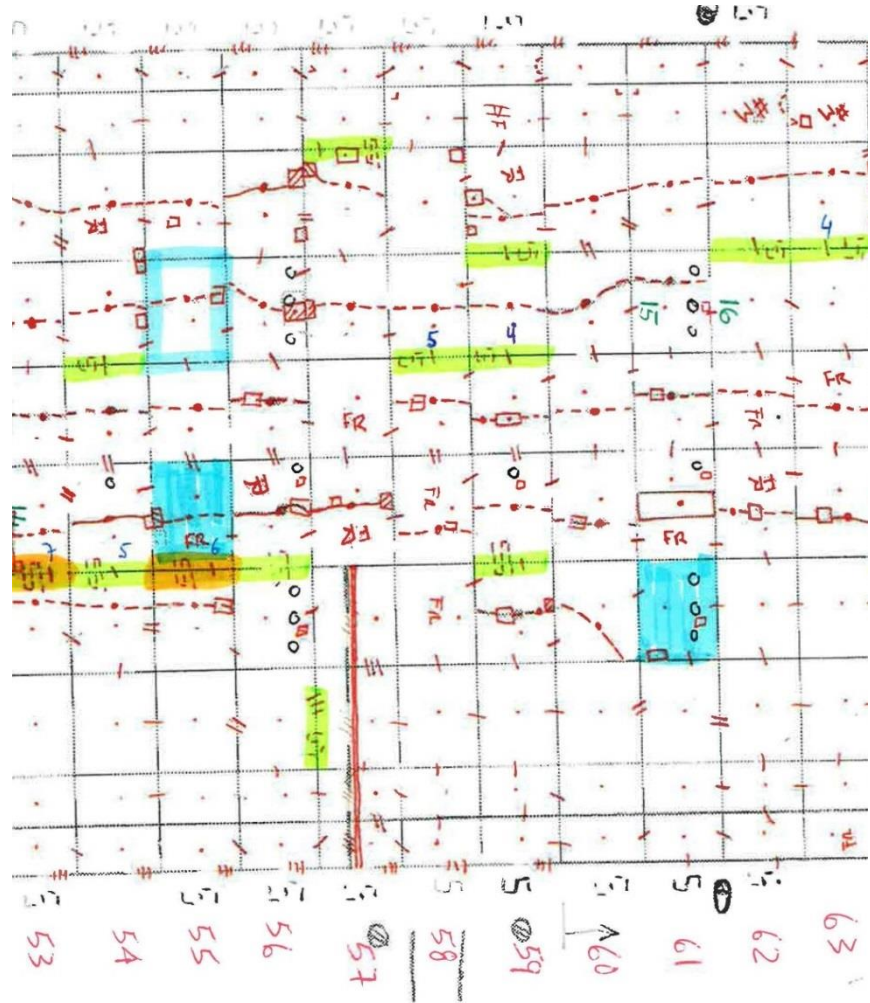
- **Visual survey of surface conditions including:**
 - Blow up
 - Corner break
 - Longitudinal cracking
 - Transverse cracking
 - Joint seal damage
 - Pop outs
 - Scaling
 - Settlement
 - Shattered slab
 - Joint spalling
 - Corner spalling
 - Electrical trenches

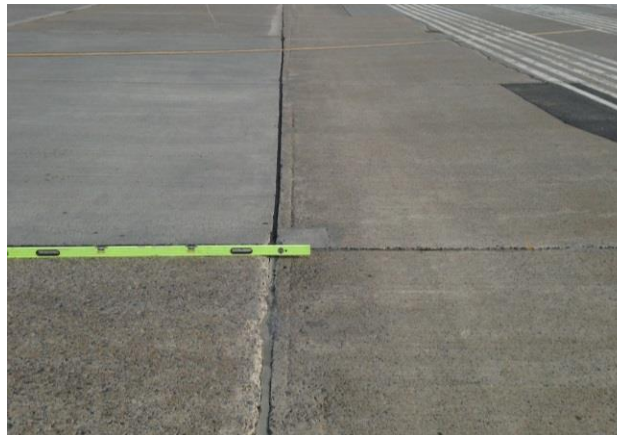
- Joint settlement measurement

Settlement or irregularity		Nb. measures	% measures
	< 6 mm	25	43.9%
	6 to 13 mm	31	54.4%
	> 13 mm	1	1.8%
Total		57	100.0%

Settlement or irregularity		Nb. measures	% measures
	< 6 mm	203	58.3%
	6 to 13 mm	142	40.8%
	> 13 mm	3	0.9%
Total		348	100.0%

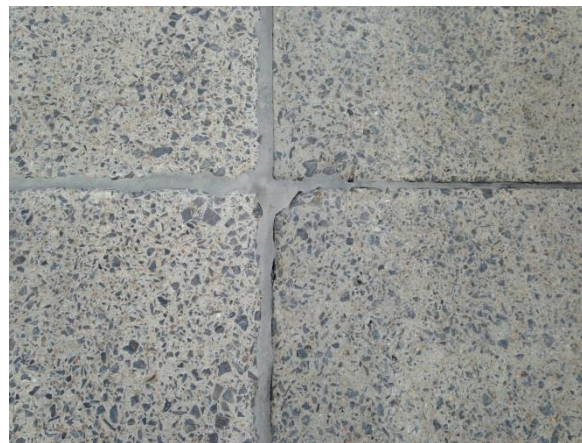
- Transversal joint opening

Average of 16 mm

Average of 14.3 mm

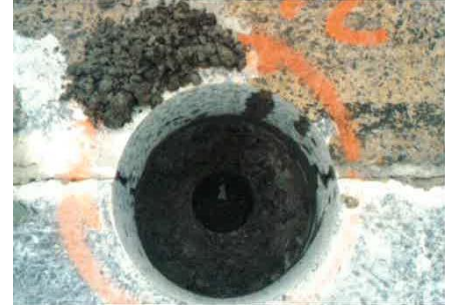
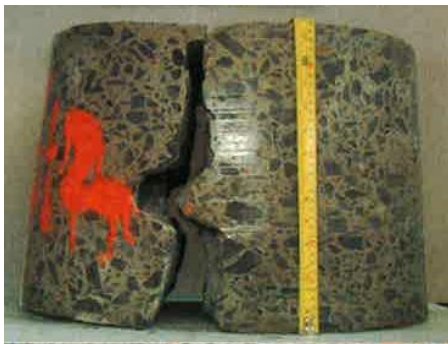
Soil Recognition

- **7 geotechnical borholes to:**
 - Confirm existing structure
 - Establish the actual CBR values and the resilient modulus with a portable DCP (Dynamic Cone Penetrometer)
- **66 concrete coring samples to:**
 - Confirm existing slab thickness
 - Confirm cement treated base course thickness
 - Determine granular composition of the concrete

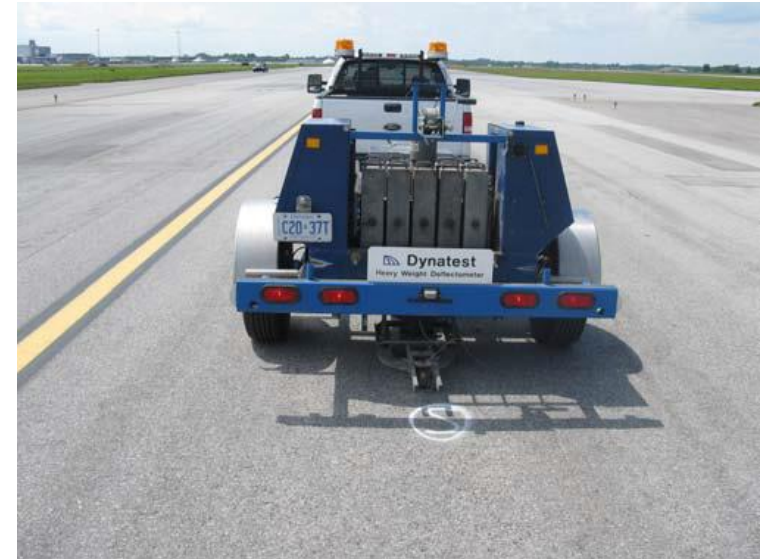
Total of 184 slabs tested

- Load transfer on joints
 - $> 75\%$: Good
 - 50 to 75% : Average
 - $< 50\%$: Poor
- HFWD modulus back calculation

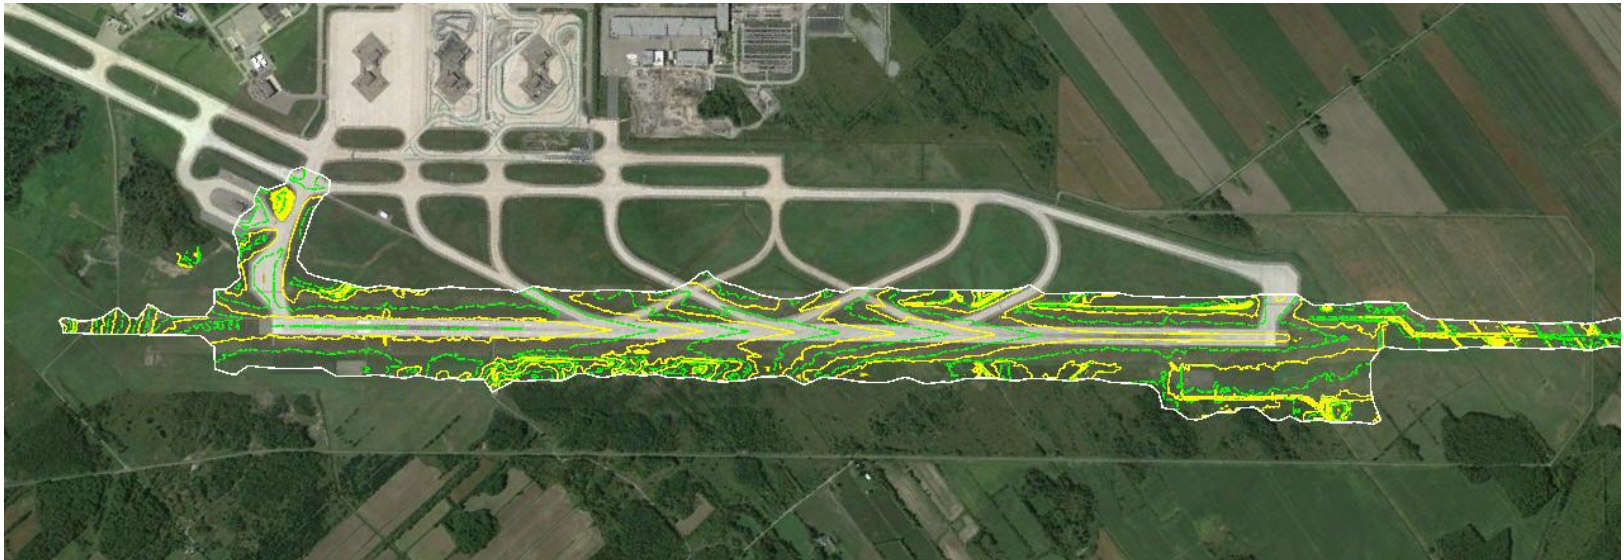
A complete site survey covering the RWY, TXY's, HB's 06 & 24, approach systems, perimeter access roads, utilities and aircraft arresting systems was made using:

- Conventional survey using a total station with 3 mm accuracy
- Lazer survey with 2 mm accuracy
- GPS survey used in grassed areas
- Over 230,000 survey points taken

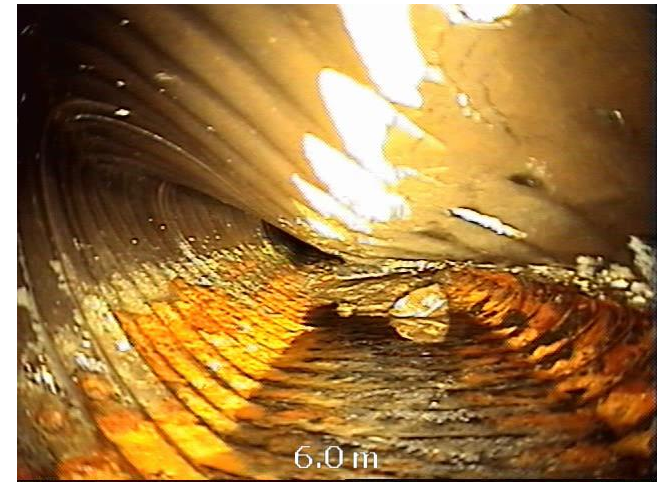
- A complete inspection campaign was initiated before the actual design phase started
- This campaign was used to determine the condition of:
 - existing foundation drains
 - existing main collectors
 - culverts
 - catch basins
 - manholes
 - ditches
 - wetlands
- Over 12,000 m of drains and 130 manholes were inspected

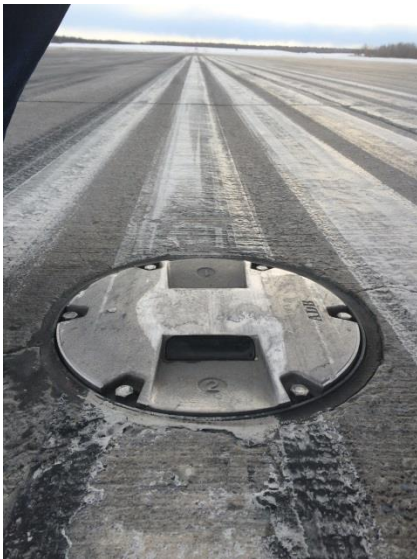
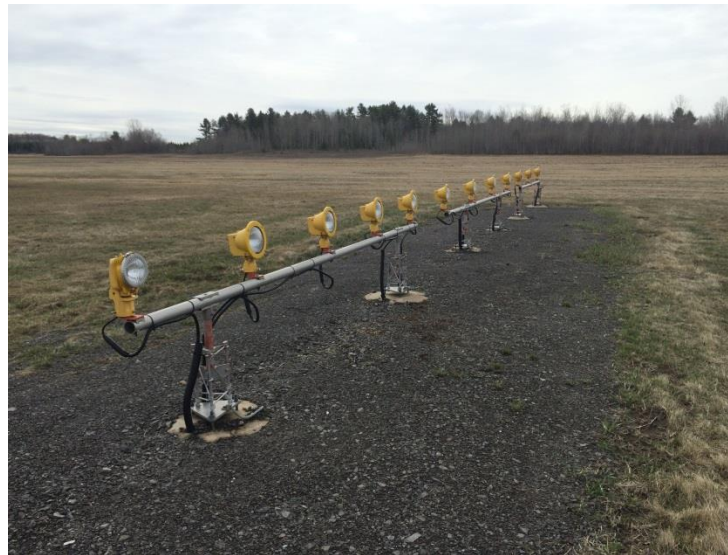
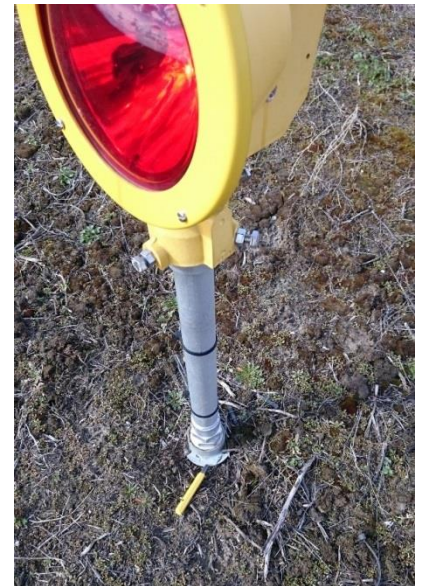
- A full inspection campaign was completed by the electrical team
- All electrical systems of the RWY have to be replaced
- Approximately 750 lights, over 150,000 m of wirings, and over 38 electric circuits affected

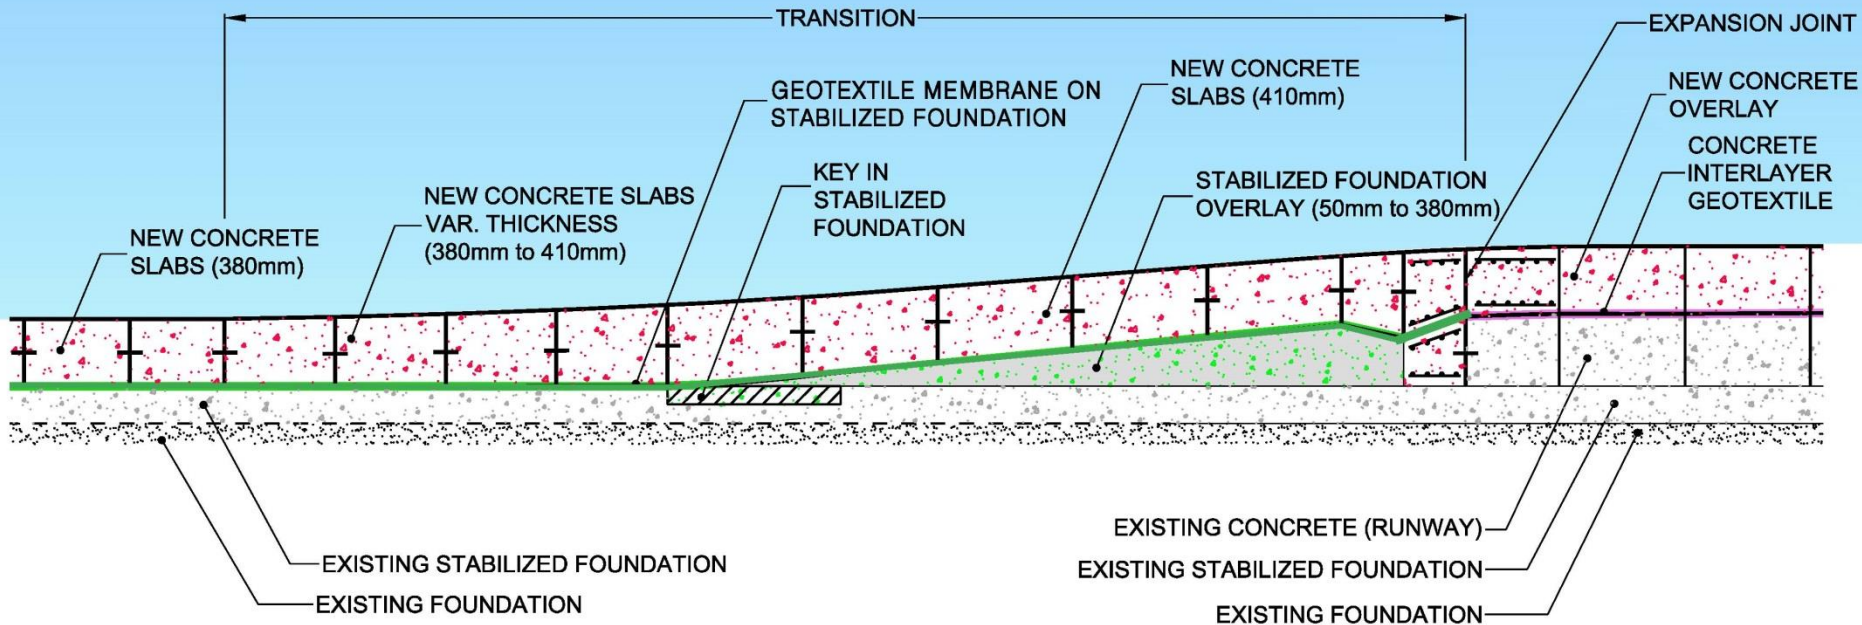
Typical profile

*Transition (between rigid pavement overlay
and reconstruction)*

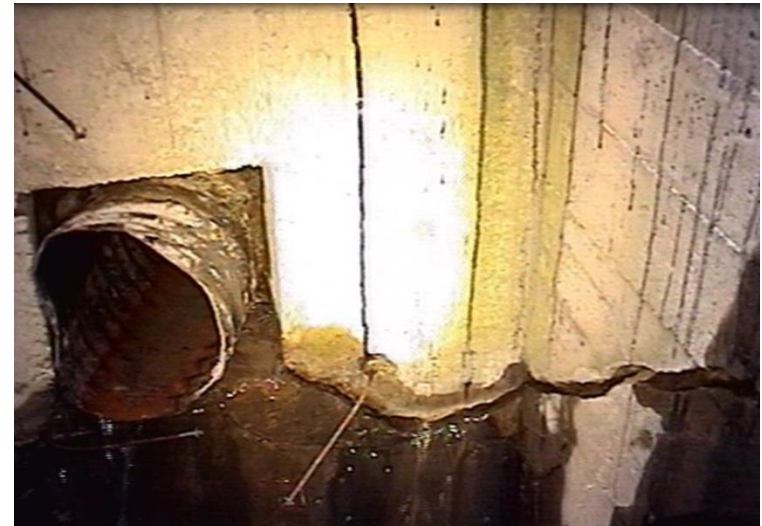
10 Final Concept: Storm Drainage

- Replacement of all existing grates
- 5 type D manholes must be replaced
- 90 manholes (type B, D and F) must be adjusted and/or raised in concrete overlay section
- 2,000 m of ditches to be reprofiled
- 1,300 m of ditches to be cleaned
- 2,000 m of drains must be replaced
- 500 m must be reinspected
