Practical Approach to Rehabilitation of Aged Airport Concrete Pavements

Ludomir Uzarowski, Ph.D., P.Eng.
Rabiah Rizvi, P.Eng.
Golder Associates Ltd., Ontario, Canada

SWIFT, Minneapolis, 2016

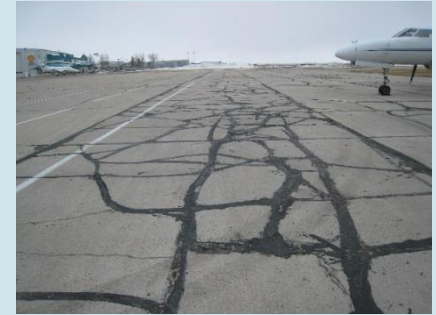
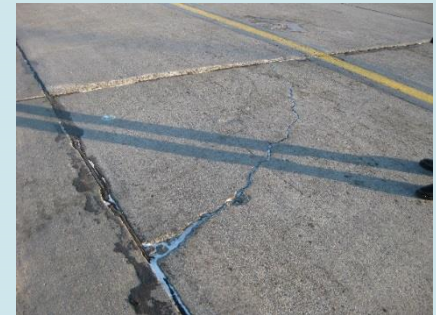
Typical distresses

- Longitudinal and transverse cracks of various severity (low to high)
- Corner breaks, joint and crack spalling, D-cracking, scaling, faulting, pumping of fines
- Low to severe Alkali Silica Reactivity (ASR) damage
- Typically poor drainage

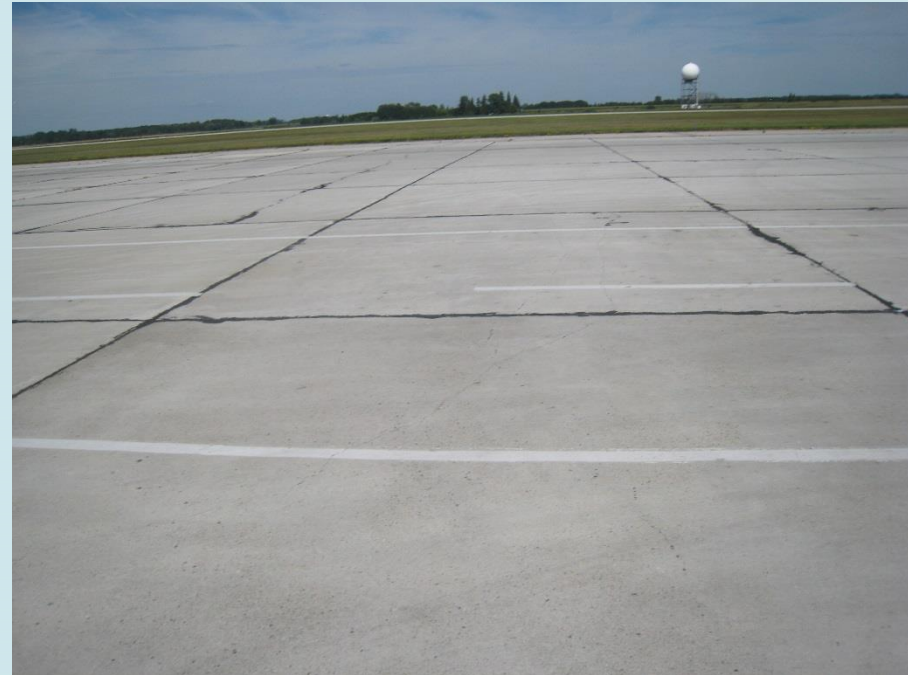
- Low severity distresses, mainly cracking
 - Do nothing or stop gap
 - Monitoring condition
 - Checking for FOD potential

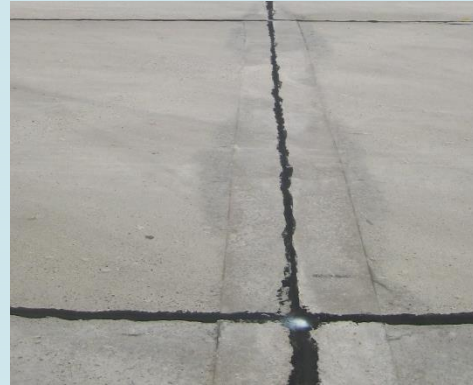
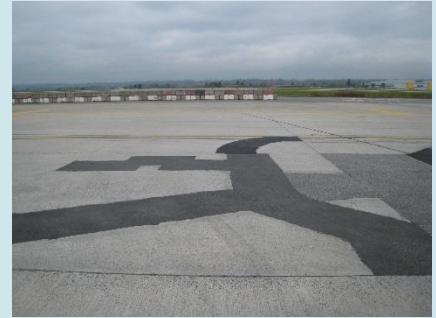
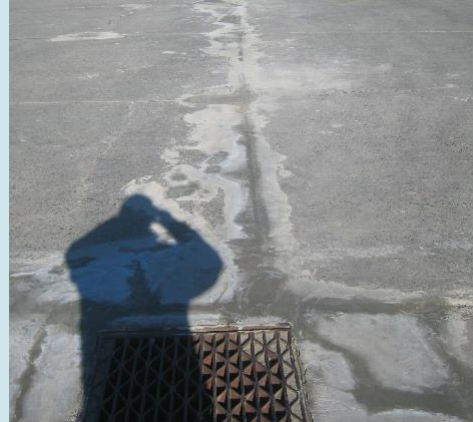
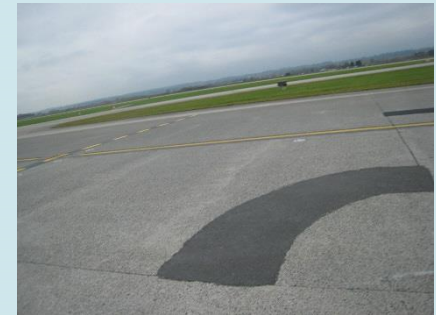
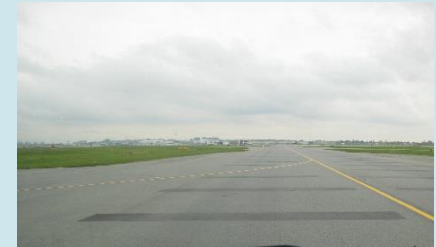
- Medium severity
 - Crack filling
 - Crack routing and sealing
 - Crack epoxy repair
 - Crack repair with HMA
 - Joint spall repairs – partial depth
 - Corner breaks
 - Joint resealing

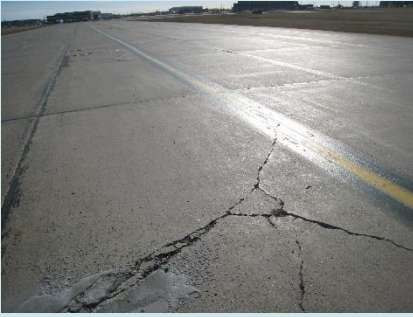
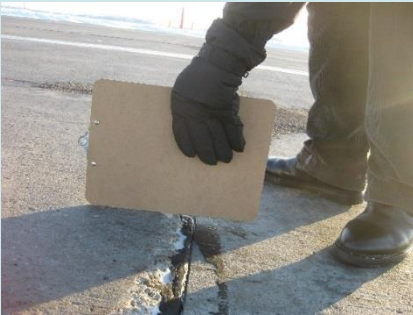
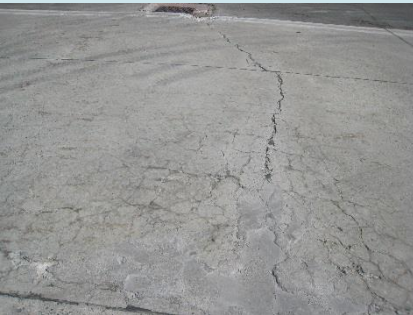
- High severity
 - Structural failure
 - Very severe cracks
 - Shattered slabs
 - Severe faulting
 - Severe corner breaks
 - Severe D-cracking and scaling

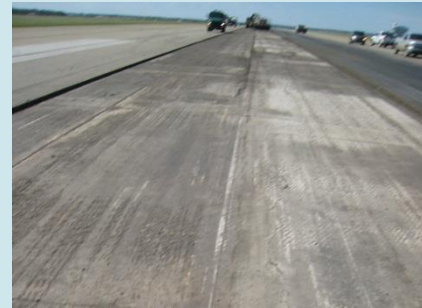
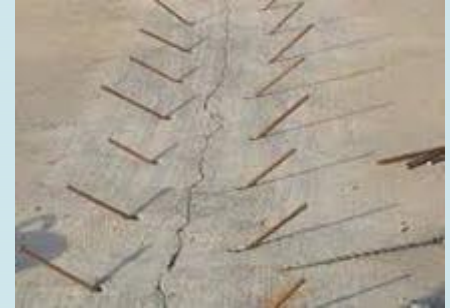
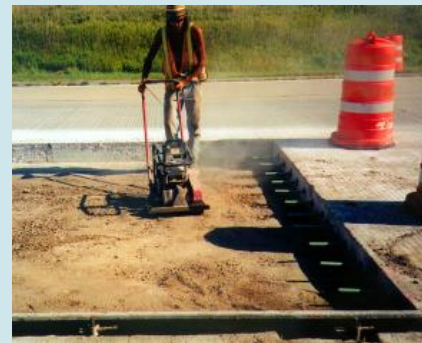
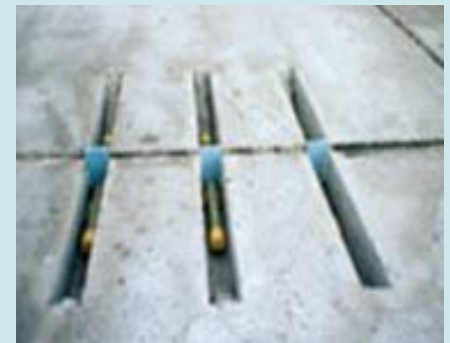
- Identify the cause of distresses
- Determine LTE
- Pavement rehabilitation
 - Soil and moisture condition
 - Granular layers, CTB or fillcrete
 - Stitching
 - Dowel bars retrofitting
 - Slab replacement (the same thickness)
 - Structural HMA overlay
 - Bonded concrete overlay (?)
 - Reconstruction

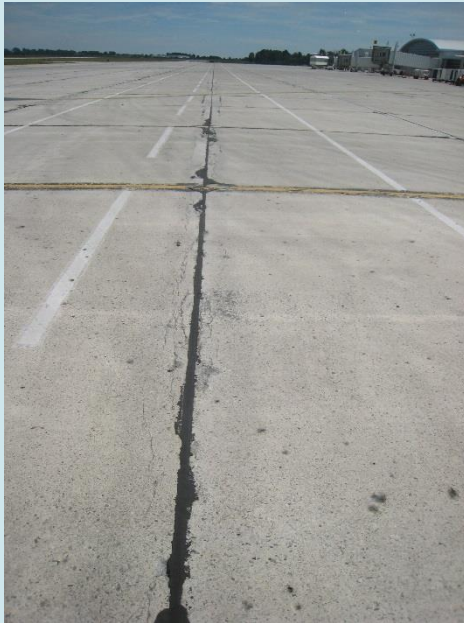
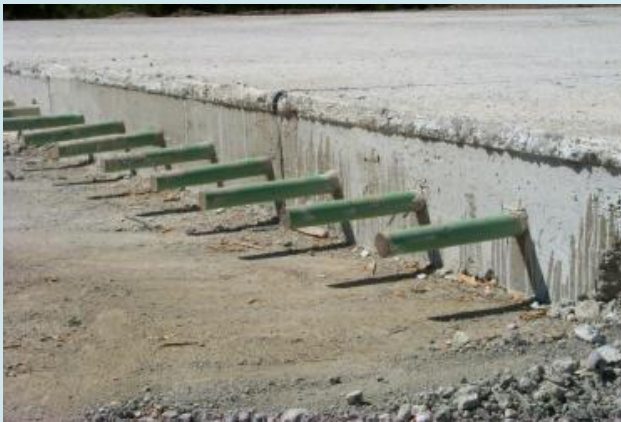
- Joints
 - Keyway
 - Sawcut
 - Dowel and tie bars
- Specifications
 - As covered in morning's presentation
 - Based on practice and experience in Canada
 - Some aspects from FAA specifications

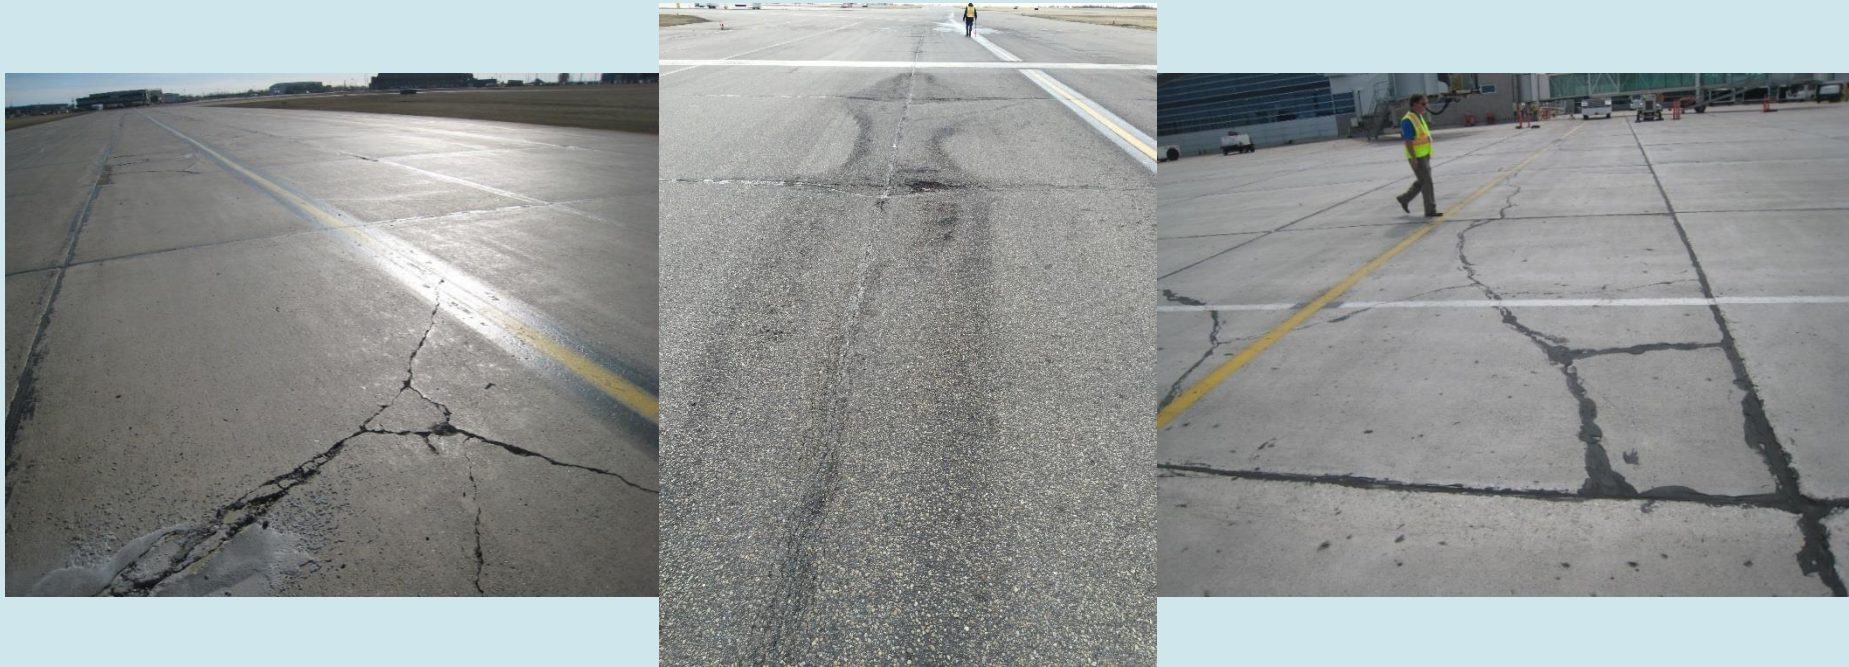
■ Taxiway and apron yellow line versus joint locations

- In PCC pavements rehabilitation
 - Realize they were originally designed for lower traffic than they are carrying now
 - Yellow line versus joints location
 - Check for ASR damage and protect
 - Take care during pavement construction
 - Many factors and details can affect the service life of replacement pavements

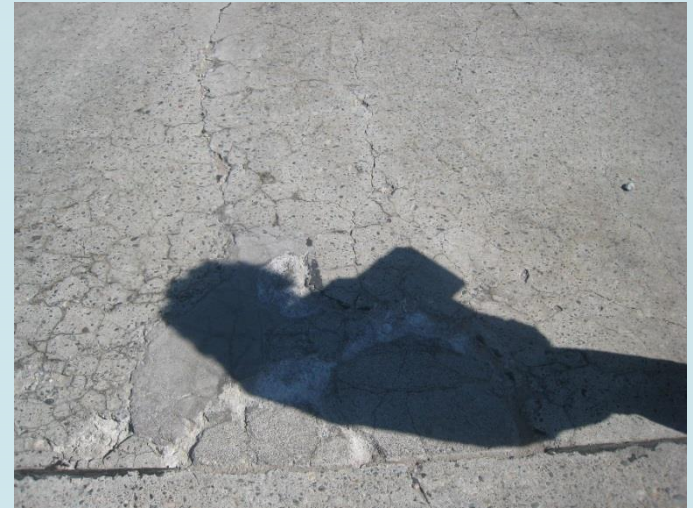
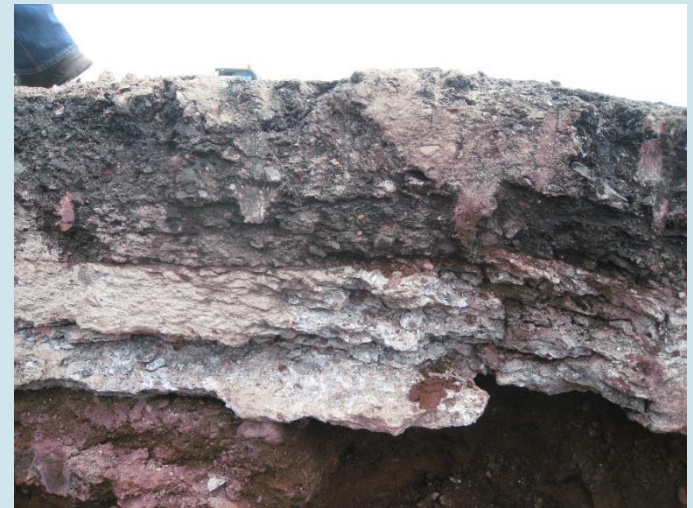
- ASR damage
 - Low severity
 - High severity
 - Current concrete mix design
 - Action required in old pavements

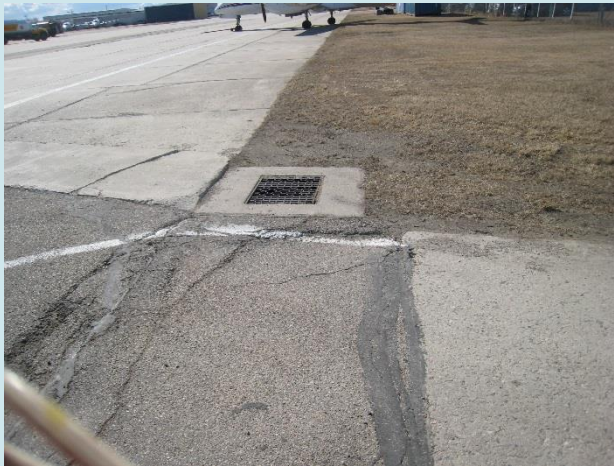
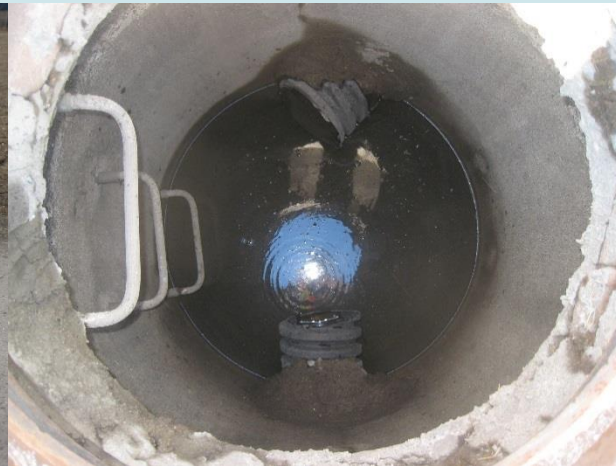
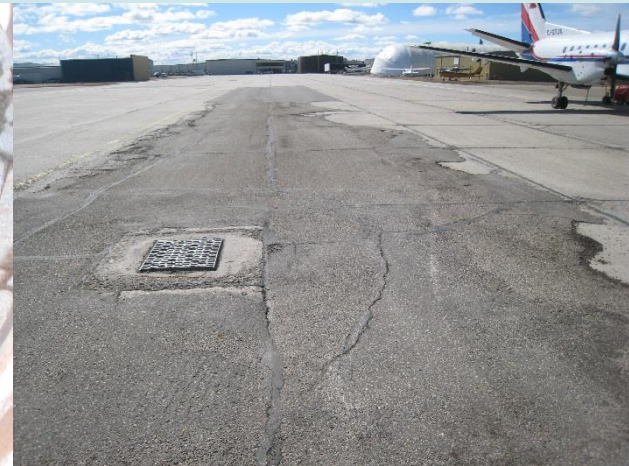
- Drainage
 - Surface
 - Subsurface – subdrain systems

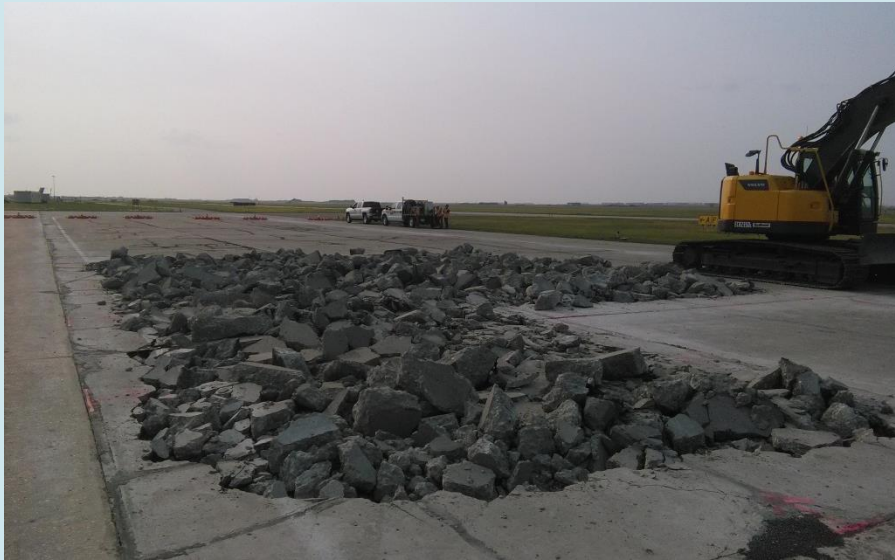
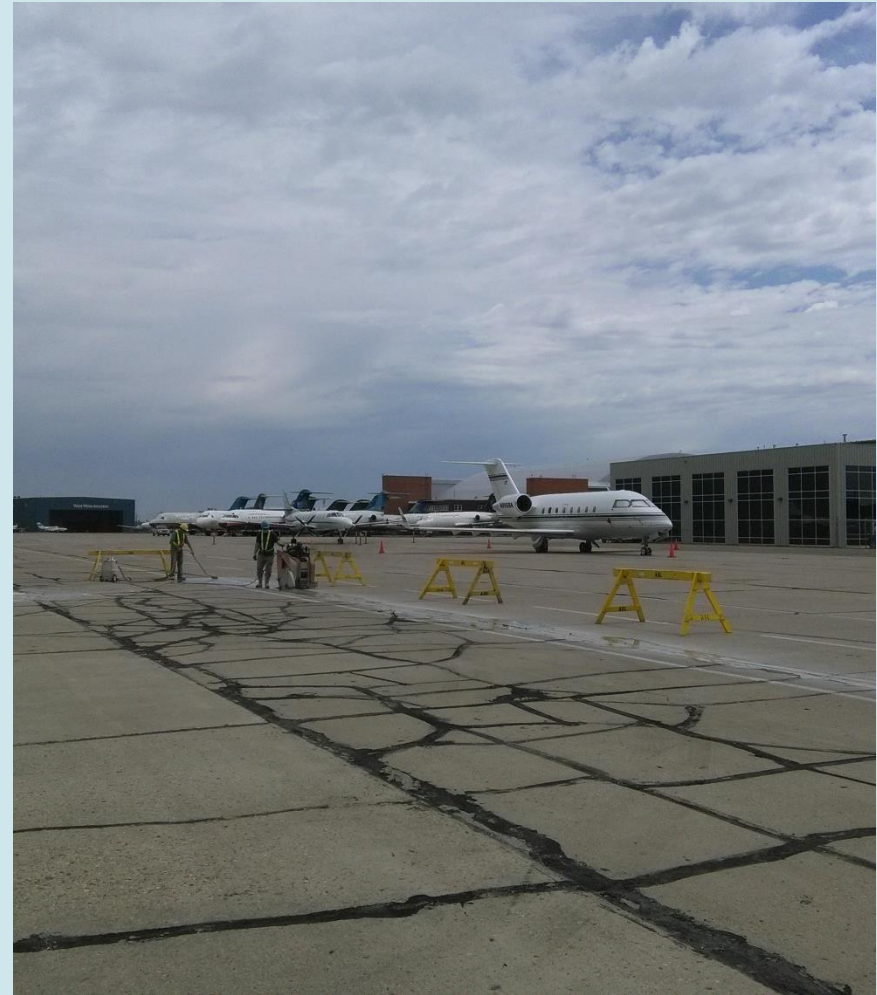
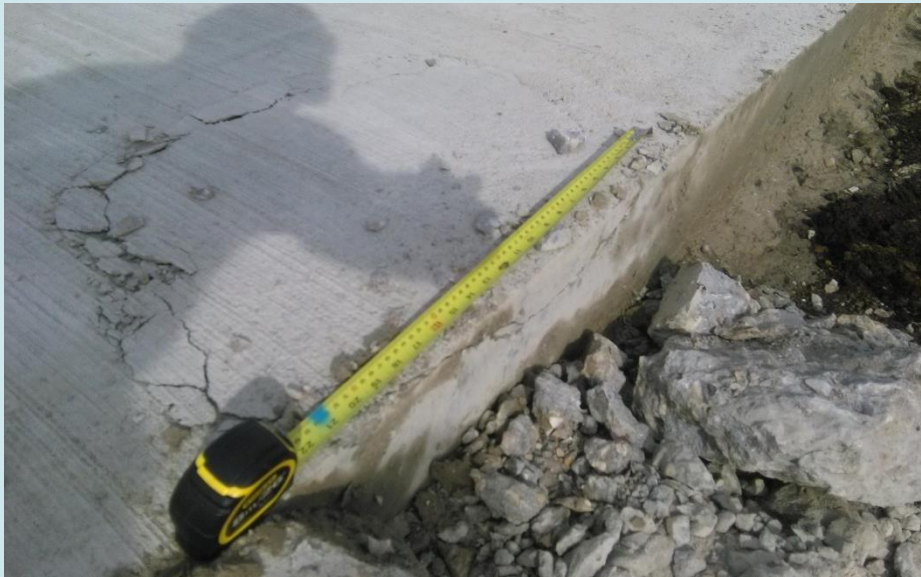
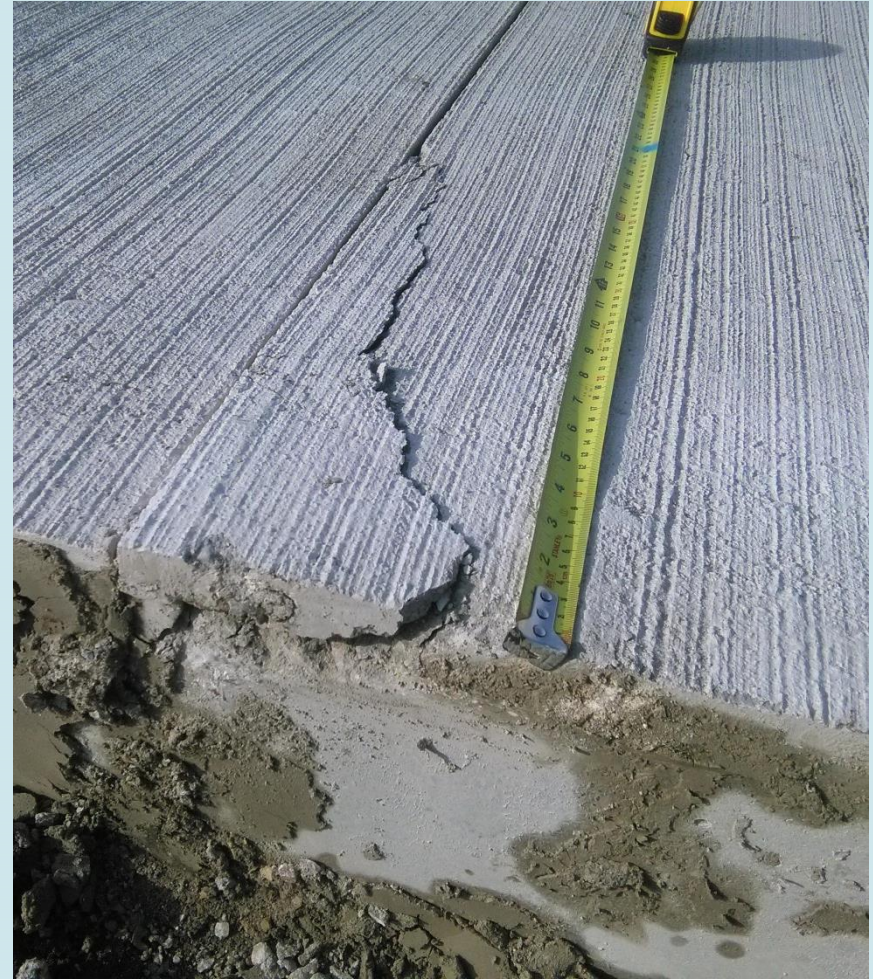
Concrete Removal

- Requires brute force
- Avoid damaging more areas with sawcutting

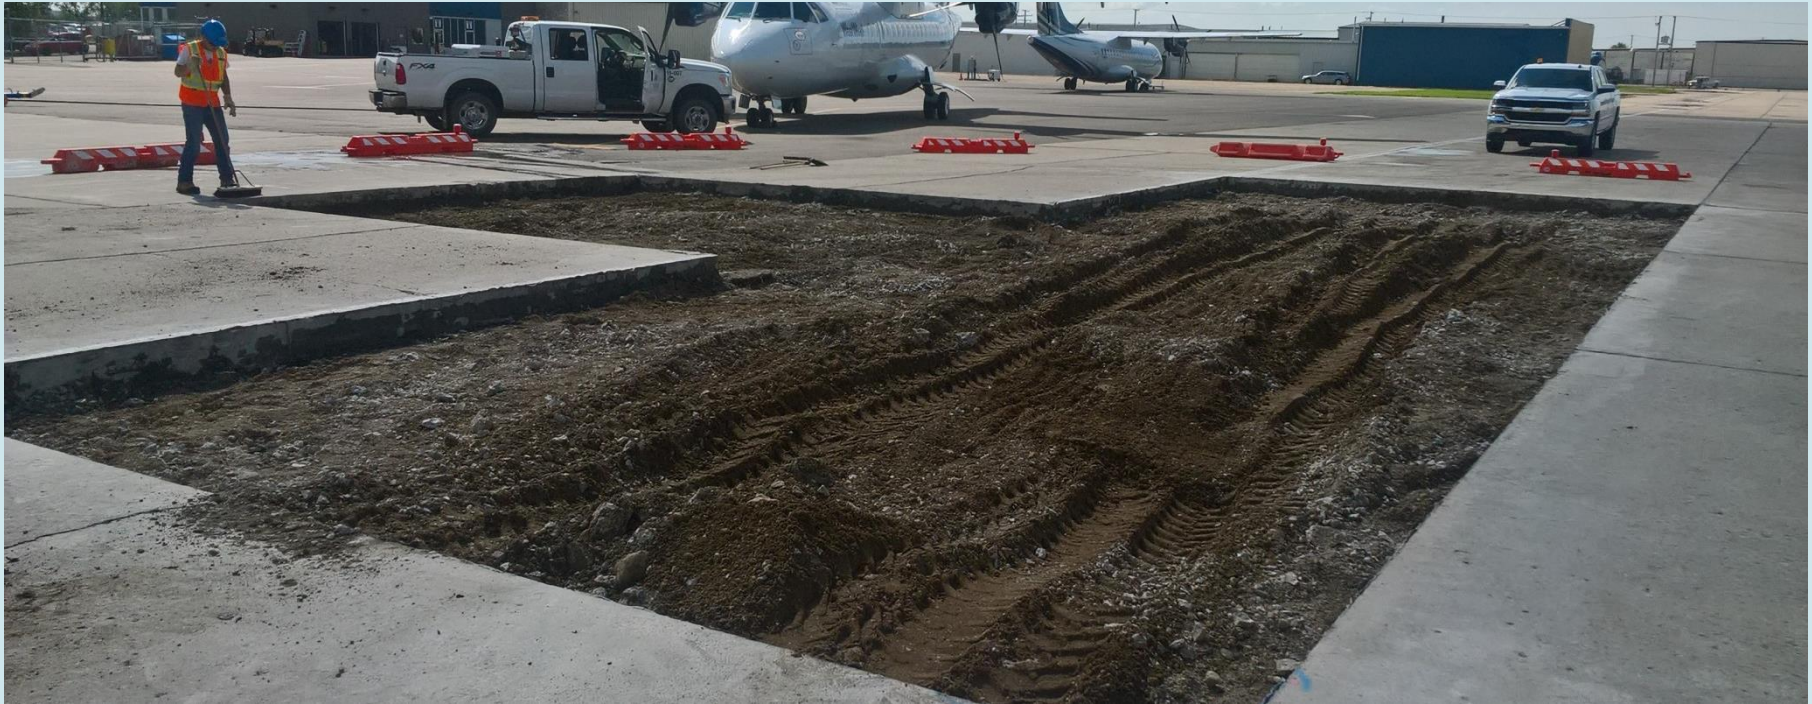
Poor Granular Base

- Hydrocarbon contamination
- Soft subgrade and granular

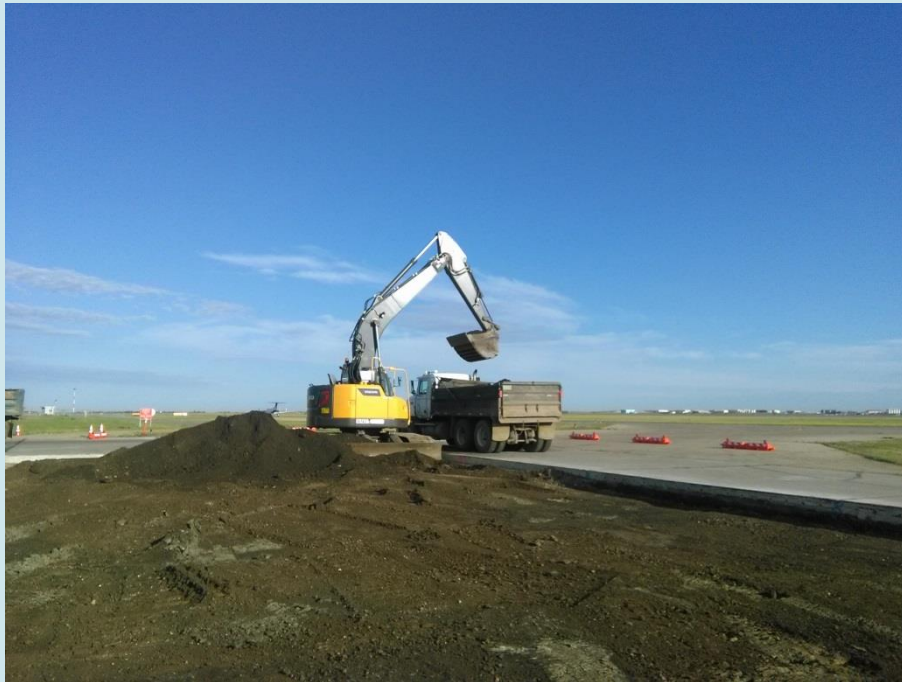
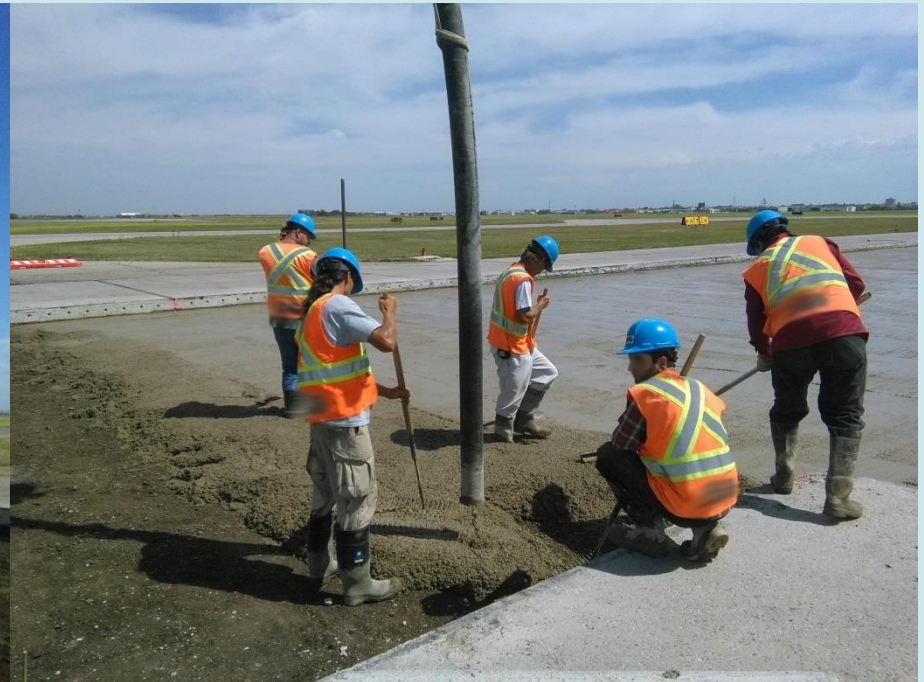
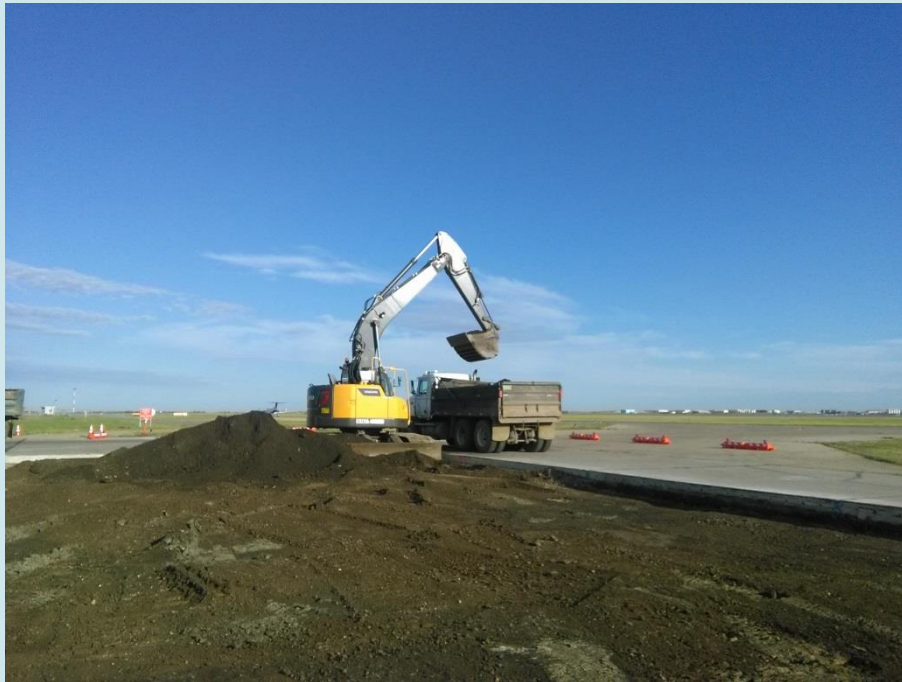
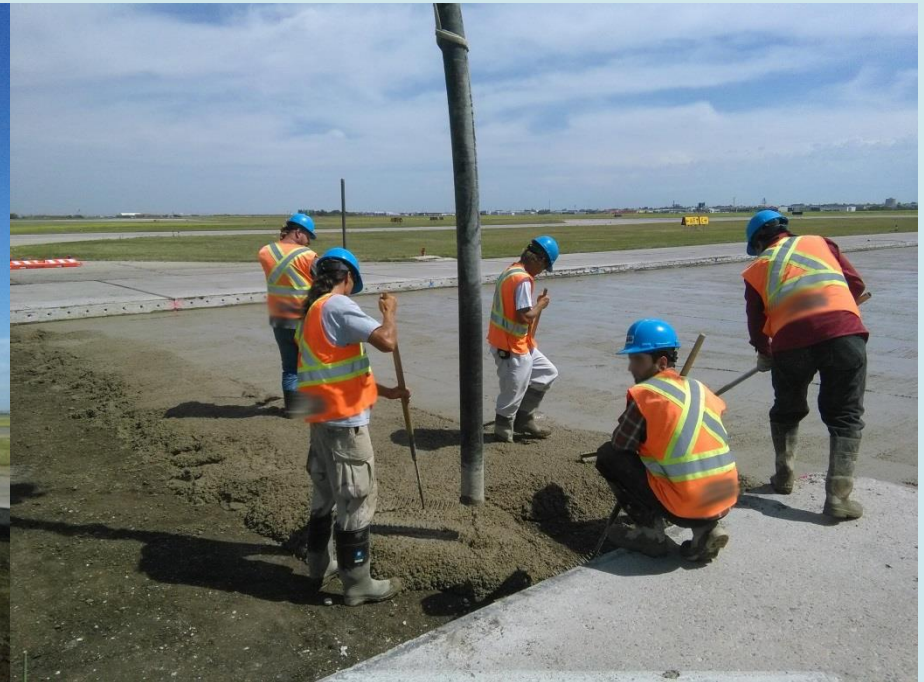
Poor Granular Base

- Fillcrete replacement
- Grade control is critical

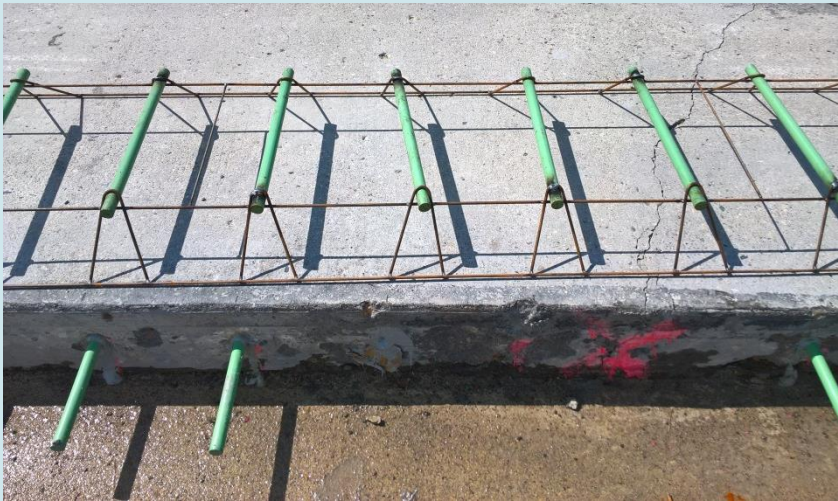
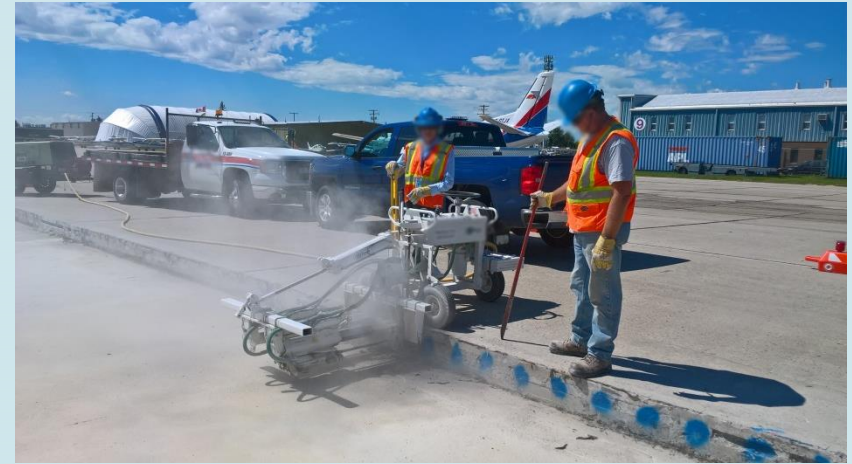
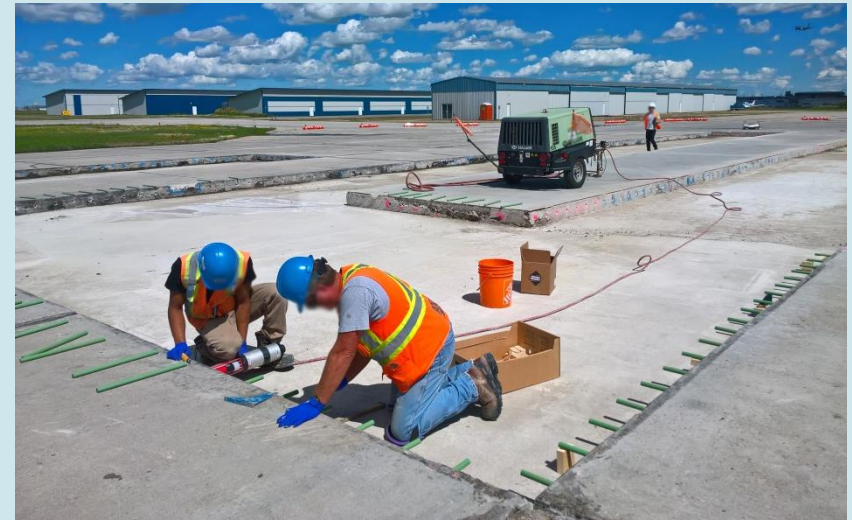
Dowel Installation

- Important that dowels are level and square

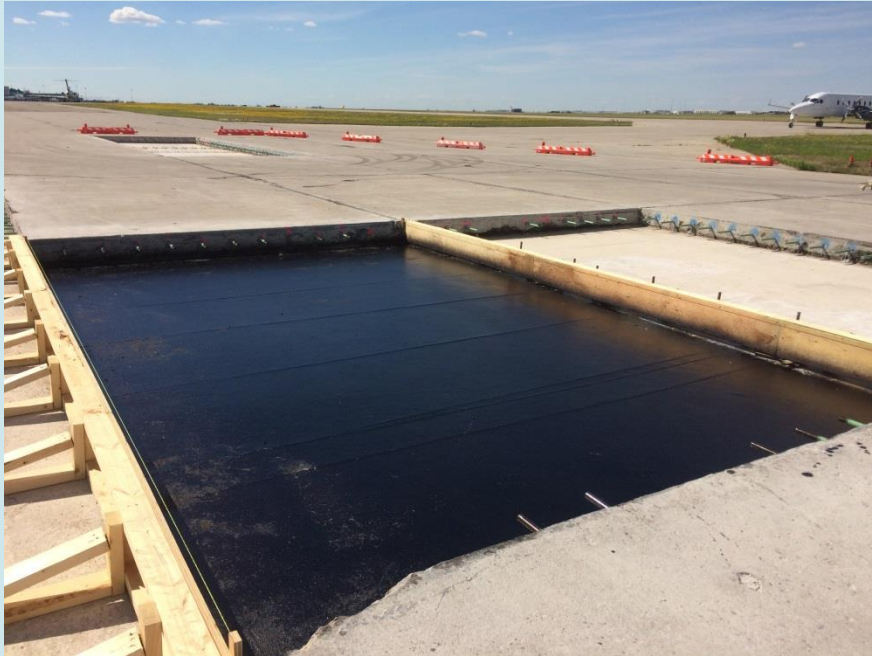
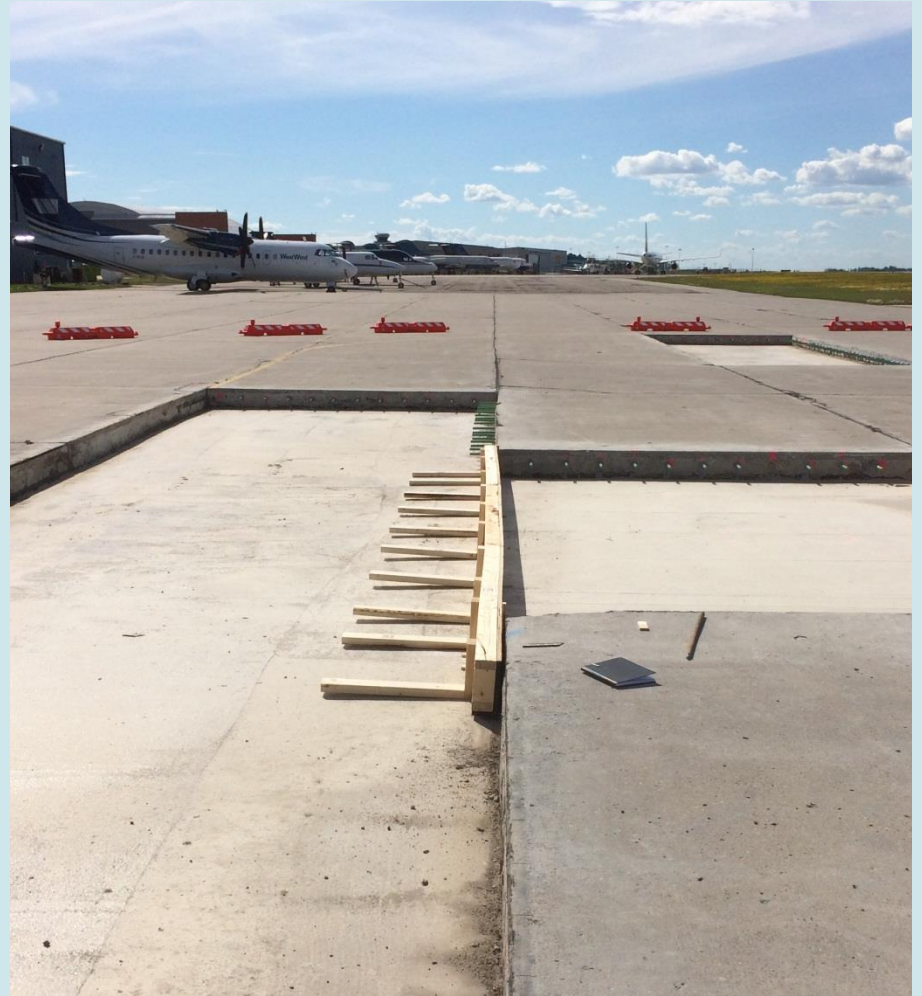
Formwork

- Alignment and Grade control is critical

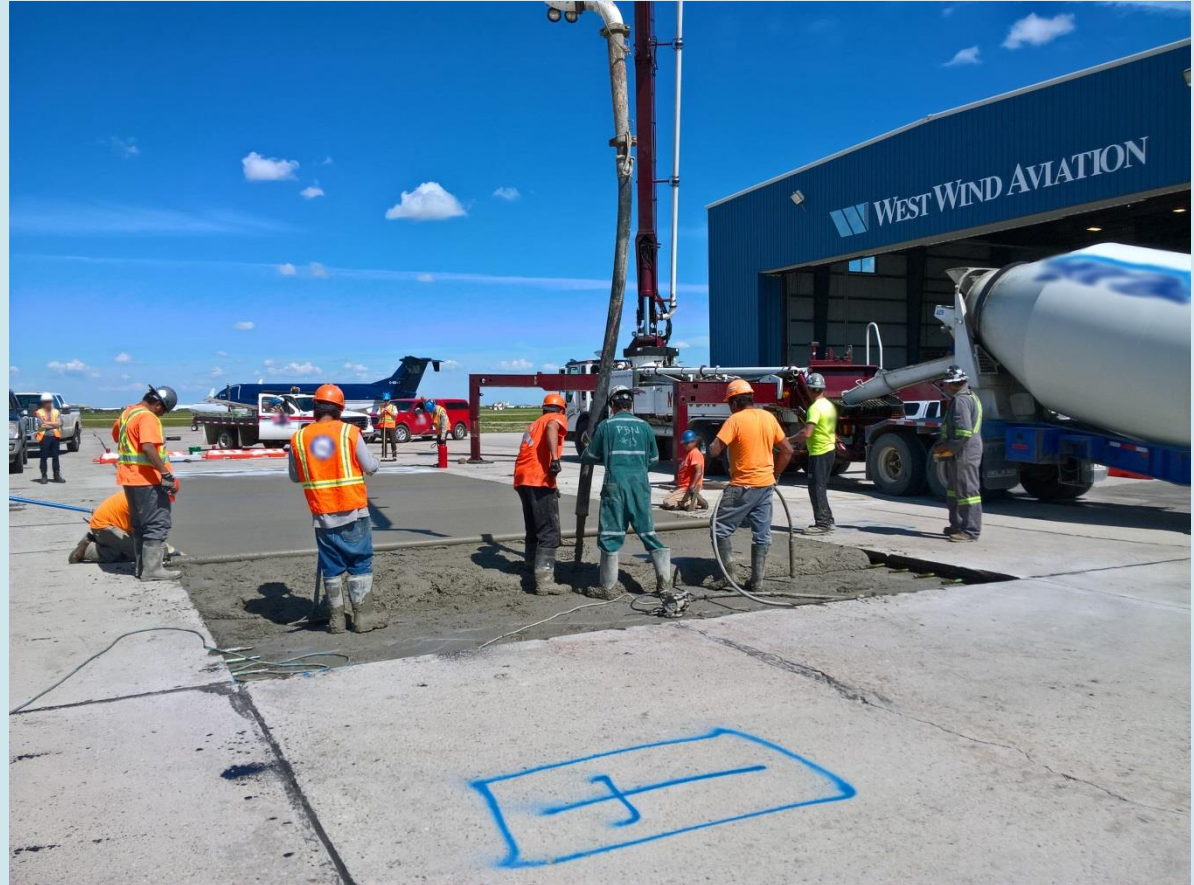
Concrete Placement

- Pump trucks can accelerate work
- Important to manage concrete supply rates
- Finishing is time sensitive

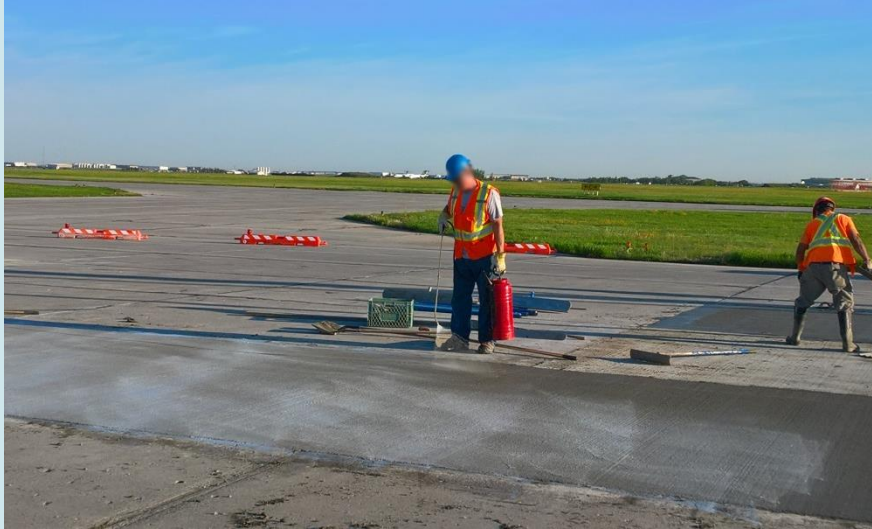
Finishing and Curing

- Curing needs to match the conditions
- Finishing is very time sensitive

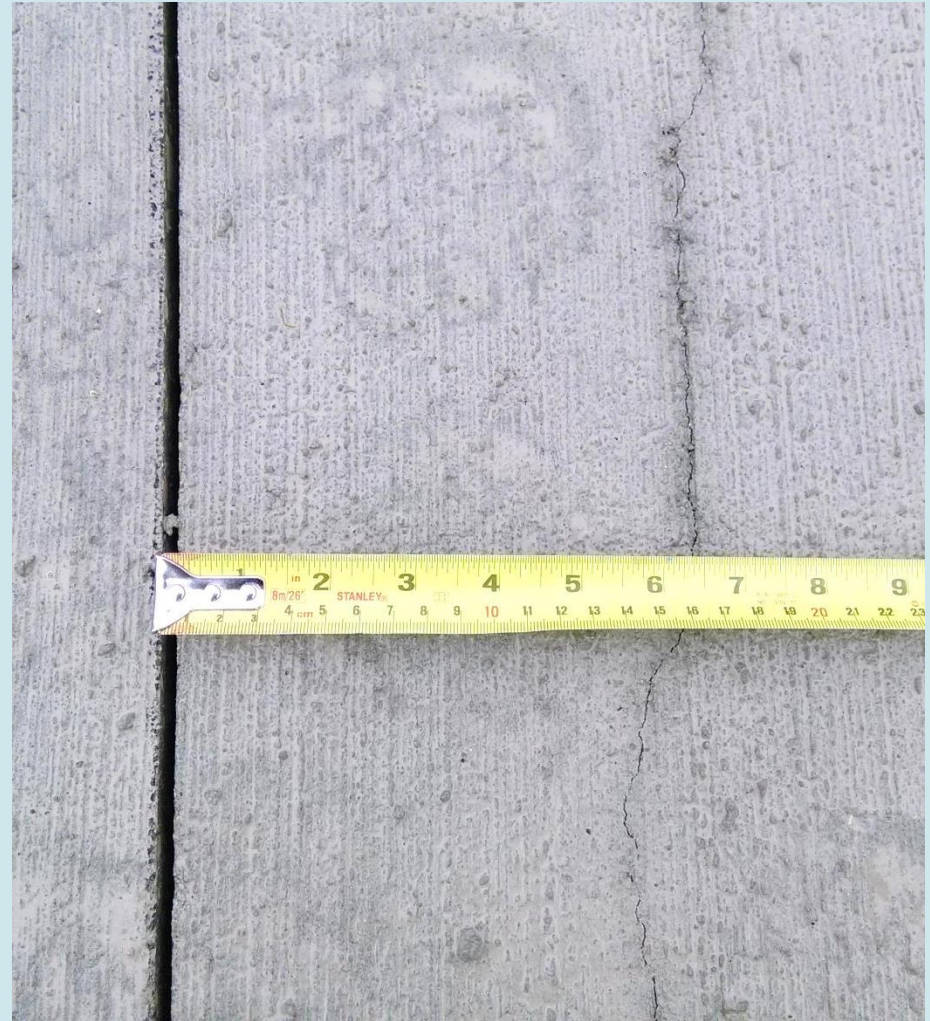
Green Cutting

- Time is of the essence
- Great variability due to weather and mix design

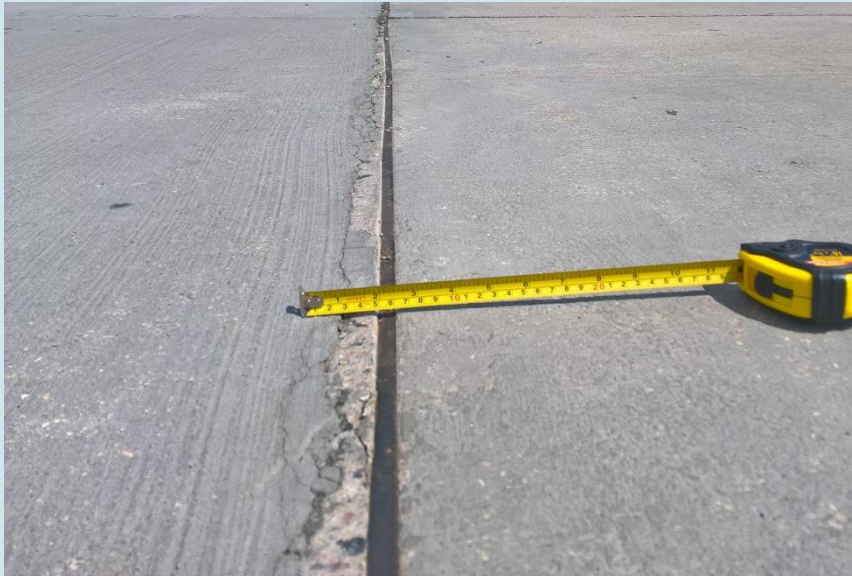
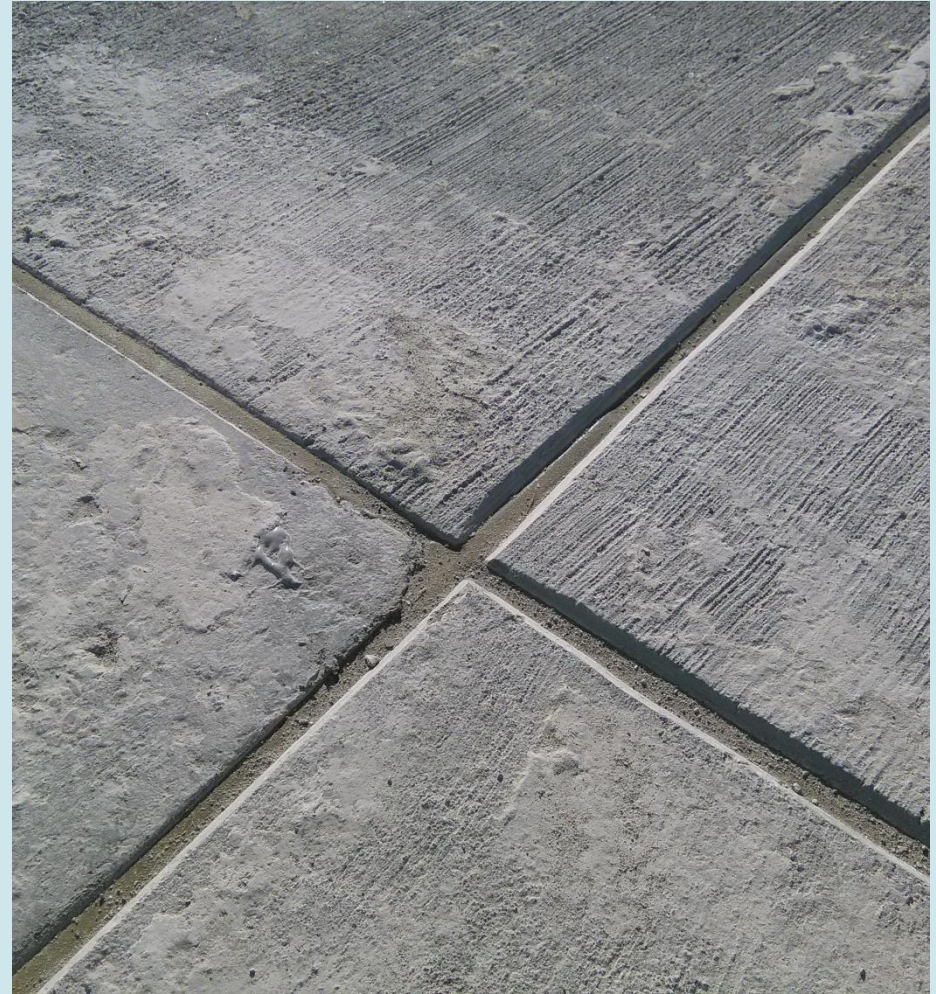
Joint Sealing

- Alignment is crucial
- Consider fuel resistance and curing times

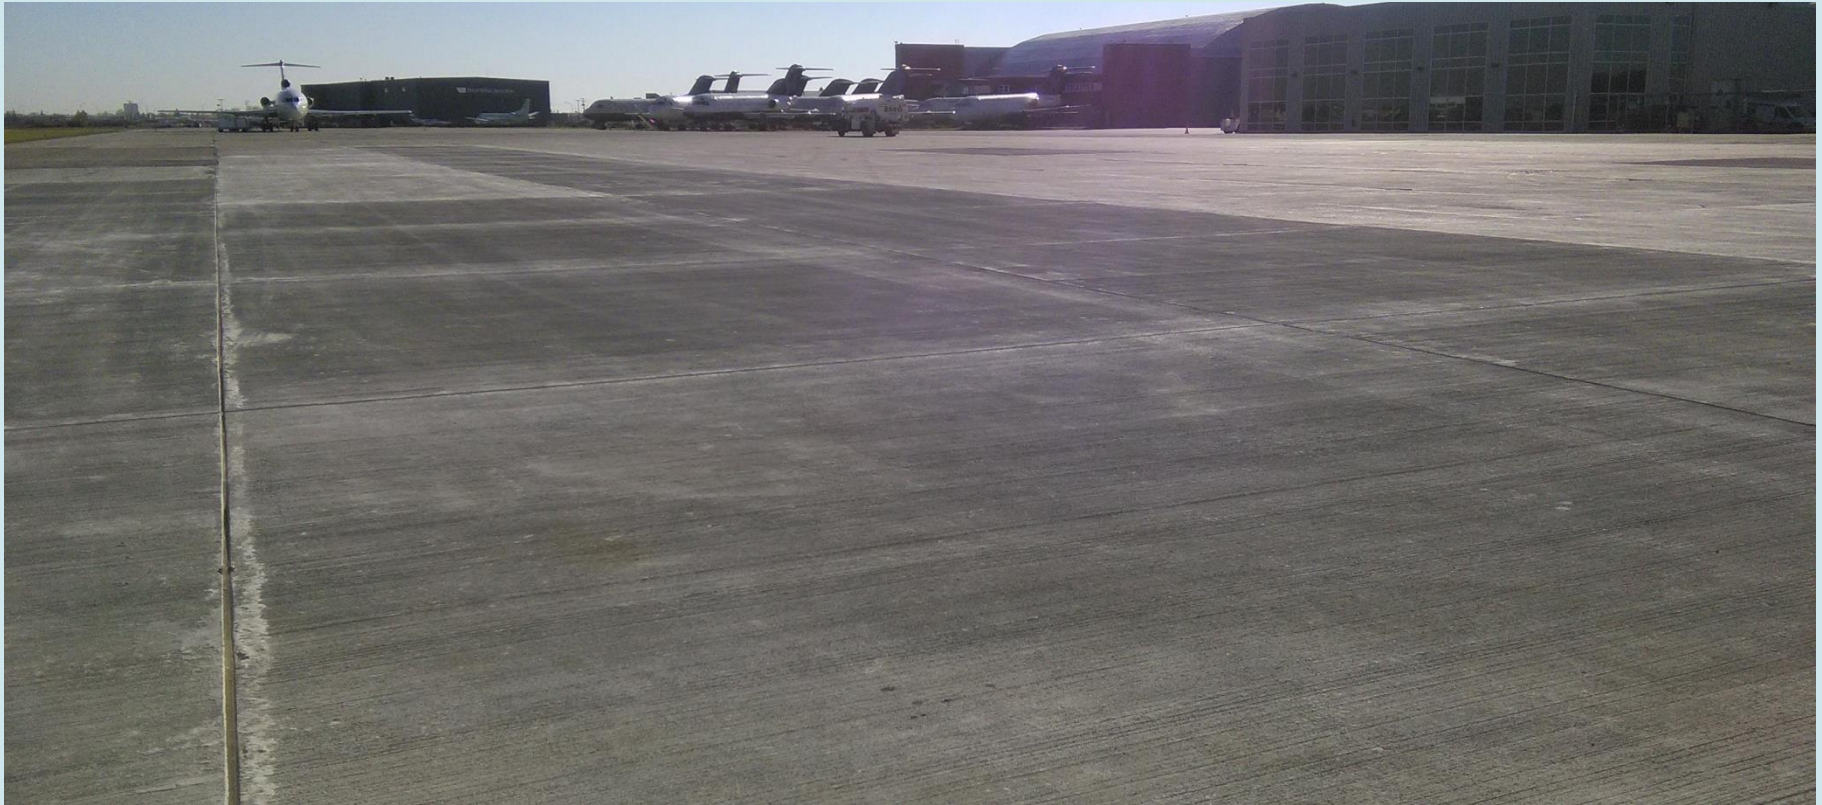
Finished Product

- 128 panels replaced on Aprons II, III & V since 2015
