Using Robotics and Computer Vision to Improve Airfield Condition Assessments

Shirley Ddamba, YVR Joshua Fowler, Niricson Rachel Loboda, Niricson

SEPT 17-19 2024

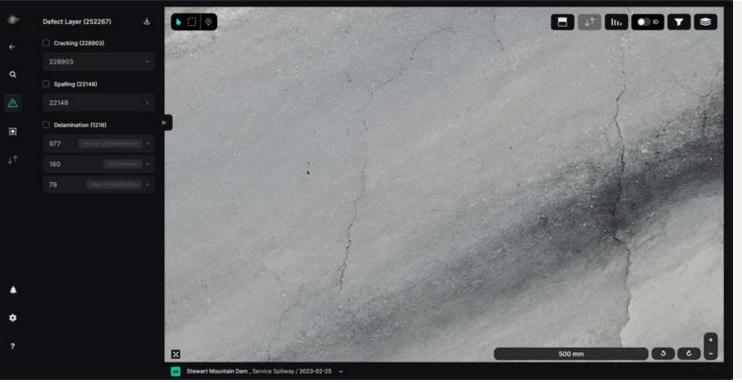
Mapping Defects

Automated Defect Mapping Generated Through Al Technology

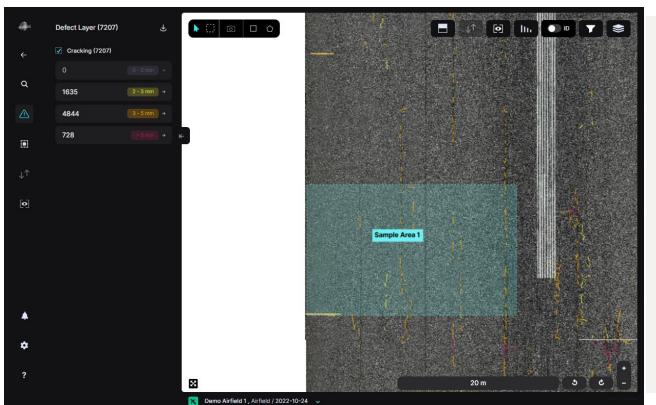
Geospatial Sample Areas

Sample areas & locations can be created on the maps, which aggregate defects within the selected area

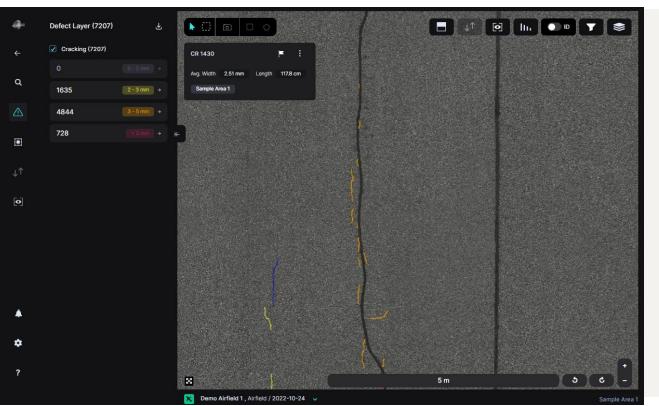
Geospatial Defect Mapping

Defects are Associated with the locations that are defined in the software

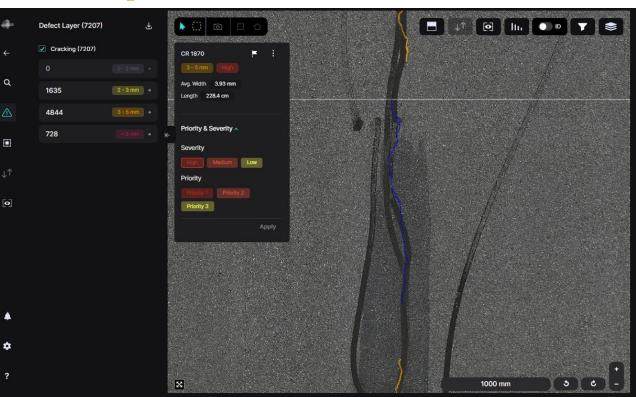
Geospatial Defect Severity

Defects can be labeled as high/medium/low severity

Defects can be labeled by 'type' on the platform

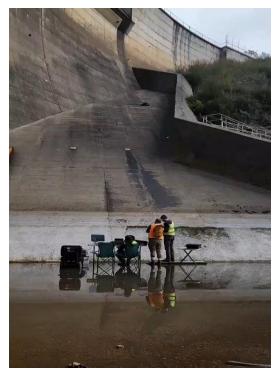
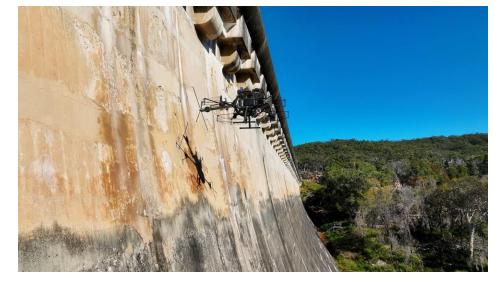
Data Collection SWIFT Concrete Soundings for PCC

- Not all spalls are visual, some PCC airfields do soundings to identify delamination
- By detecting delamination before the concrete spalls, we can be proactive with maintenance
