FAA Research on Small Unmanned Aircraft System (sUAS) for Pavement Condition Inspections

Peter-Paul Dzwilewski, P.E.

SEPT 17-19 2024

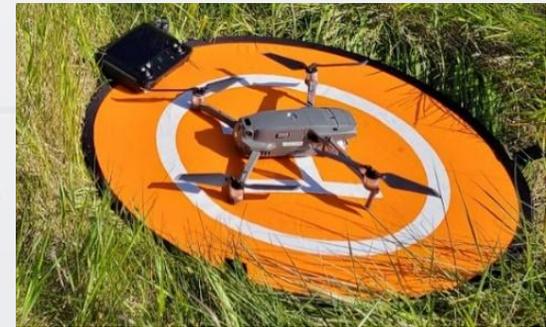
sUAS platform	Type	Sensor	Claimed Flight Time (minutes)
Bergen Hexacopter	Six rotors, larger	Nikon D850 45.7-mp RGB optical	16
		FLIR Vue Pro R 640x512 thermal	
		Tetracam Micro-MCA6	
Tarot X6	Six rotors, larger	Nikon D850 45.7-mp RGB optical	35
MicroDrones mdMapper1000+	Four rotors, larger	Sony RX1R-II 42.4-mp RGB optical	40
DJI Mavic 2 Pro	Four rotors, small	20-mp RGB optical	31
Mavic 2 Enterprise Advanced	Four rotors, small	48-mp RGB optical Quad Bayer and 640x512 thermal	31
DJI Mavic 2 Enterprise Dual	Four rotors, small	12-mp RGB optical and FLIR 160x120 thermal	31

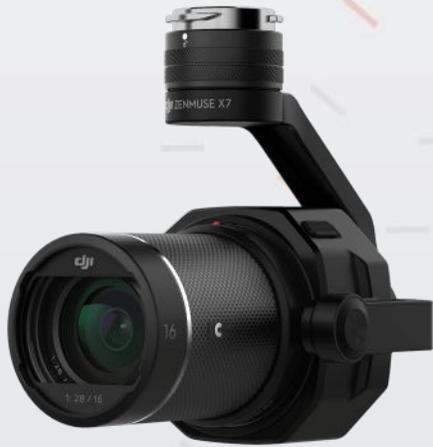
- Nikon D850 (45.7 mp), DJI X7 (24 mp), Sony RX1R-II (42.4 mp)
- 20 and 48 mp Quad Bayer (**true 12 mp**) on DJI Mavic
 - In Quad Bayer sensors, each pixel is divided into four adjacent sub-pixels

- Full-frame RGB camera sensors (42+ mp) provide better visual details
 - Not directly integrated with platforms and additional knowledge are required to use them for data collection
- The light sensitivity, aperture, and shutter speed (exposure triangle) need to be adjusted on the non-integrated RGB full-frame cameras to capture the best quality images under different light conditions, flight altitudes, and flight speeds
 - Additional equipment and processing steps are required to capture position information and geotag the collected imagery

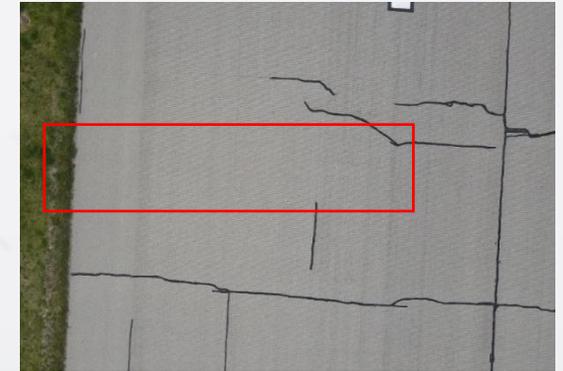
2.5 mm/pix

31 mm/pix

L&T cracks underneath an asphalt overlay show heat signature in thermal data

- 640x512-integrated sensors on DJI
- 640x512 FLIR VUE PRO R
- Only recommended to complement RGB data
- Sealed cracks through pavement marking detection
- Cracks on underlying pavement before a new pavement layer was placed

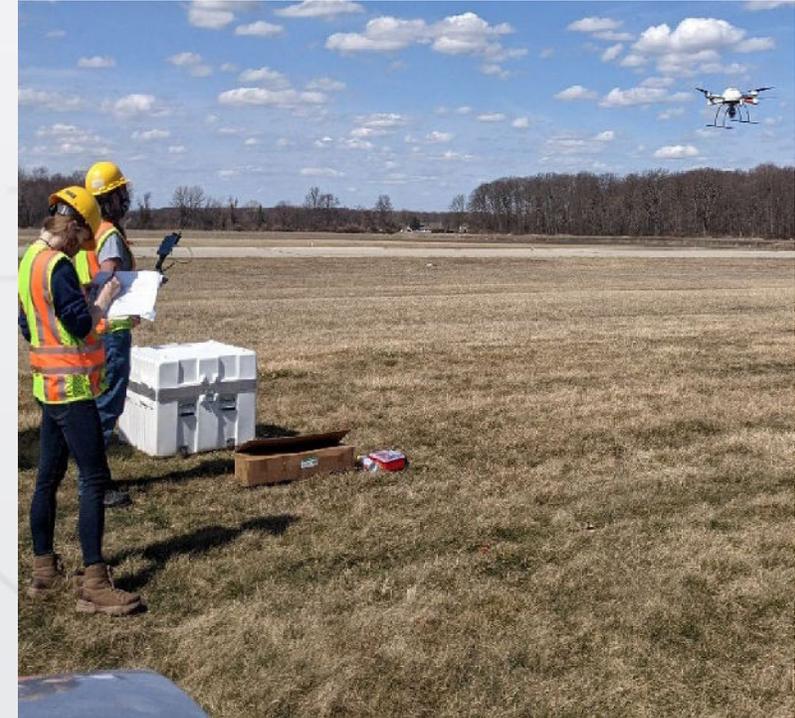
High-resolution sUAS data collection with mdMapper1000+ and Bergen Hexacopter sUAS platforms

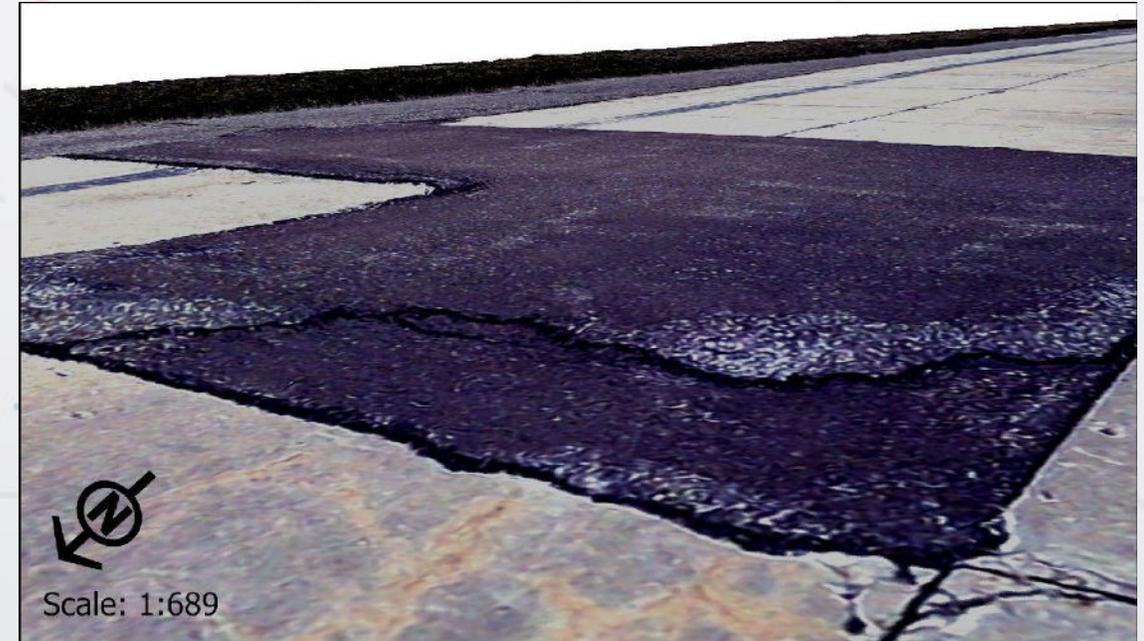
Example of draping an sUAS-derived Orthophoto over a DEM showing elevation differences for patching on airport runway

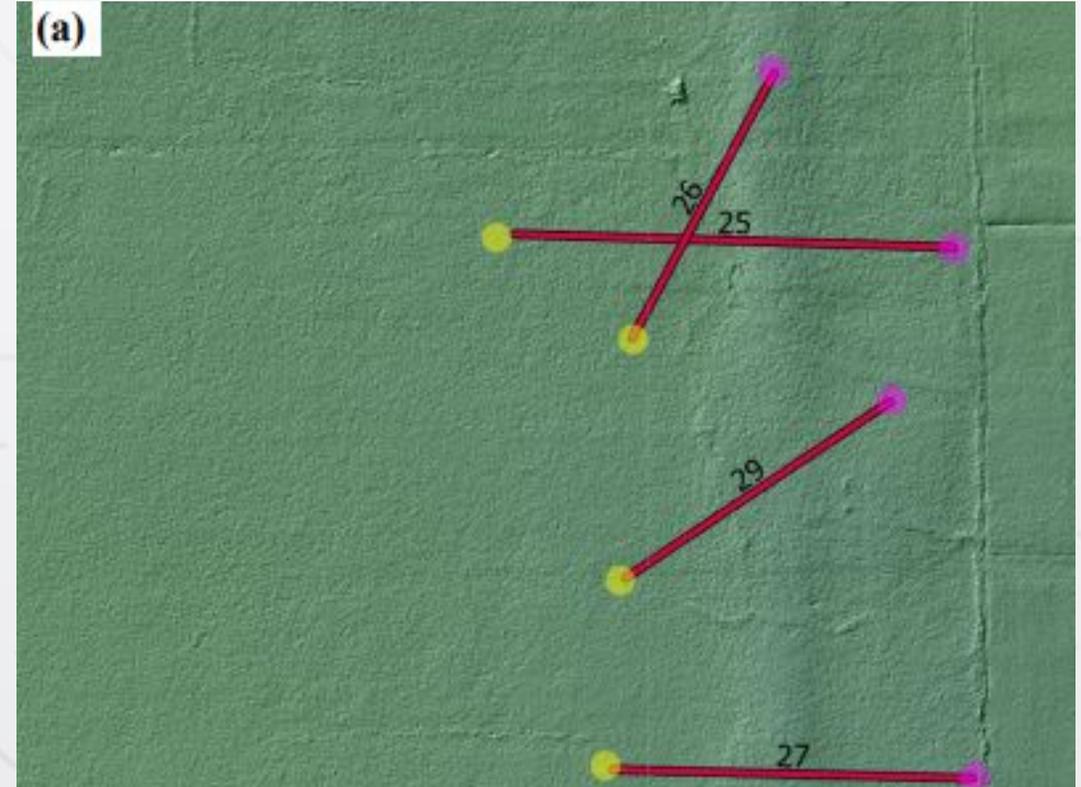
EXAMPLES (WWD)

3D profile of pavement with Shoving (L)

- Shoving (L)
- (a) 5.9-mm/pix DEM
- (b) Elevation Difference of the DEM on Line 25
- (c) Elevation Difference of the DEM on Line 27
