“An Innovative Approach to Locate and Repair a Runway Roughness Event at YYZ”

Kevin Chee, GTAA
Robert Pouliot, Air Canada
Tony Gerardi, APR Consultants Inc.

Toronto Pearson Airport – Canada's Largest Airport

Reported Runway Roughness

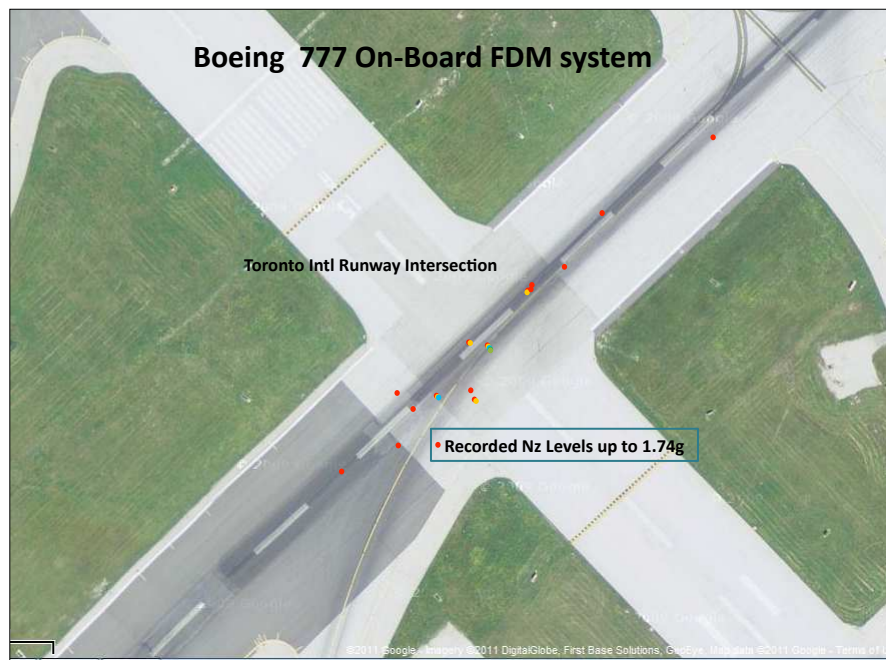
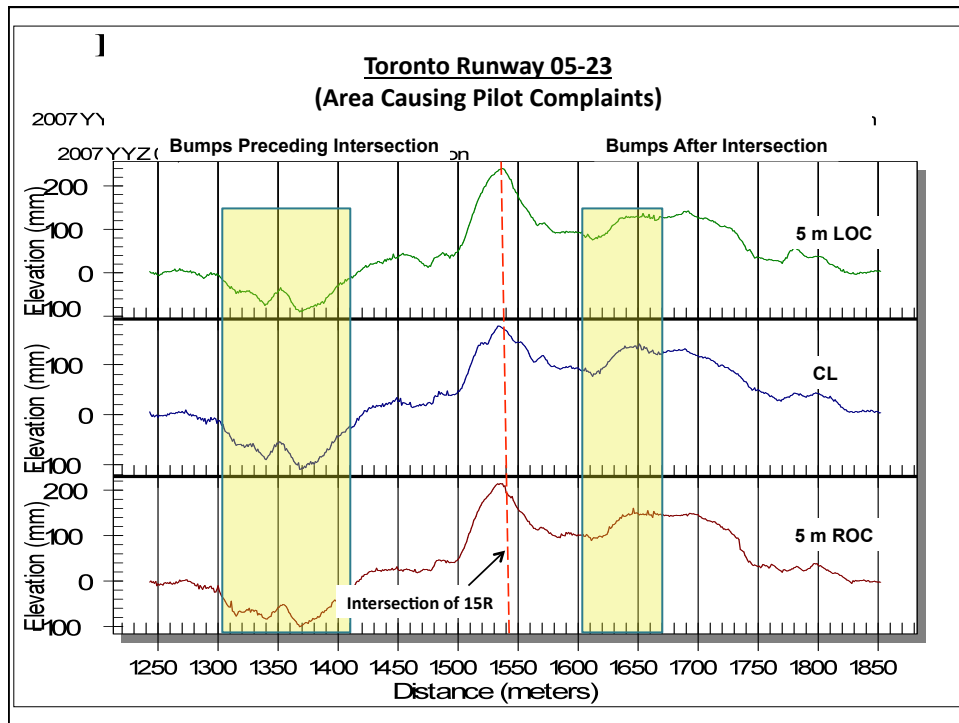
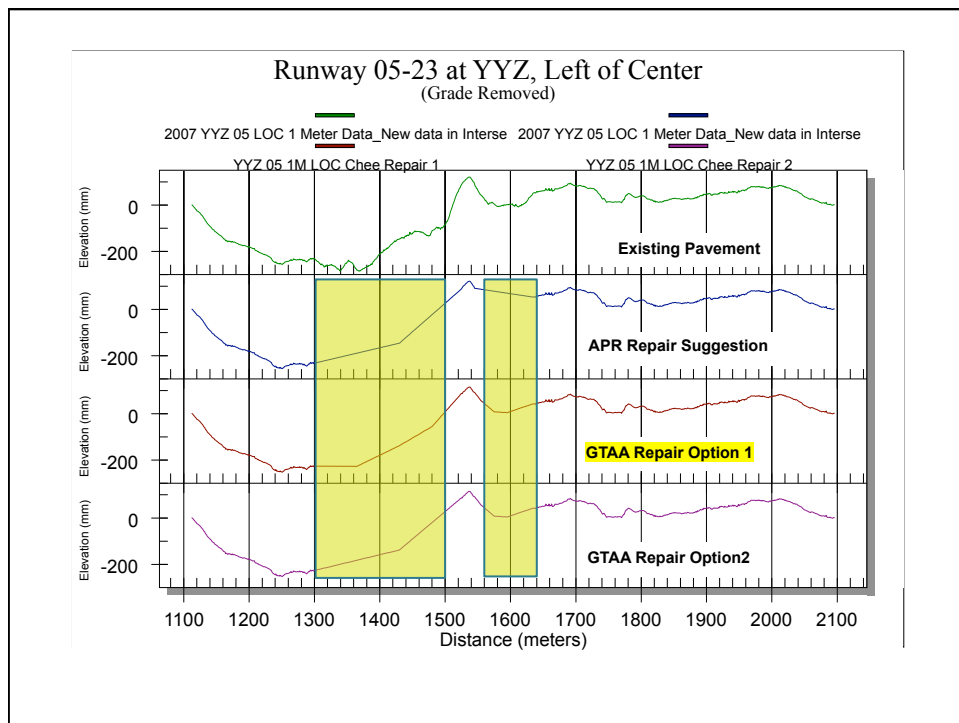
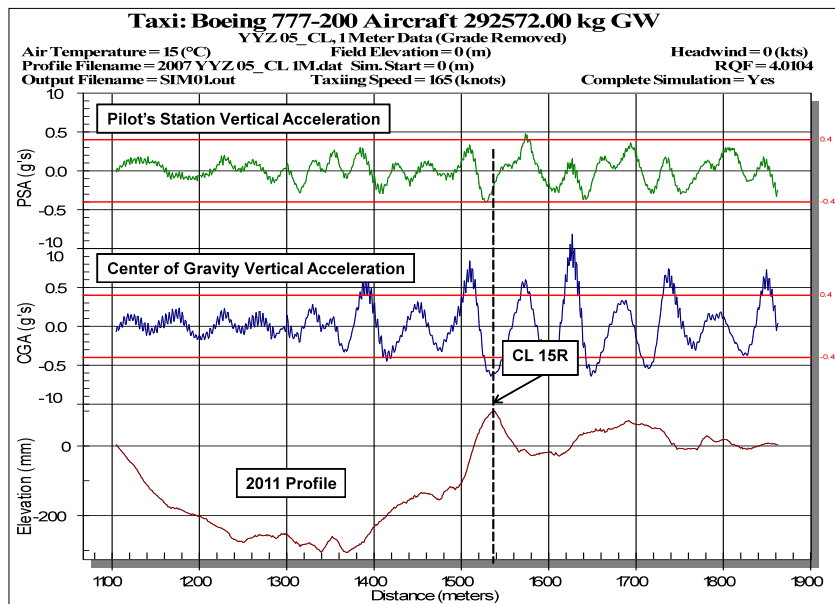
On-Board Health Monitoring Systems on Air Canada Jets

- Sophisticated sensor network designed to track the structural integrity of each aircraft by tail number
- “Nz” Center of gravity vertical acceleration measures the aircraft response to bumps/dips
- GPS accurately locates the event
