YVR Taxiway Delta Rehabilitation

George Nowak, P.Eng.

SWIFT September 22, 2016

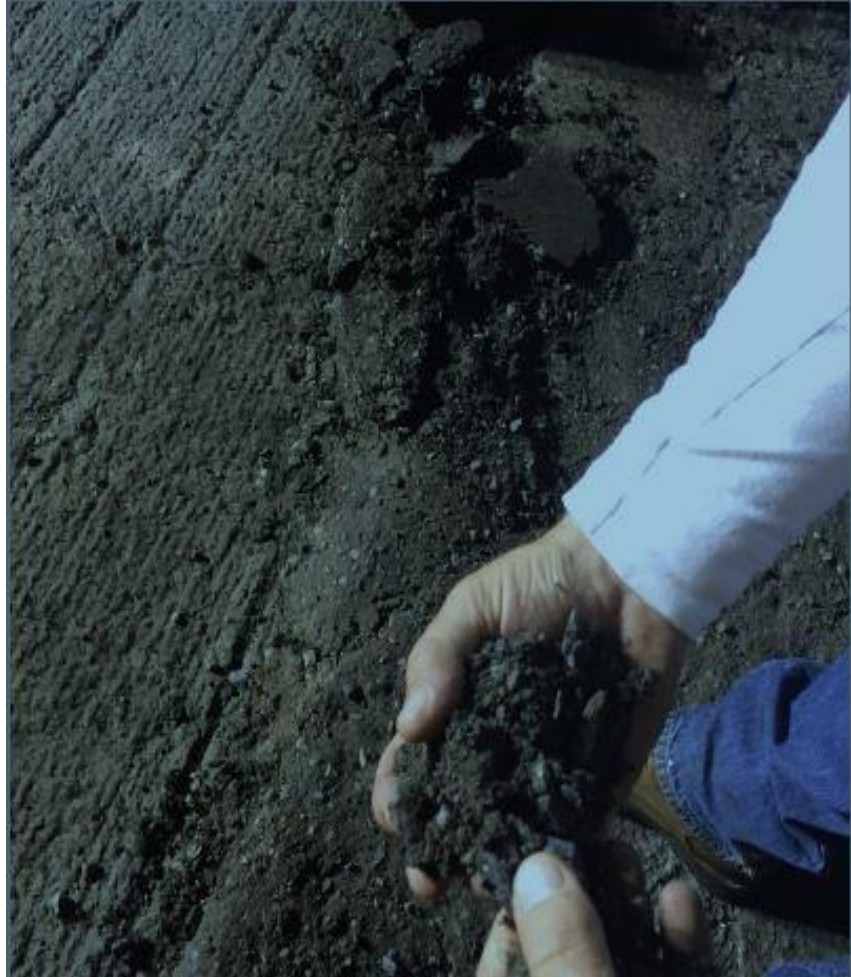
Pavement Loading and Hot Mix Ageing

- Pavement was not designed for increased heavy traffic (1960's vintage PCC: 360 mm + keyways , 150mm CGB, 460 mm river sand subbase, subgrade CBR=2-3% with 2+ HMA overlays)
- Select rigid ACN's : DC-8-62 (77), B747-400 (88), A380-800(110), B777-300ER (128) – for ICAO D Ultralow) - 66% increase.
- Extreme stripping in lower HMA layers
