Runway 05-23 Rehabilitation

at Toronto Pearson International Airport

Presenter: Jessica Hernandez – Englobe, Kevin Chee – GTAA
Date: Sept 21, 2017
Location: 2017 SWIFT - Halifax

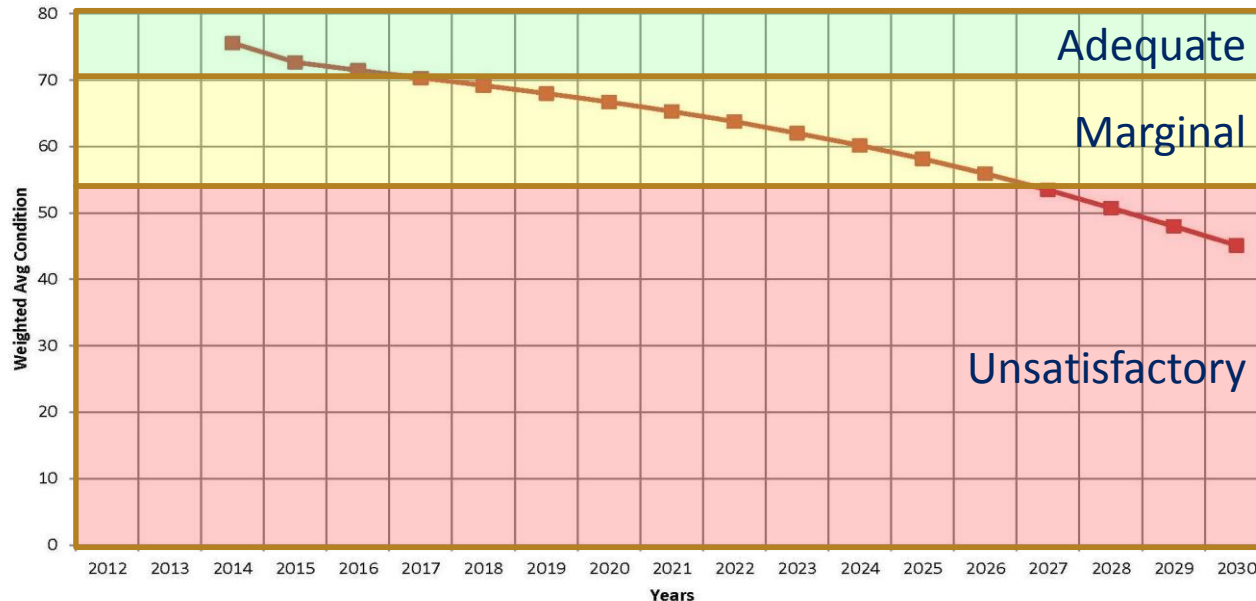
Runway 05-23
Annual PCI Condition Prediction

Based on the consultant Pavement Condition Index (PCI) inspections completed in 2014, the predicated PCI values of the runway overall are as follows:

Runway 05-23	2014	2015	2016	2017	2018
Predicted PCI based on 2014 Inspection data	76	73	71	70	69

According to the U.S. Air Force (USAF) ETL 99-7 Pavement Condition Assessment Standards, the condition of the runway is considered to be Marginal when the PCI is 55 to 70.

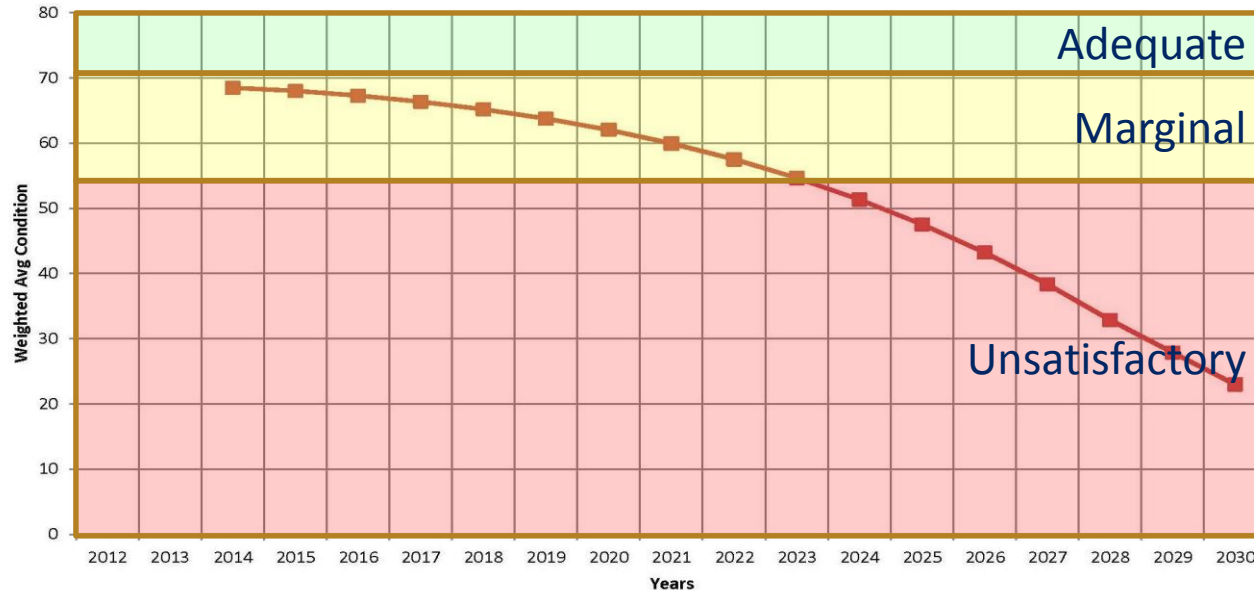
Runway 05-23 west of 15R
Annual PCI Condition Prediction

and the predicated PCI values west of 15R are as follows:

Runway 05-23 west of 15R	2014	2015	2016	2017	2018
Predicted PCI based on 2014 Inspection data	69	68	67	66	65

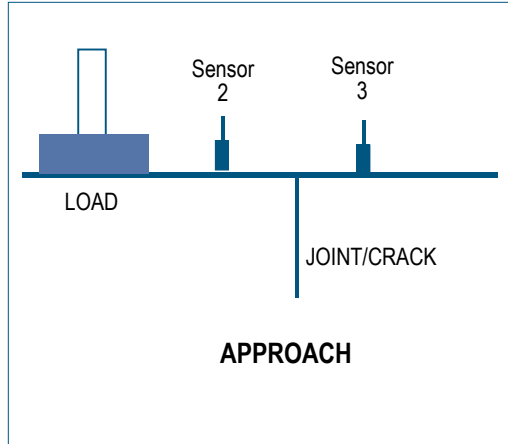
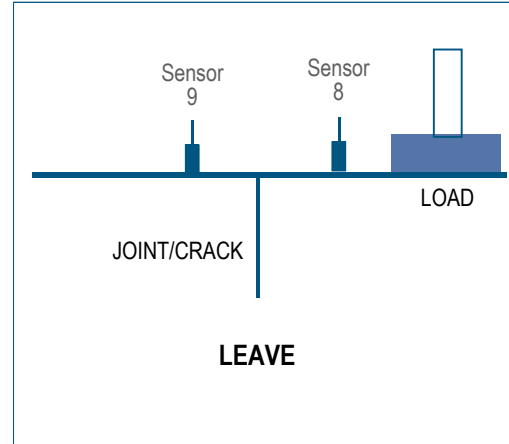
HWD Testing

Three load levels (180, 220 and 240 kN) were used to determine the deflection response of the pavements at all transverse joints/cracks

A total of 904 individual slab panels were tested

CONDITION	LTE, PERCENT
Acceptable	70 to 100
Fair	50 to 70
Poor	Less than 50

LTE CONDITION	NUMBER OF TRANSVERSE JOINTS	PERCENTAGE (%)
Acceptable	1,135	62.8
Fair	235	13.0
Poor	432	23.9
Not Estimated	6	0.3
TOTAL	1,808	100

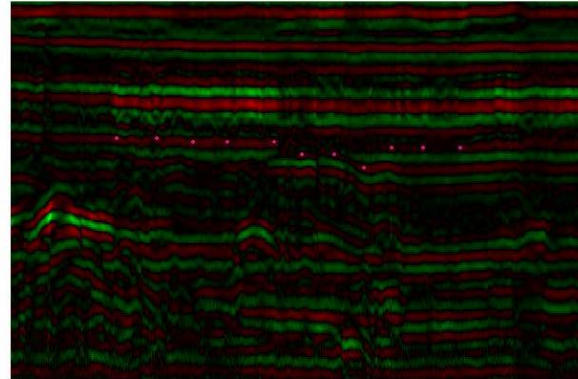
GPR Testing

- ◆ A supplementary survey/voids investigation of the project area was carried out using GPR equipment (using a 70 MHz antenna).
- ◆ The purpose of the GPR testing was to assess the extent of possible voids (or deteriorated CSB) beneath the thick runway composite pavement.

- ◆ **Joints where voids/soft spots were identified:** Underslab grouting (to fill voids under the slabs and in the CSB)
- ◆ **Joints with Load Transfer Efficiency (LTE) less than 60%:** Load transfer restoration techniques (dowel bar retrofit using 35 mm diameter, 600 mm long dowels at 450 mm spacing)

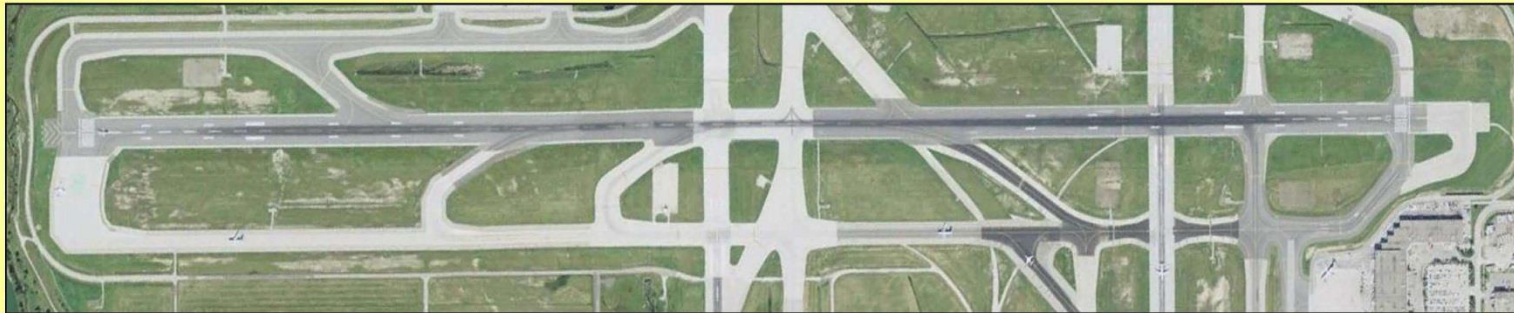
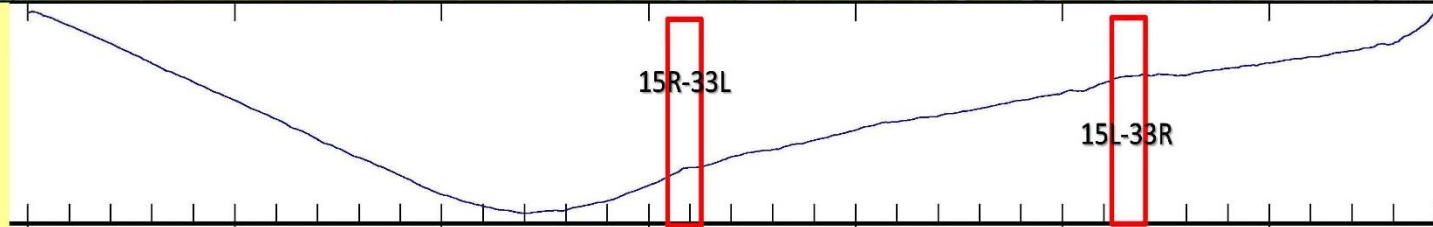
Aircraft Ride Quality Analysis Prior to Paving

5																								32
Section	1	2	3	4	5	6	7	8	9	10	11	12	13	14	15	16	17	18	19	20	21	22	23	
Distance	0 - 150	150 - 300	300 - 450	450 - 600	600 - 750	750 - 900	900 - 1050	1050 - 1200	1200 - 1350	1350 - 1500	1500 - 1650	1650 - 1800	1800 - 1950	1950 - 2100	2100 - 2250	2250 - 2400	2400 - 2550	2550 - 2700	2700 - 2850	2850 - 3000	3000 - 3150	3150 - 3300	3300 - 3400

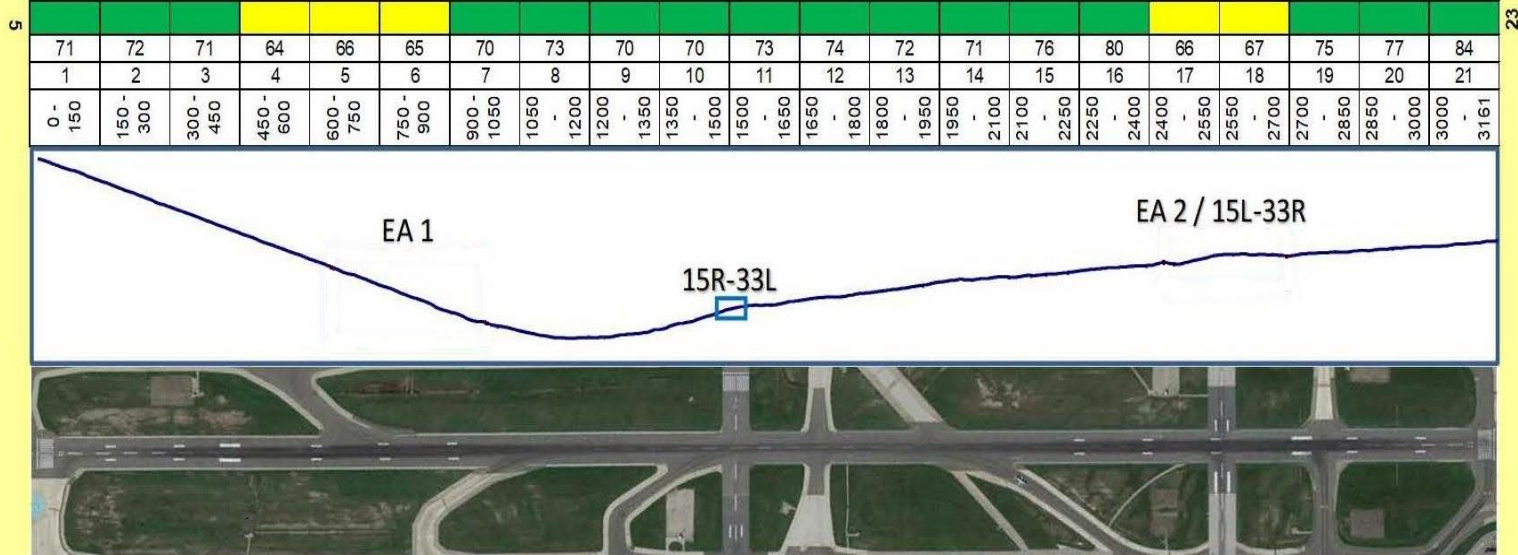
Aircraft Ride Quality Analysis after Paving

PSI Number		Comments	Recommended Action
70-100		Smooth	Survey Periodically
60-69		Mildly Rough	Survey Within Two Years
40-59		Moderately Rough	Consider Repairs
20-39		Significant to Severe Roughness	Immediate Repairs Should be Considered
0-19		Severe Roughness	Cease Aircraft Operations Until Repaired
