USING IMAGERY TO COLLECT ASSET MANAGEMENT DATA

at Toronto Pearson International Airport

Presenter: Alain Duclos, MSc., P.Eng.

Location: SWIFT 2023 - Winnipeg

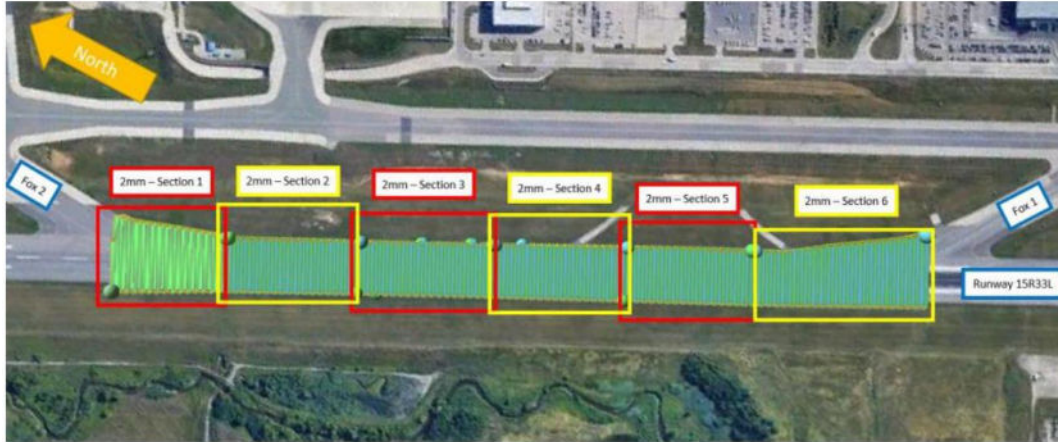
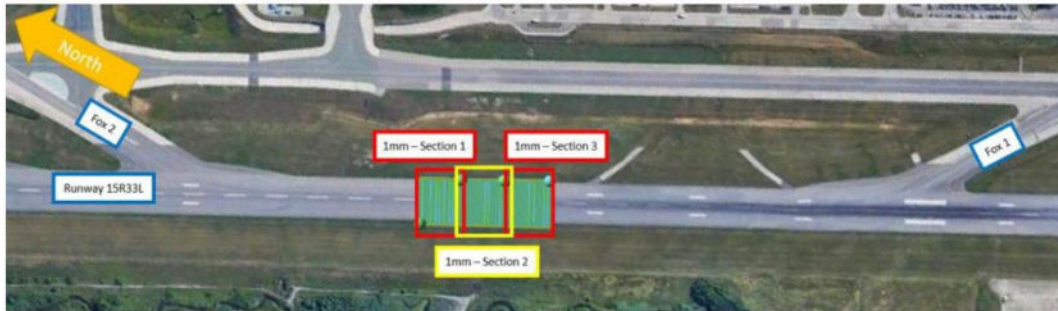
A 6 hour closure was arranged for the drone inspection and the imagery area was approx. 7 hectares on RWY 15R33L between F2 and F1. The 2mm flights were split into 6 semi-equal sized sections shown in the top photo, averaging 26 minutes per section.

The 1mm flights were split into 3 sections shown in the bottom photo, averaging 30 minutes per section.
