# Non-Destructive Data Collection for Airport Infrastructure

September 16, 2010  
Darel Mesher, PhD, P.Eng

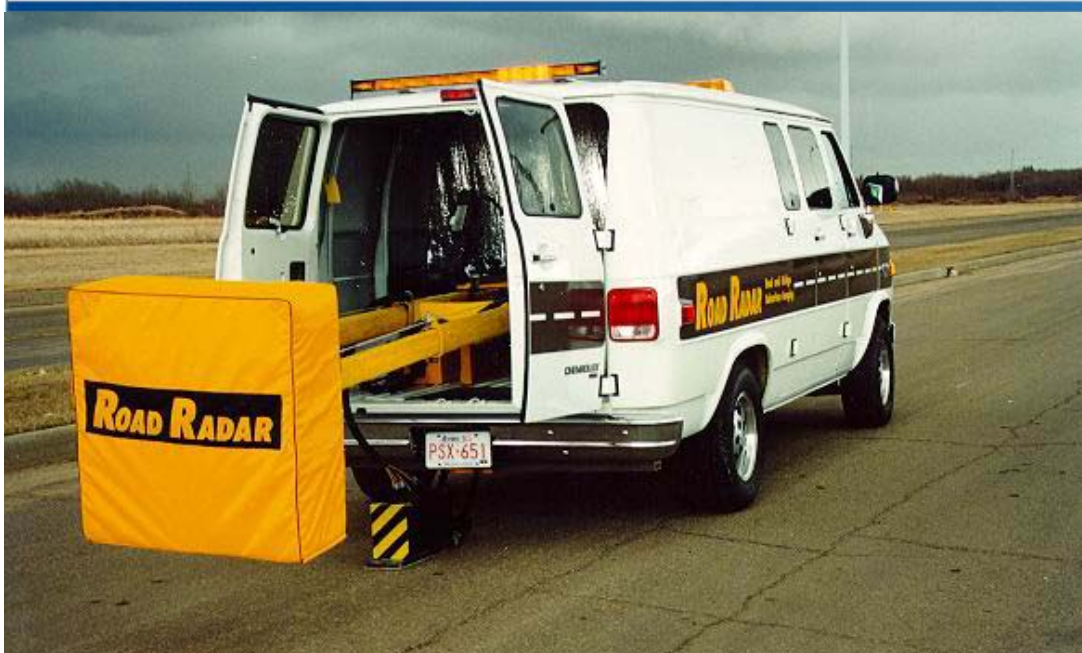
# The Road Radar™ System

## Specifications

- Max Penetration Depth: 2m
- Min Layer Thickness: 50mm
- Accuracy (uncalibrated): +/- 5%
- Maximum Survey Speed: 100kph

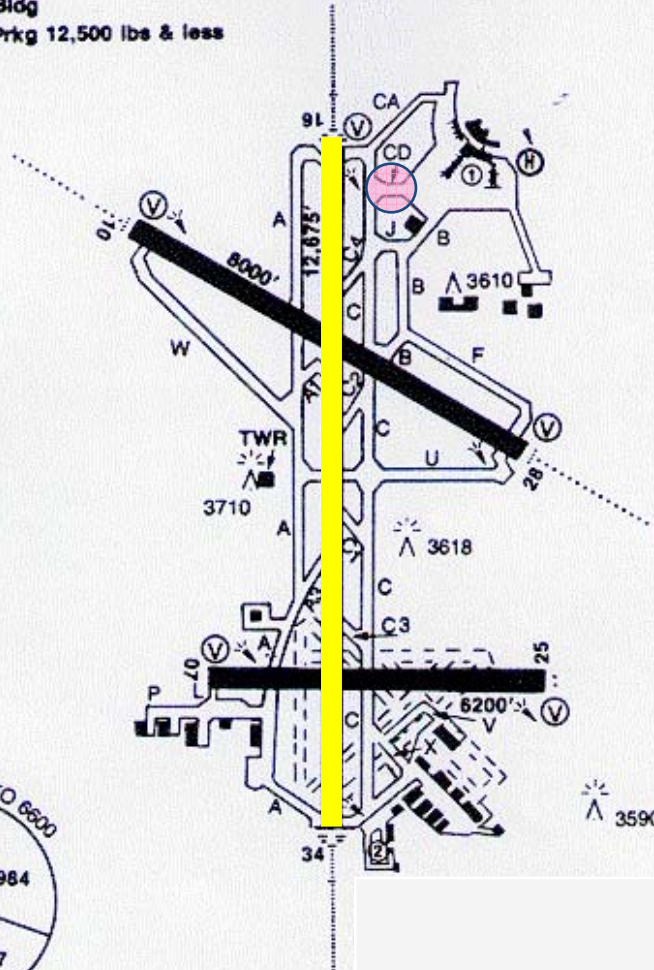
# Structural Verification/Analysis

## Runway

- 4 Lines
- 3,875m Long
- 0.20m Spacing
- 19,735 Samples/line

## Taxiway

- 44 Lines
- 65m Long
- 0.015m Spacing
- 4,333 Samples/line

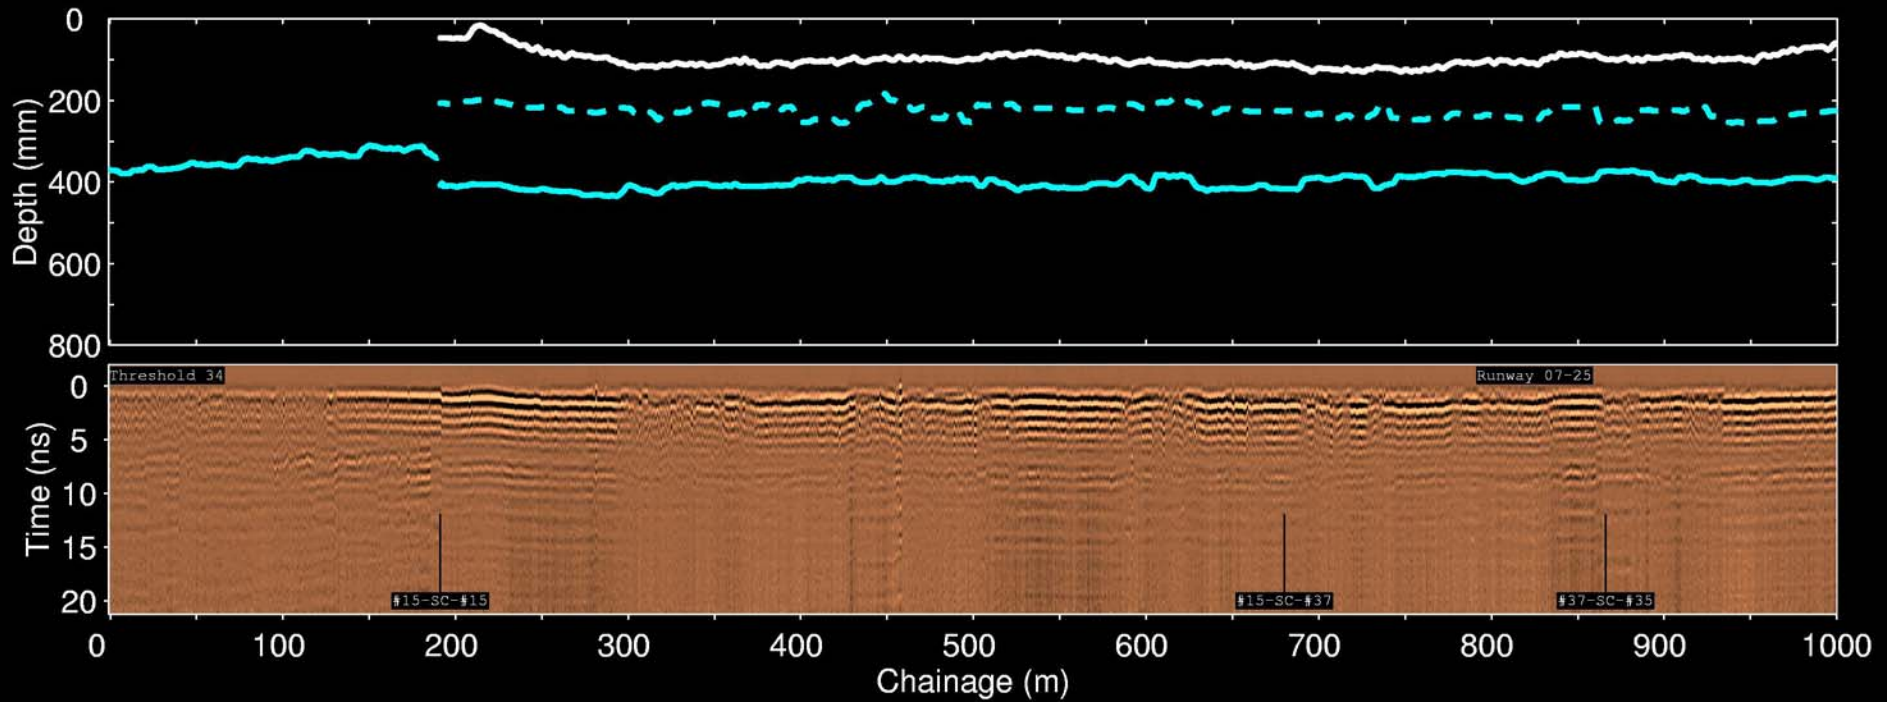
# As-Built Structure

Pavement Structure Types are based on the  
Pavement Restoration History Drawing

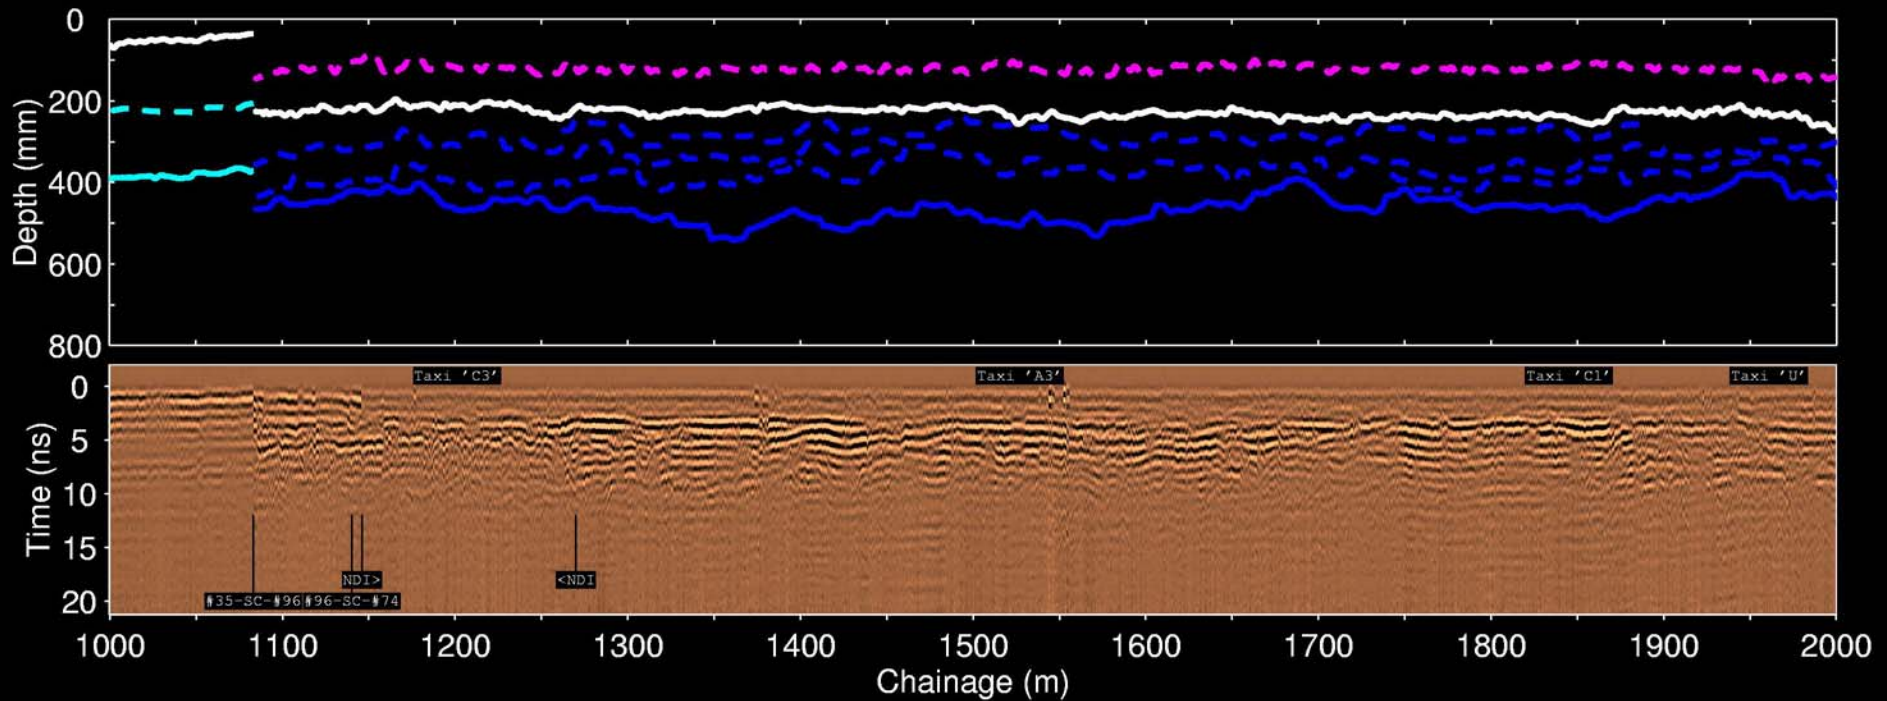
# As-Built Structure

Pavement Structure Types are based on the  
Pavement Restoration History Drawing

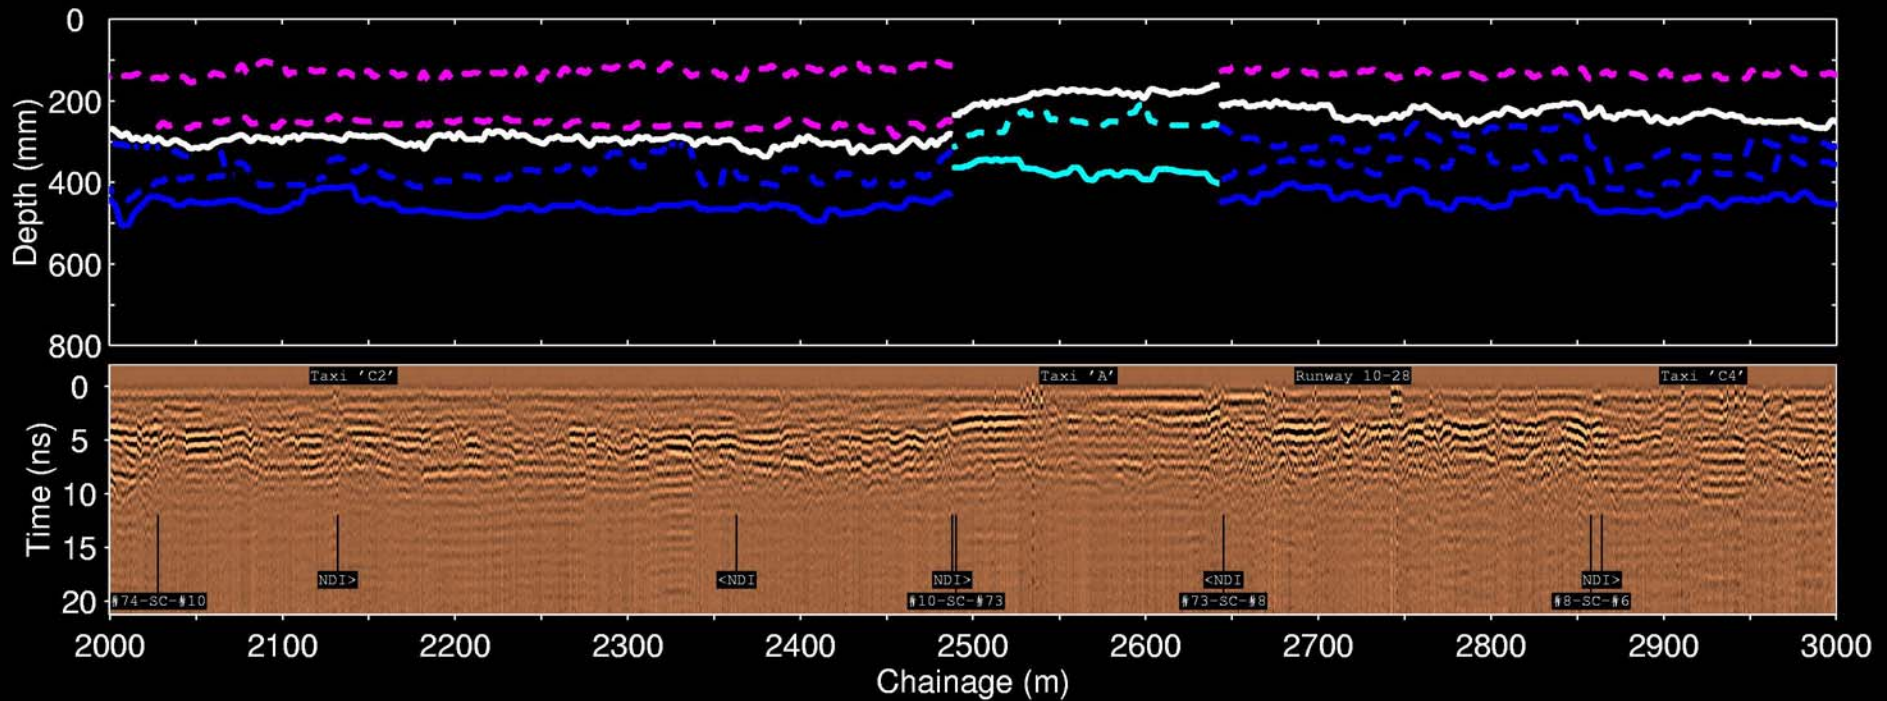
# As-Built Structure

Pavement Structure Types are based on the  
Pavement Restoration History Drawing

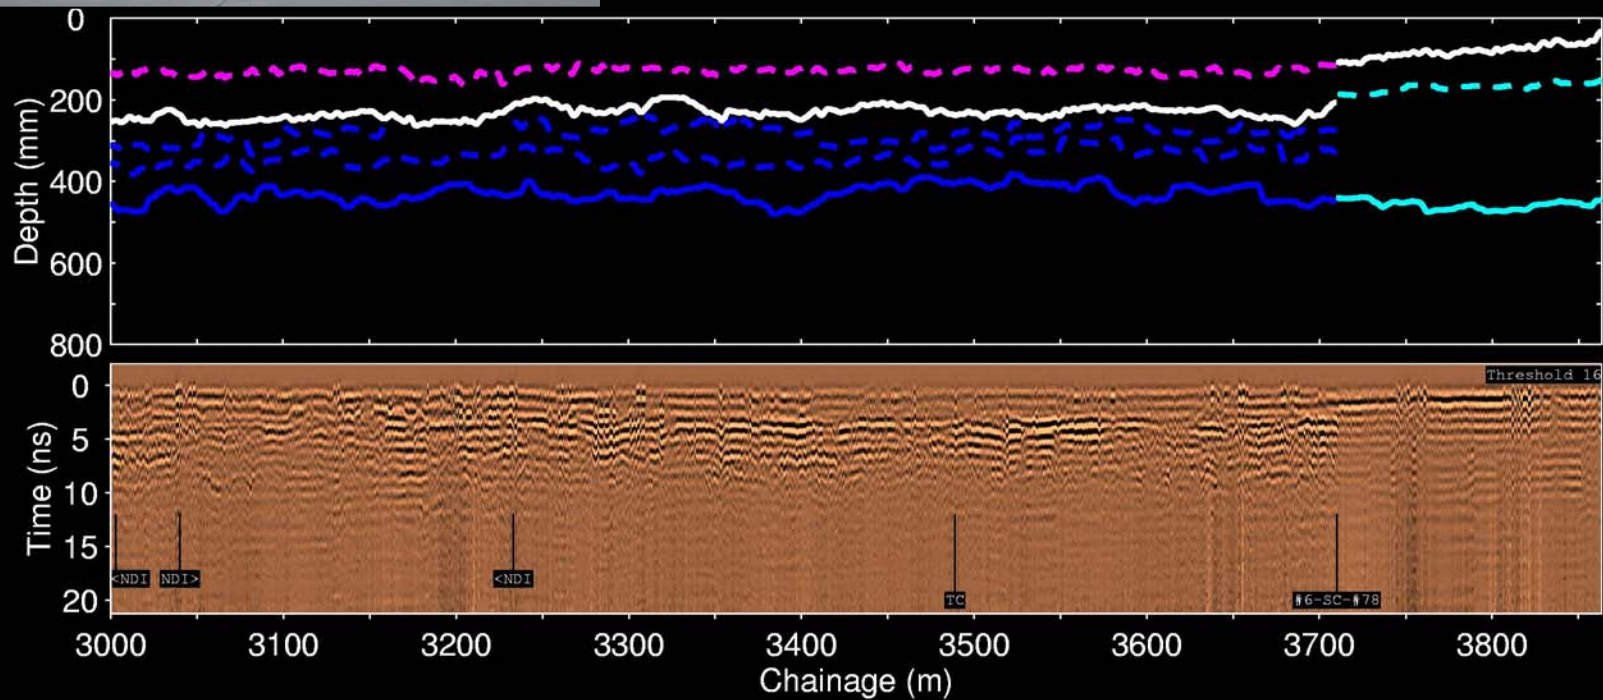
Pavement Structure Types are based on the Laboratory Drawing

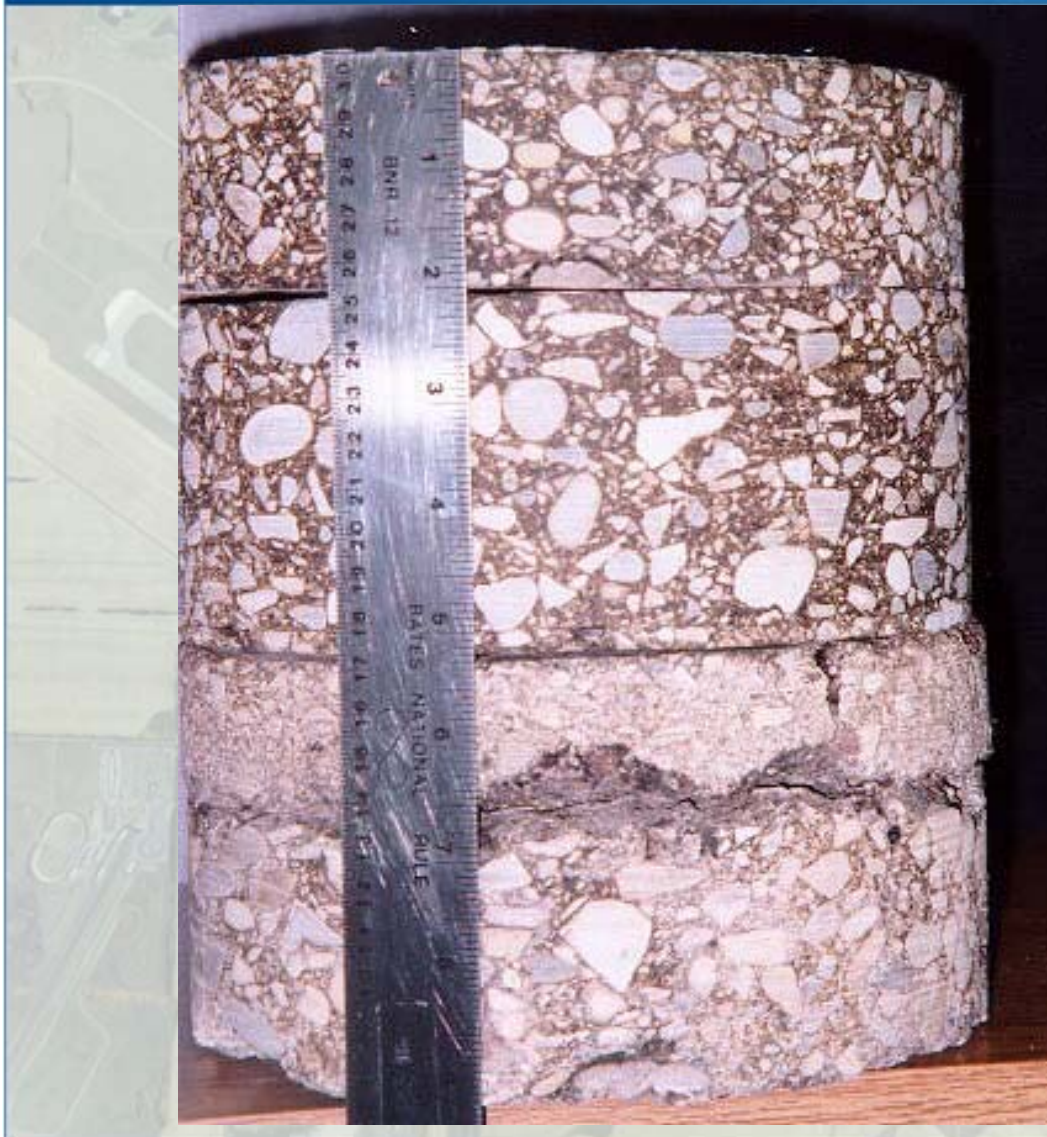
# Runway Core

Multiple ACP Layers

Stripped Original ACP

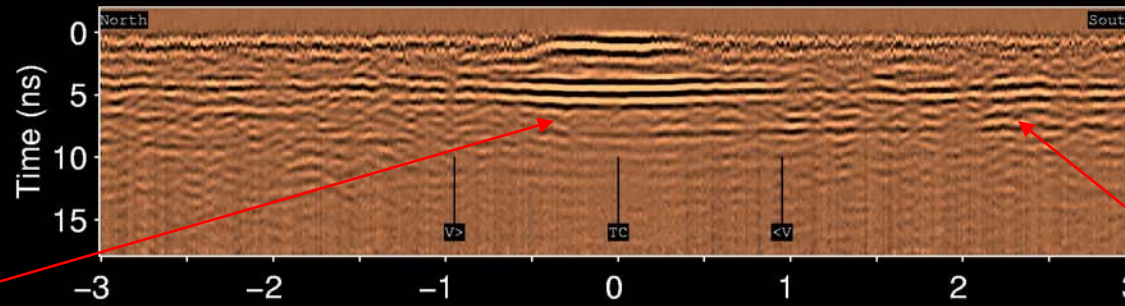
GRAPHICAL RADAR DATA WINDOW

moisture

stripping

- slight deformation
- seal damaged

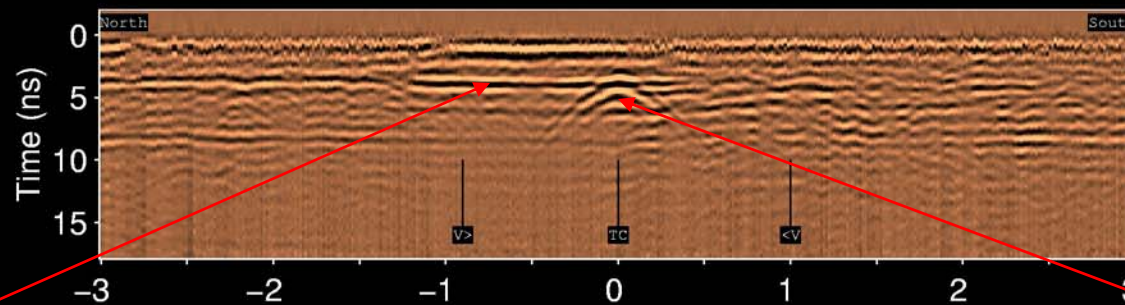
GRAPHICAL RADAR DATA WINDOW

moisture

void

- little / no deformation
- seal intact

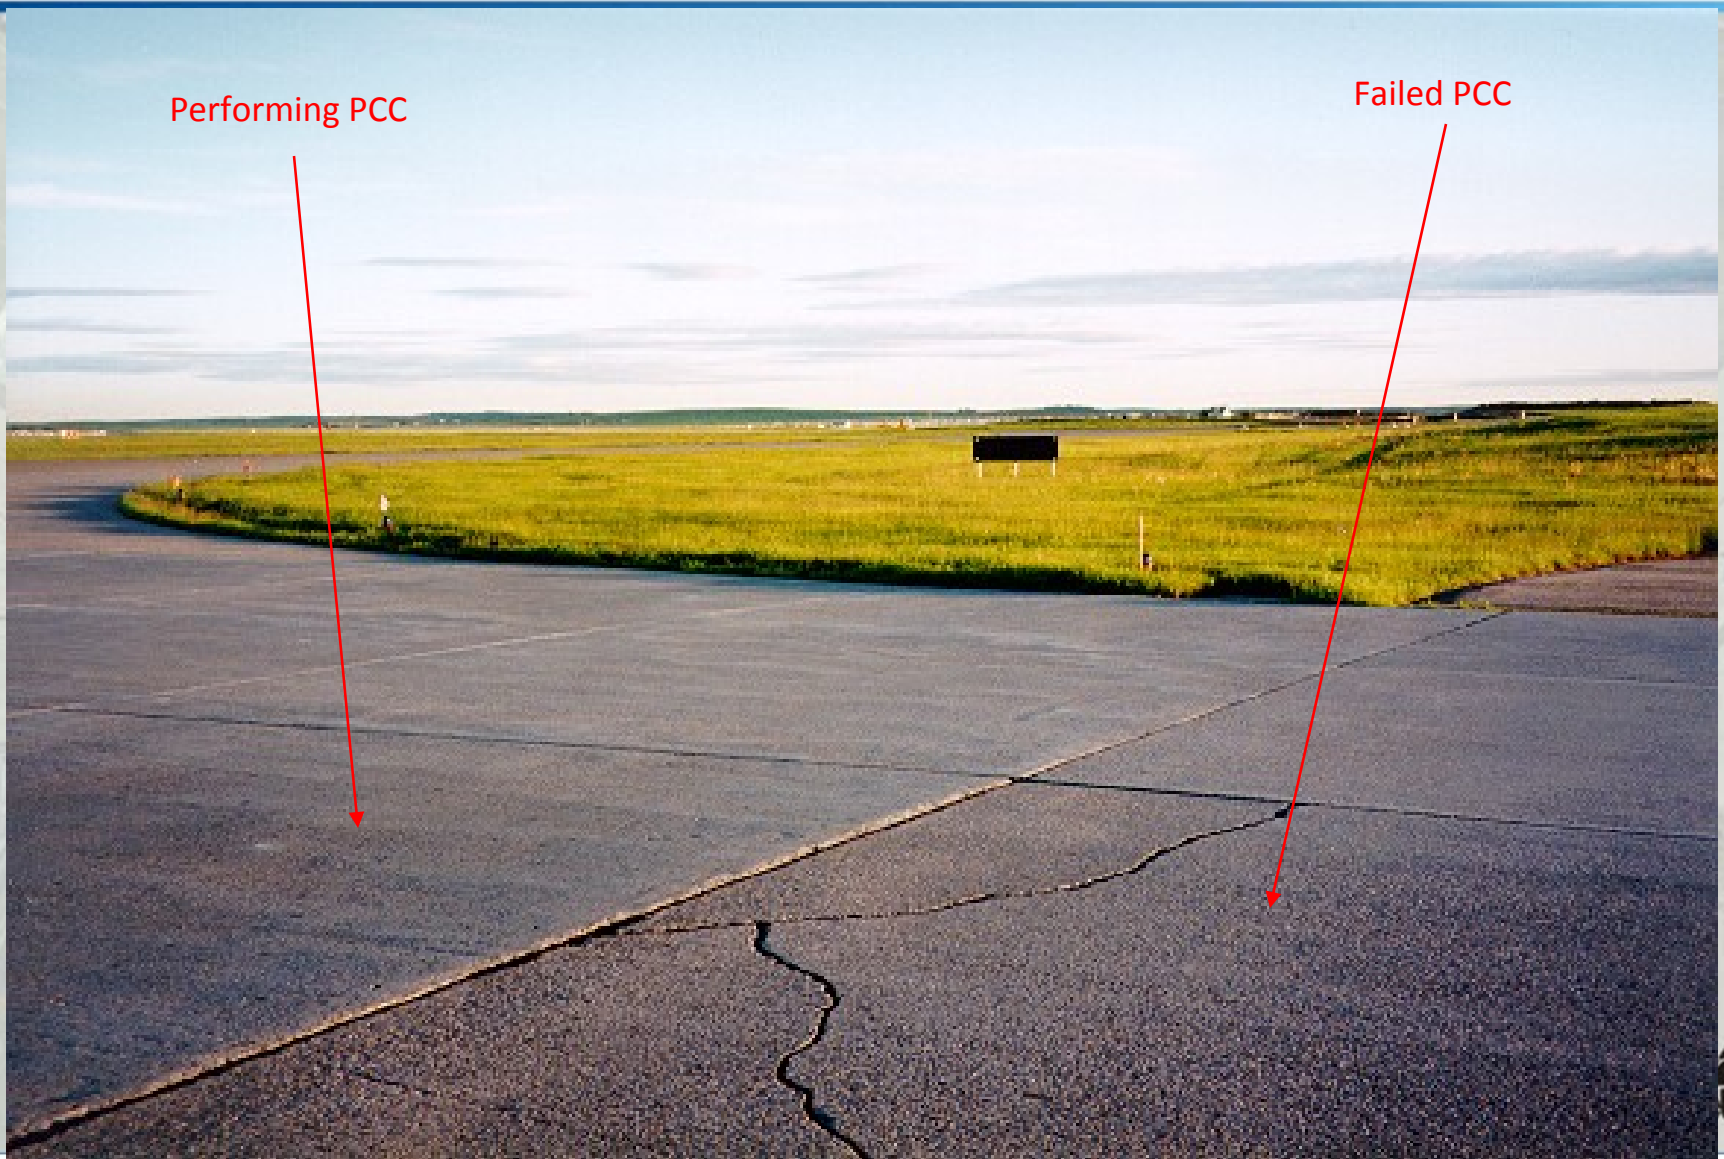
# Taxiway

Performing PCC

Failed PCC

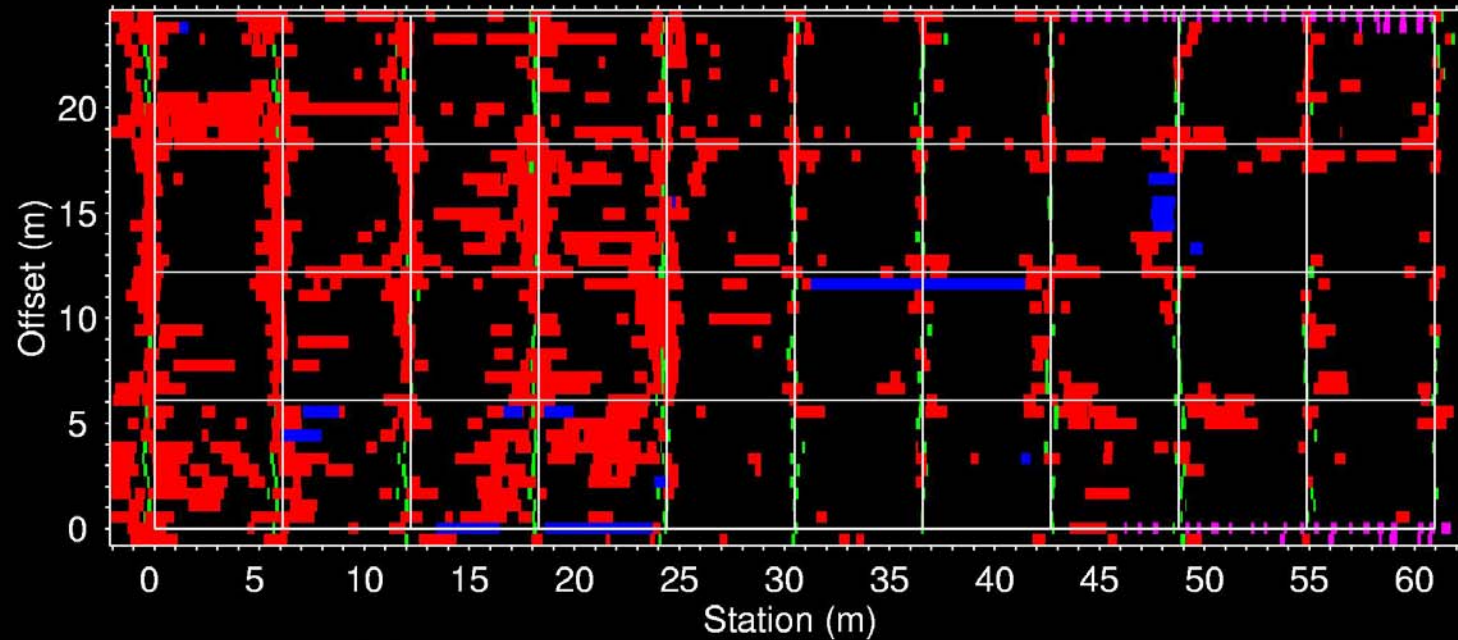
# Subsurface Anomalies

18 sq.m ( 1.1%) Joints  
8 sq.m ( 0.5%) Re-bar  
17 sq.m ( 1.1%) Delaminations  
332 sq.m (20.1%) Potential Voids  
Surveyed Area: 1652 sq.m

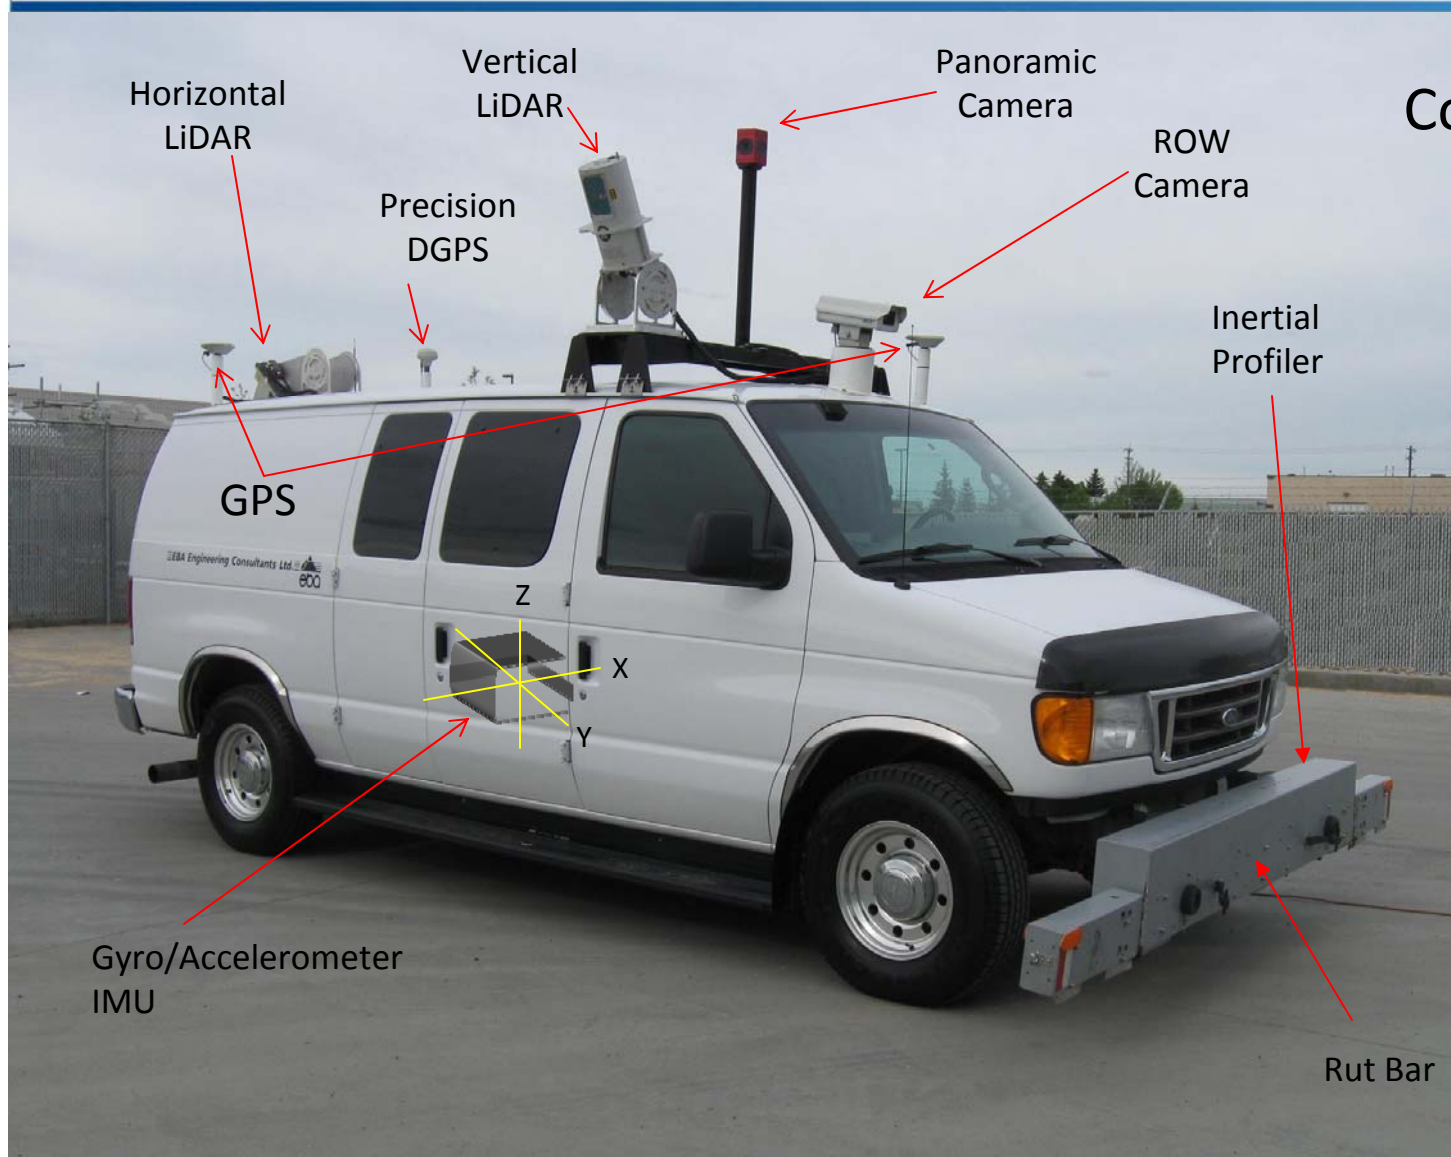
# Data Collection Vehicle

## Collected Data:

- Longitudinal Profile
- Transverse Profile
- Geometrics
- ROW Images
- Panoramic Images
- Surface LiDAR
- 3D LiDAR
- Surface Distress
- Spatial Reference Synchronization

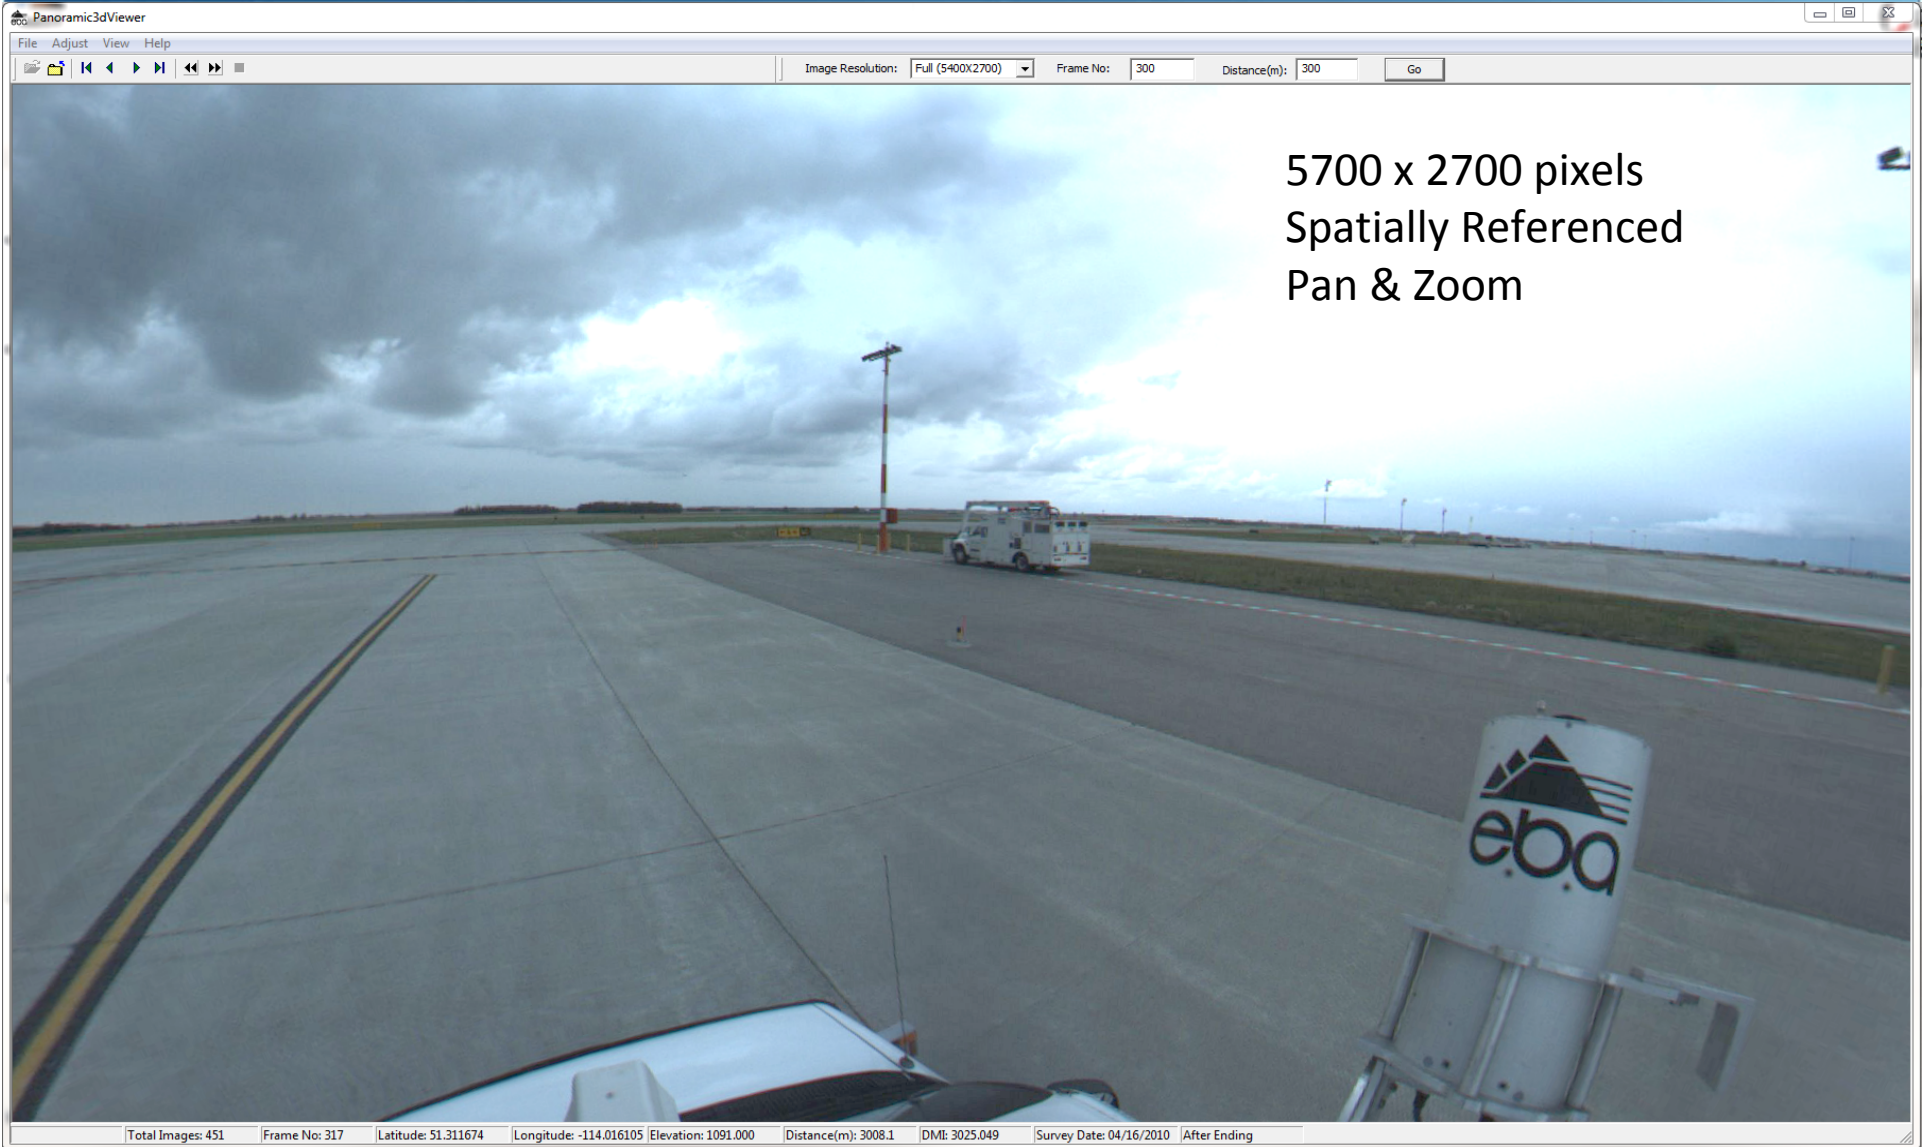
# Panoramic Videolog

5700 x 2700 pixels  
Spatially Referenced  
Pan & Zoom
