Taxiway Lima Rehabilitation at YVR Airport Lessons Learned from Different Perspectives

YVR International Airport
South Airfield Pavement Rehabilitation 2023 (Taxiway L, L2, L4, L6, D3)

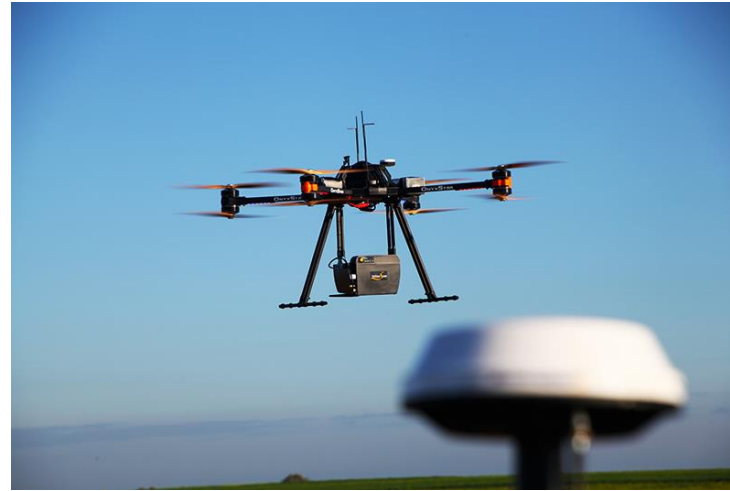
What Is a LiDAR Survey?

- LiDAR surveys are aerial surveys completed by using a LASER to create a topographical cloud of points.
- A LiDAR survey must be “processed” to turn it into a standard topographic surface suitable for design.

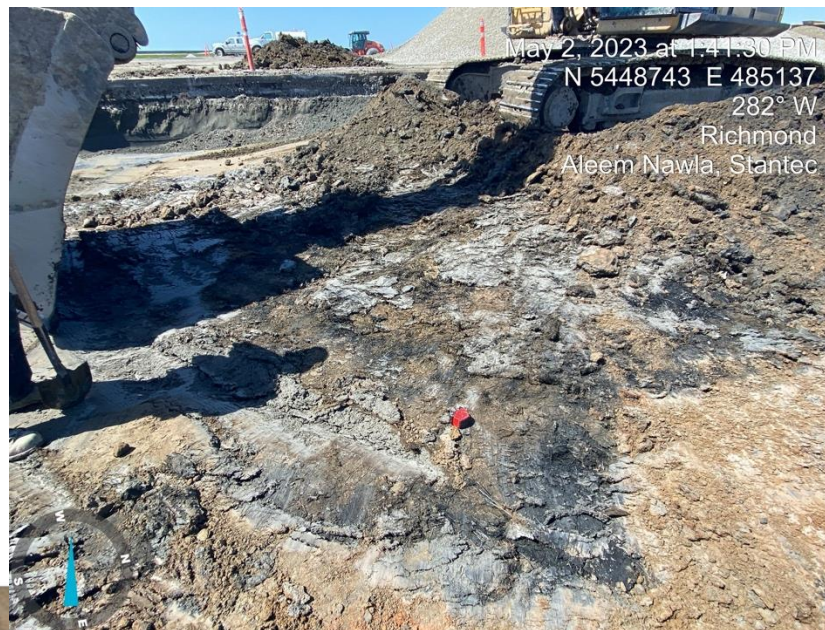
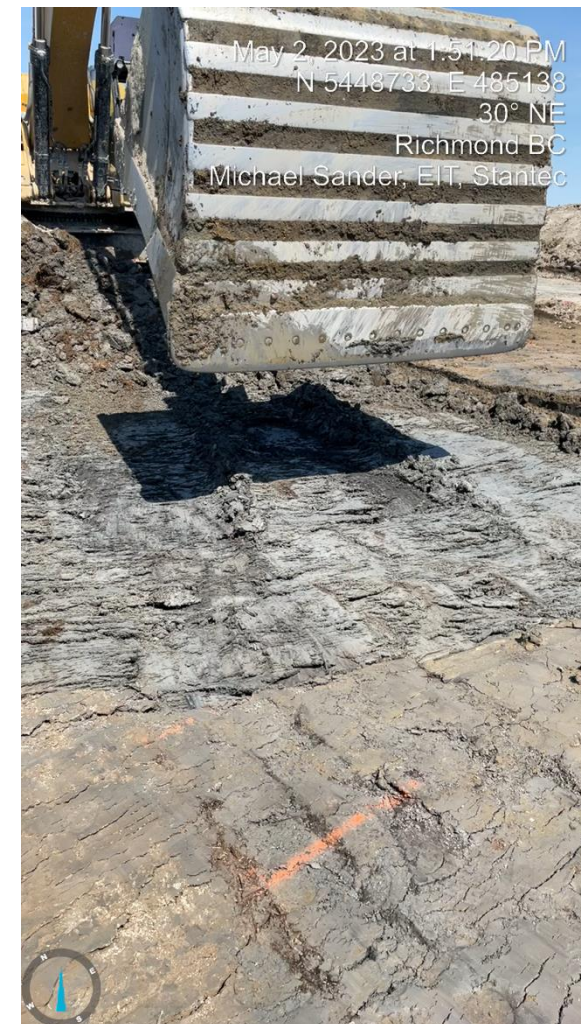
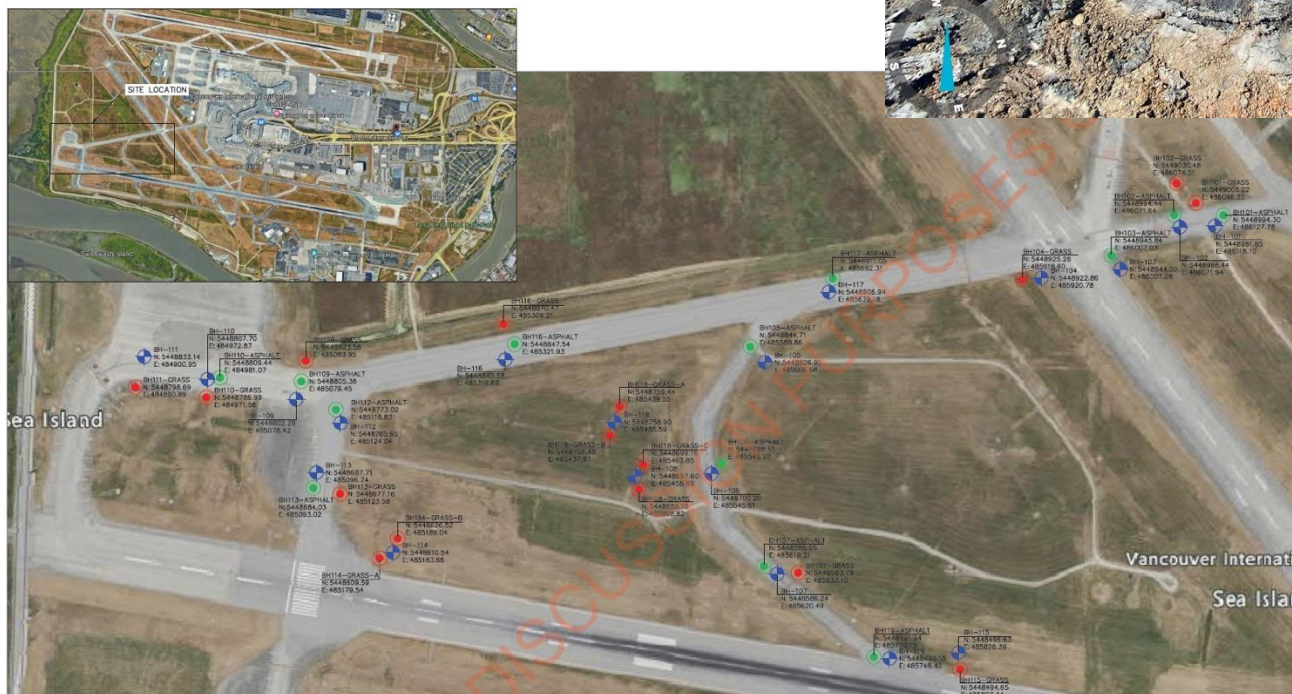
Geotechnical Boreholes

- Boreholes are an effective method to determine subsurface conditions using a representative sample.
- Initial investigations showed a very weak subgrade that would require strengthening and consolidation.
- Subgrade material was largely clay and silt.
- Large masses of organic material were found in the subgrade.

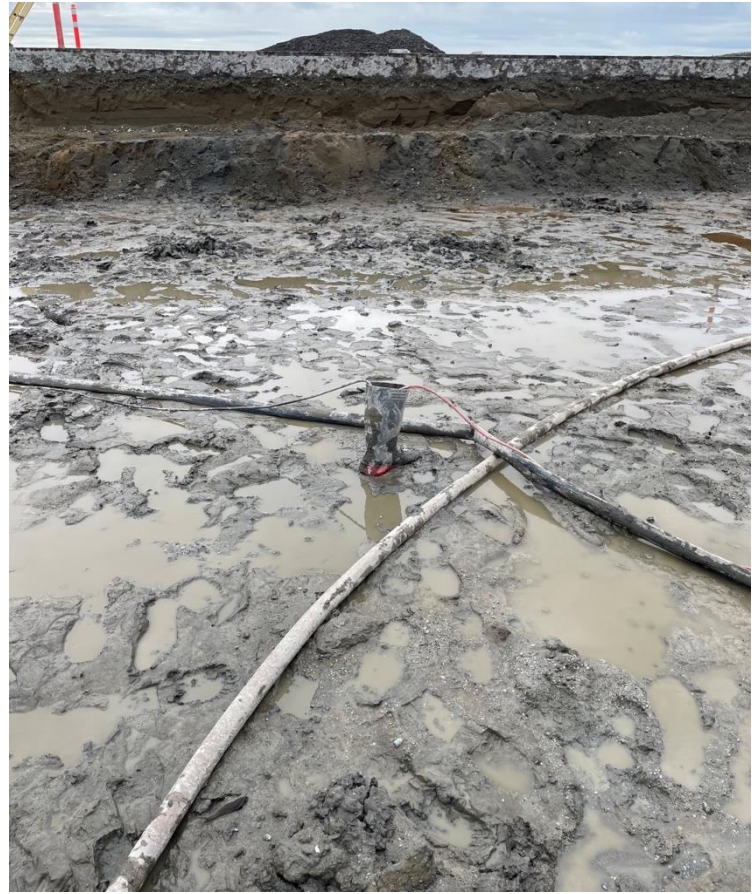
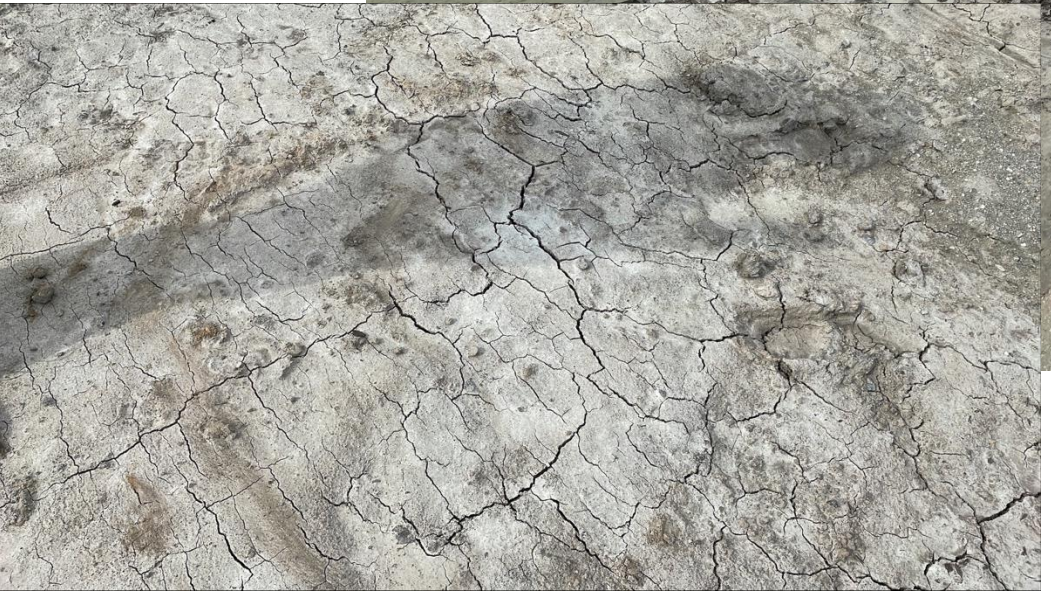
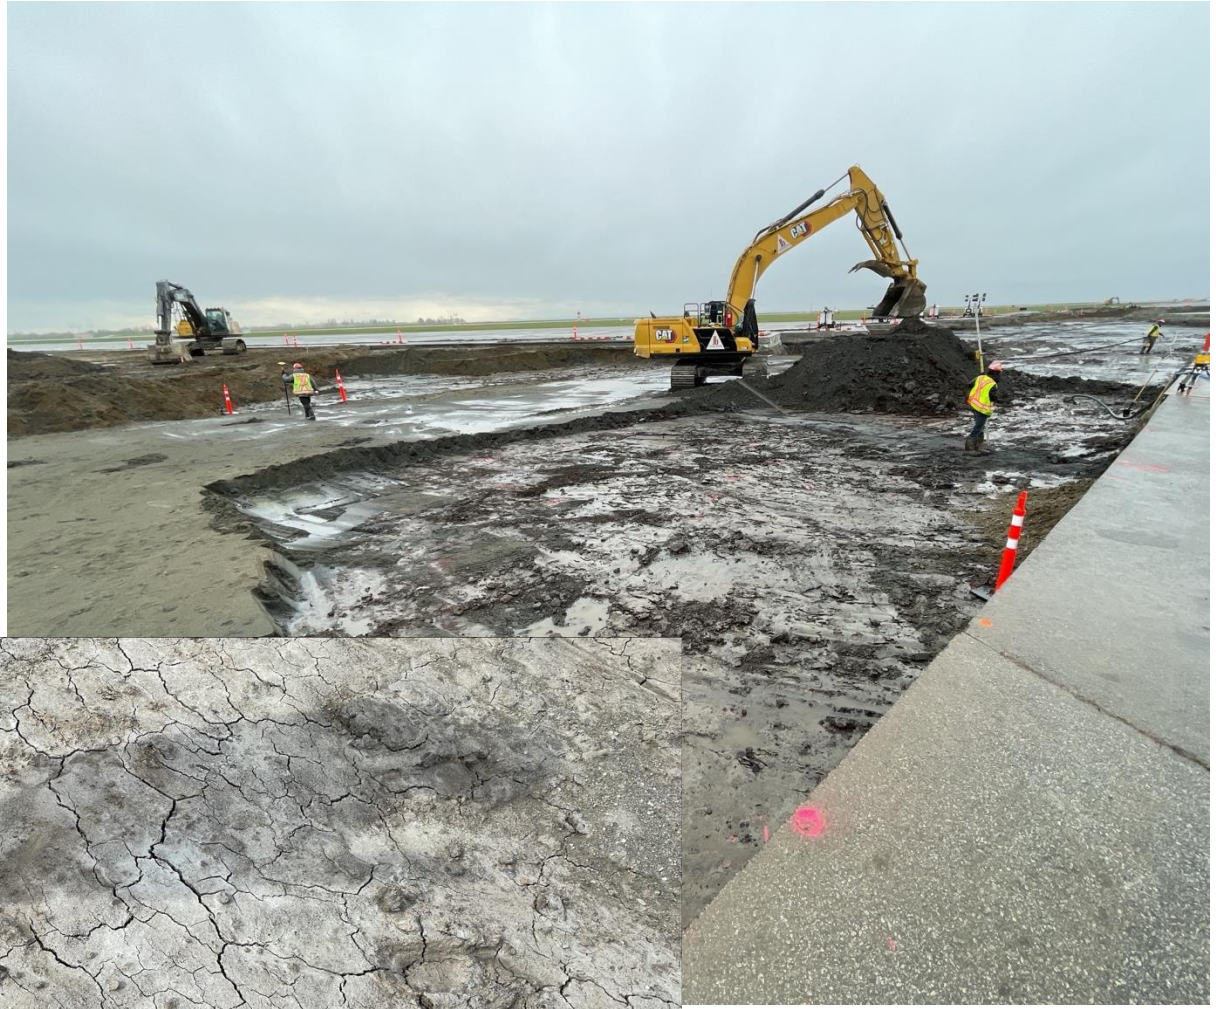
Challenges

- Perched water
- Agitated silty clay

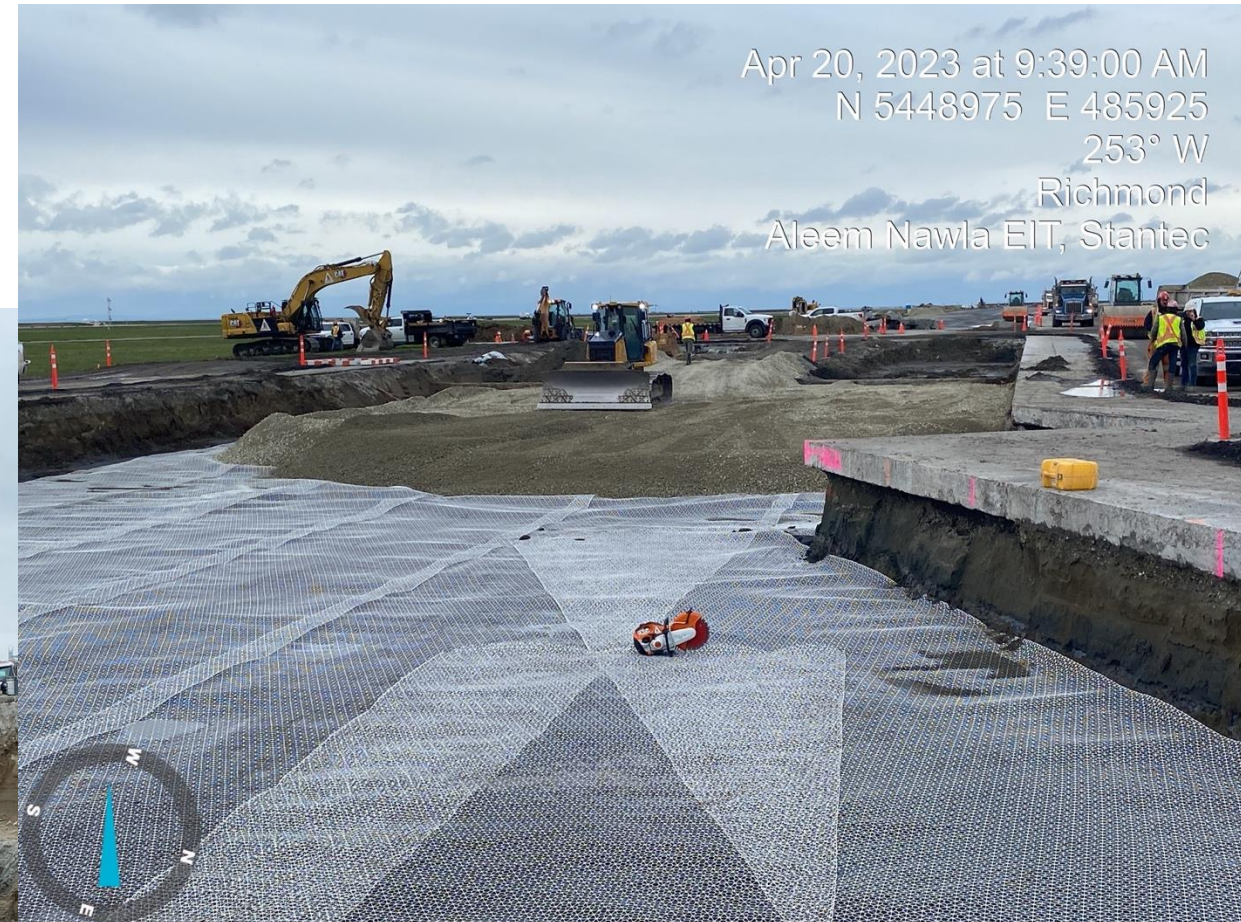
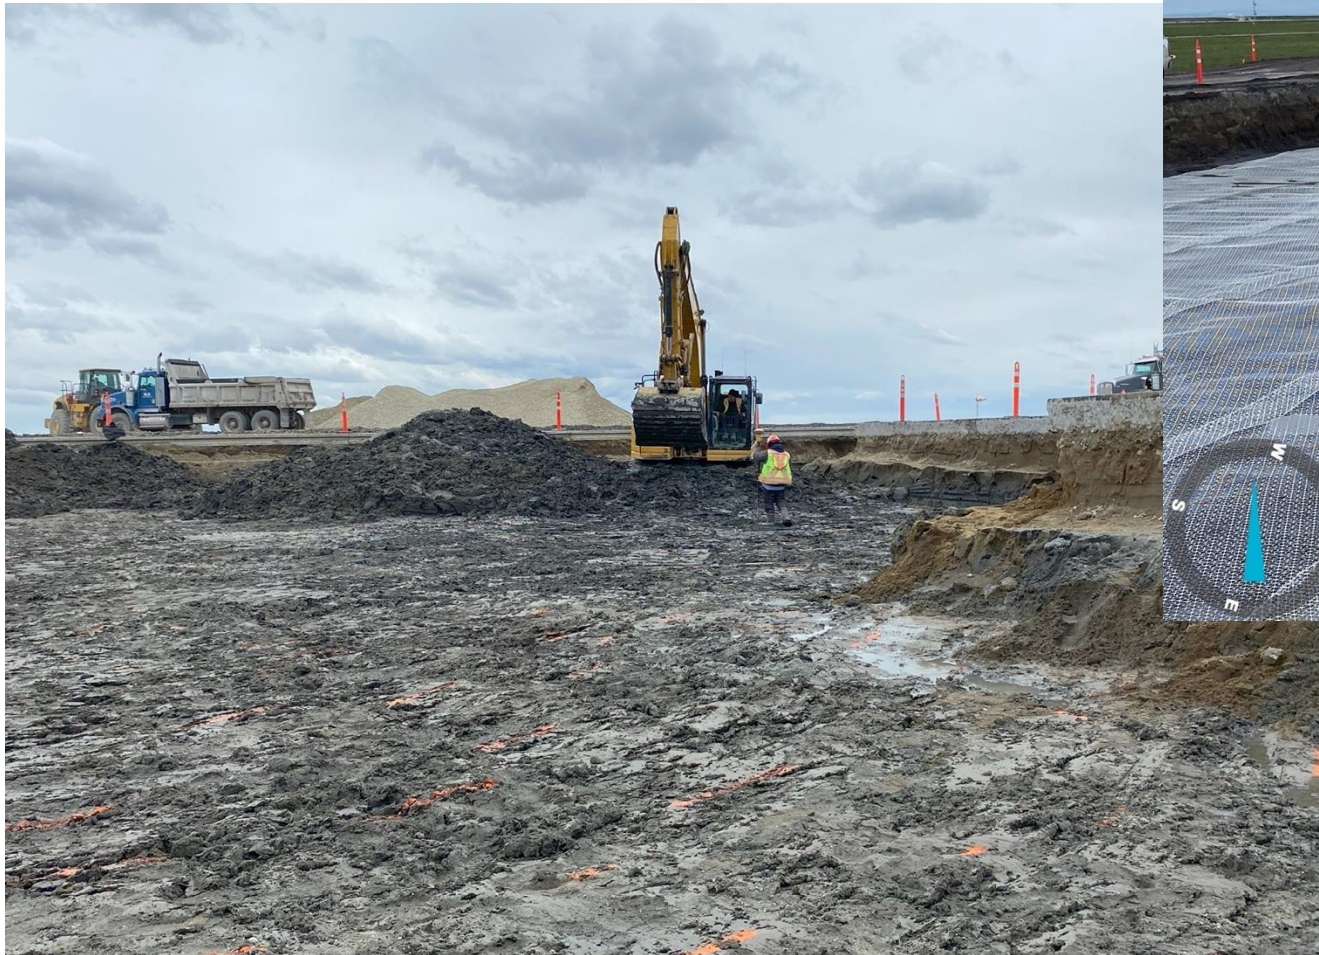
Solution – Subgrade Improvement

- Addition of lime
- Over-excavation to 300 mm below the designed subgrade depth. Place and compact a 300 mm layer of granular material, wrapped in geotextile to prevent migration of fines.
- Tensar TX160

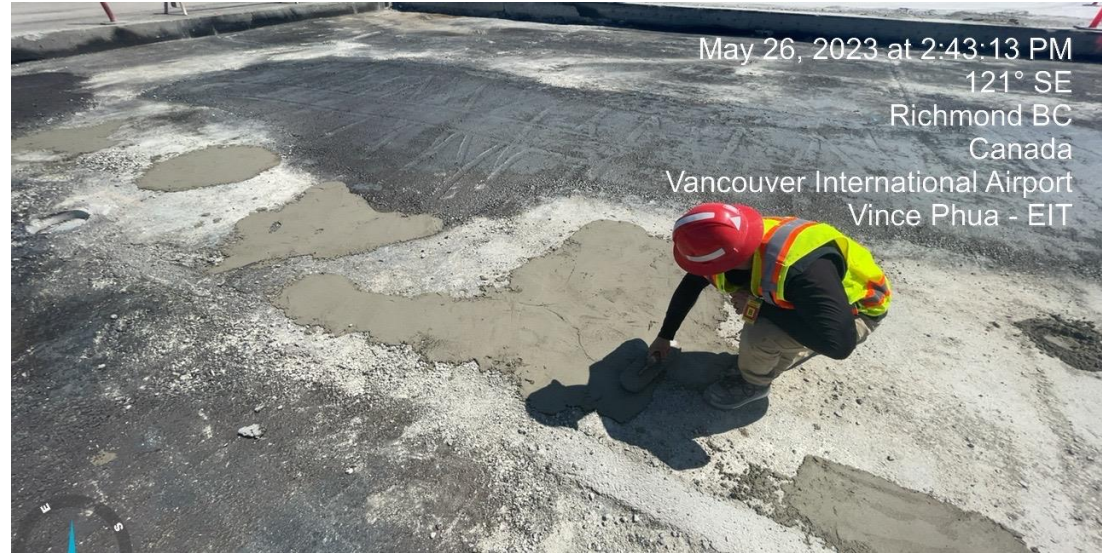
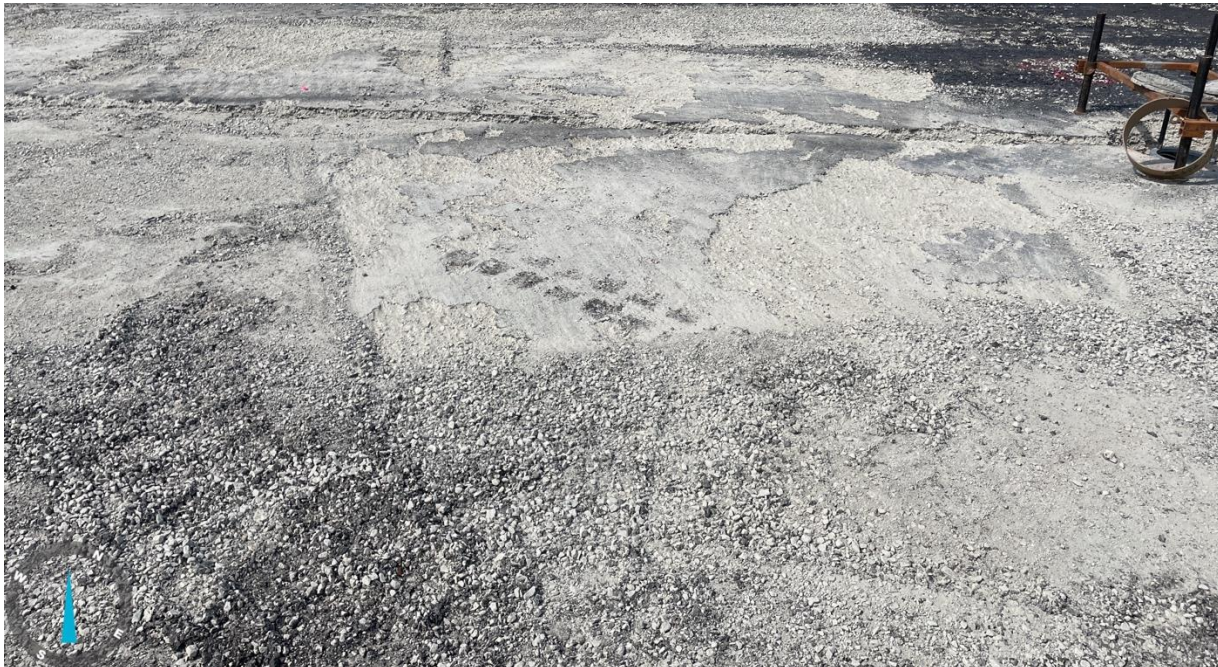
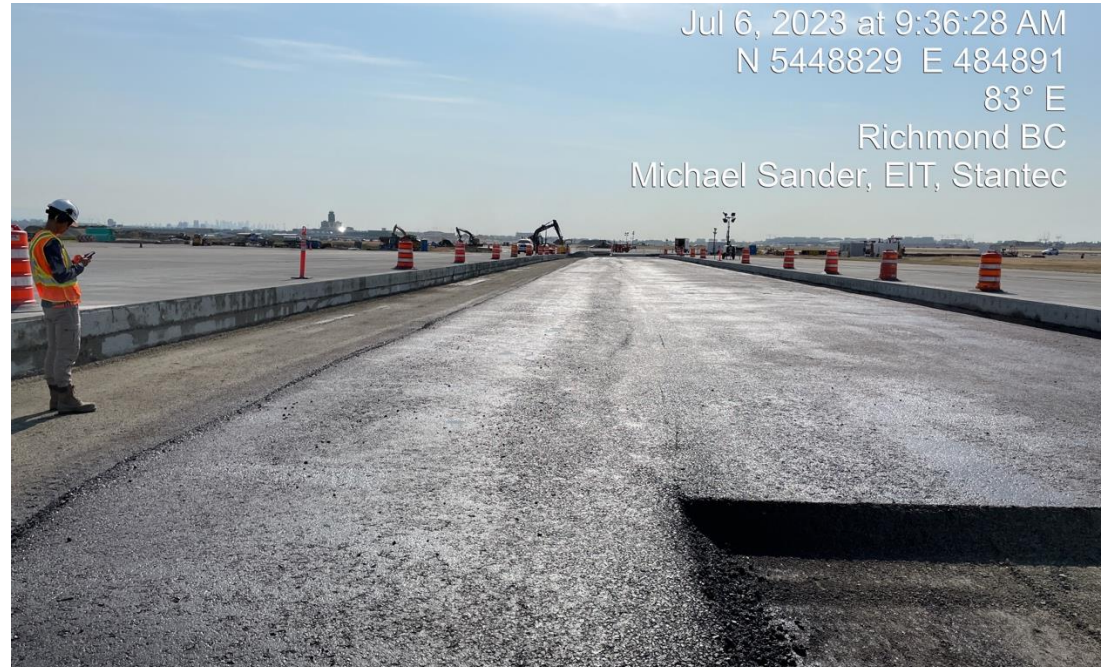
- Design mix resulted in some segregation of the coarse aggregate at the surface and poor adhesion due to cure times and ambient temperatures.

- Team quickly remedied the deficient surface and worked to fine tune the mix for the site conditions.

- Further CTB placement during the project occurred without issue

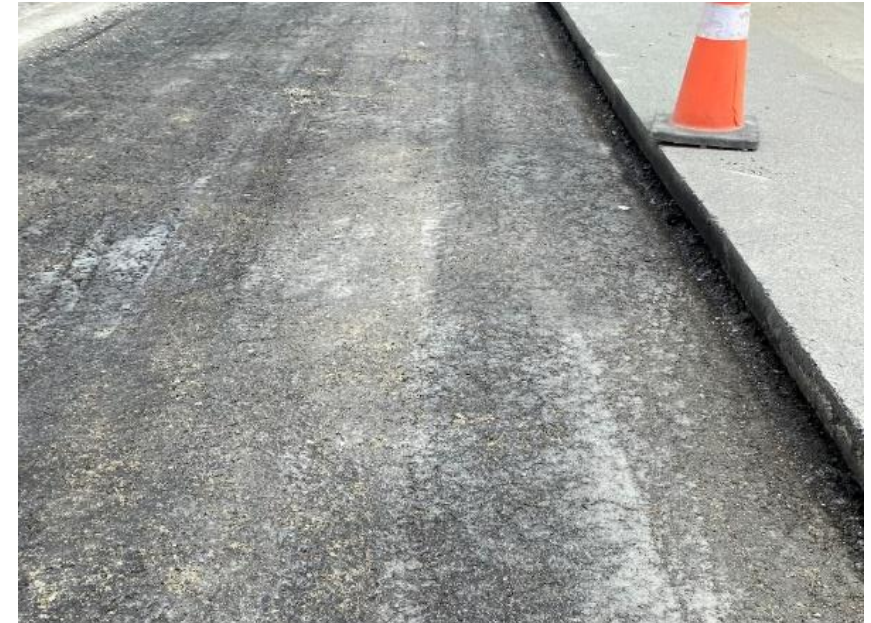
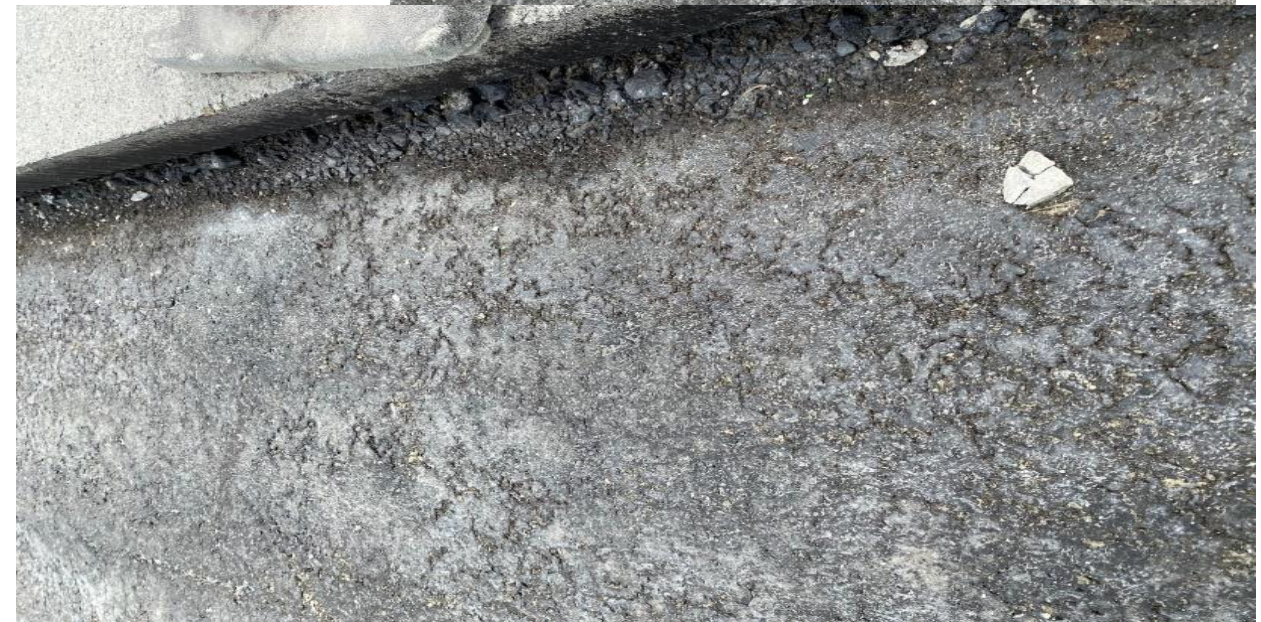
- CTB used in flexible pavements tends towards shrinkage cracking which can reflect up through the asphalt layers similar to Joint Reflection Cracking from Asphalt paved over PCC slabs.

- 2 separate methods in place to address shrinkage and reflective cracking.
- Team jointly reviewed methodology on TSA pavement at TWY L as a trial.
- Surface pre-cracked using a vibratory roller within 24-72h of placement during curing period.
- Measured timing and optimal number of roller passes to achieve desired surface cracking.

- Induced hairline cracks help mitigate effects localized shrinkage cracking.
- Thickness of HMAC layer intended to bridge any discontinuity.

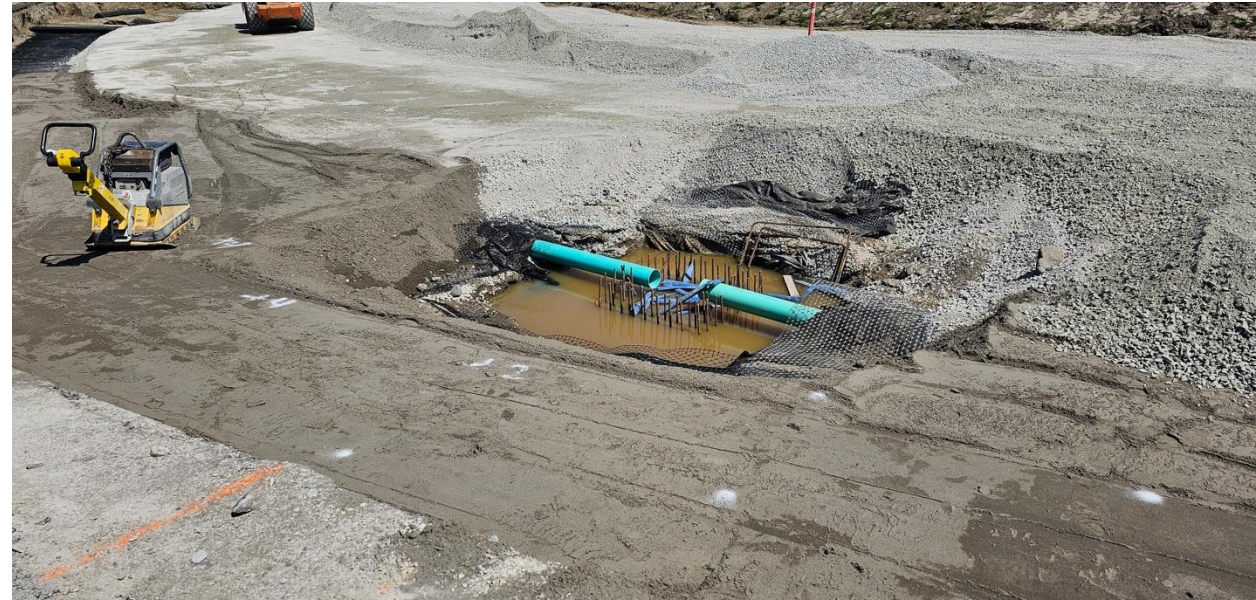
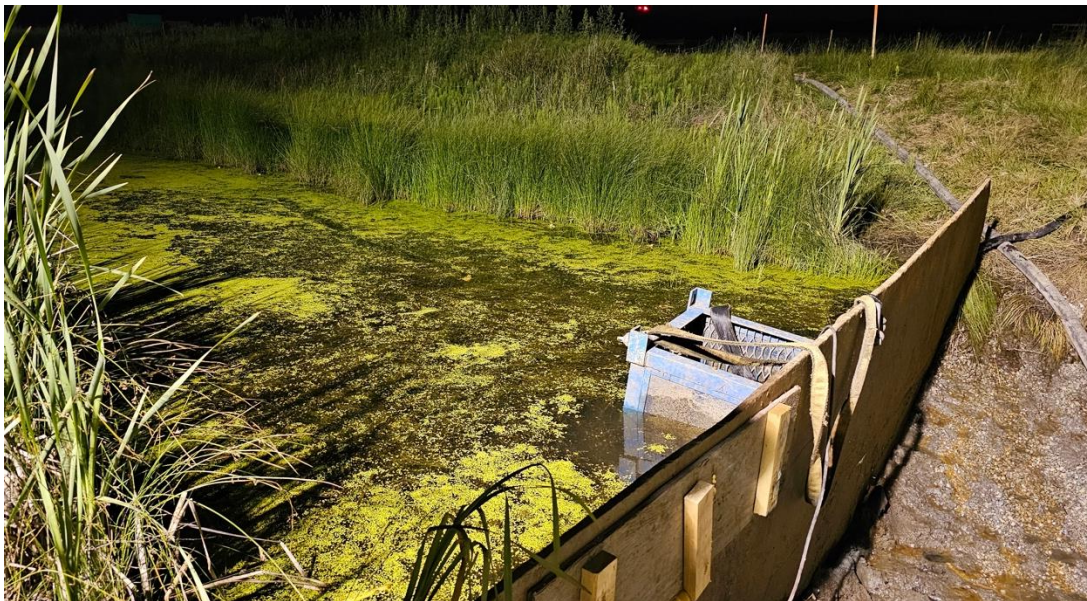
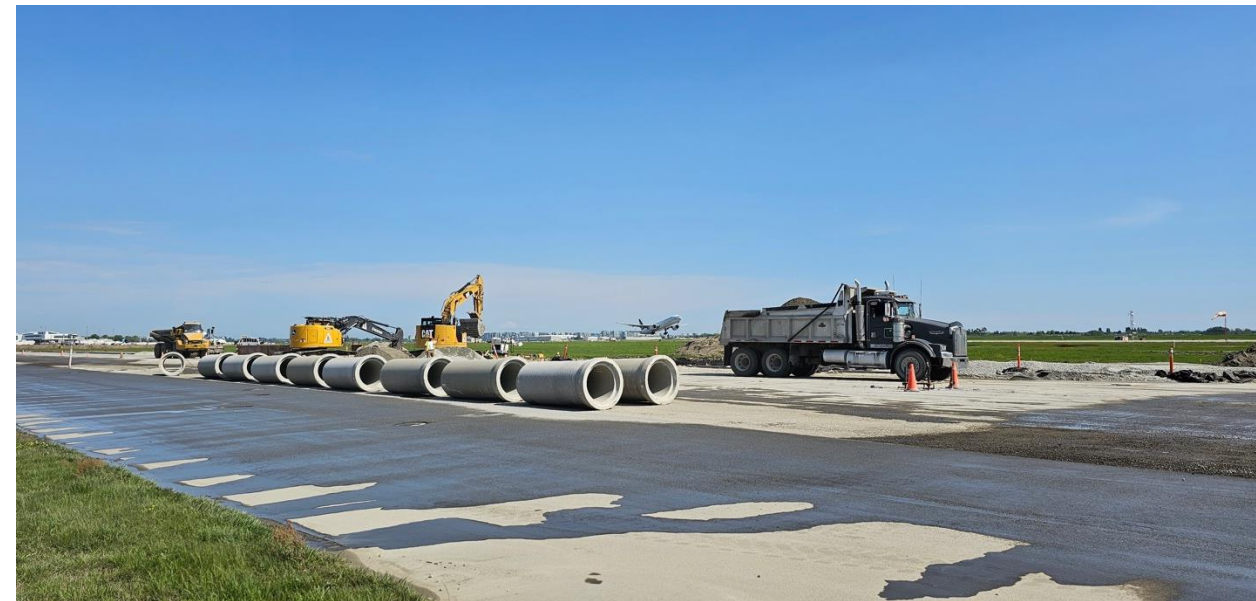
Design Constraints

- A high water table and perched water above the silty subgrade leaves very little room between the bottom of the pavement structure and the elevation of the ground water, especially in rain.
- Long pipe runs compress the ability to add adequate slope to the pipes.
- Aging base plans (Tie-ins, Slopes, Inverts) lead to lost data that is rediscovered in the field.
- YVR is built on Musqueam traditional territory and respecting areas of archaeological importance is a high priority.
