Airfield Lighting & Operational Continuity

SWIFT
VANCOUVER SEPT 17-19 2024

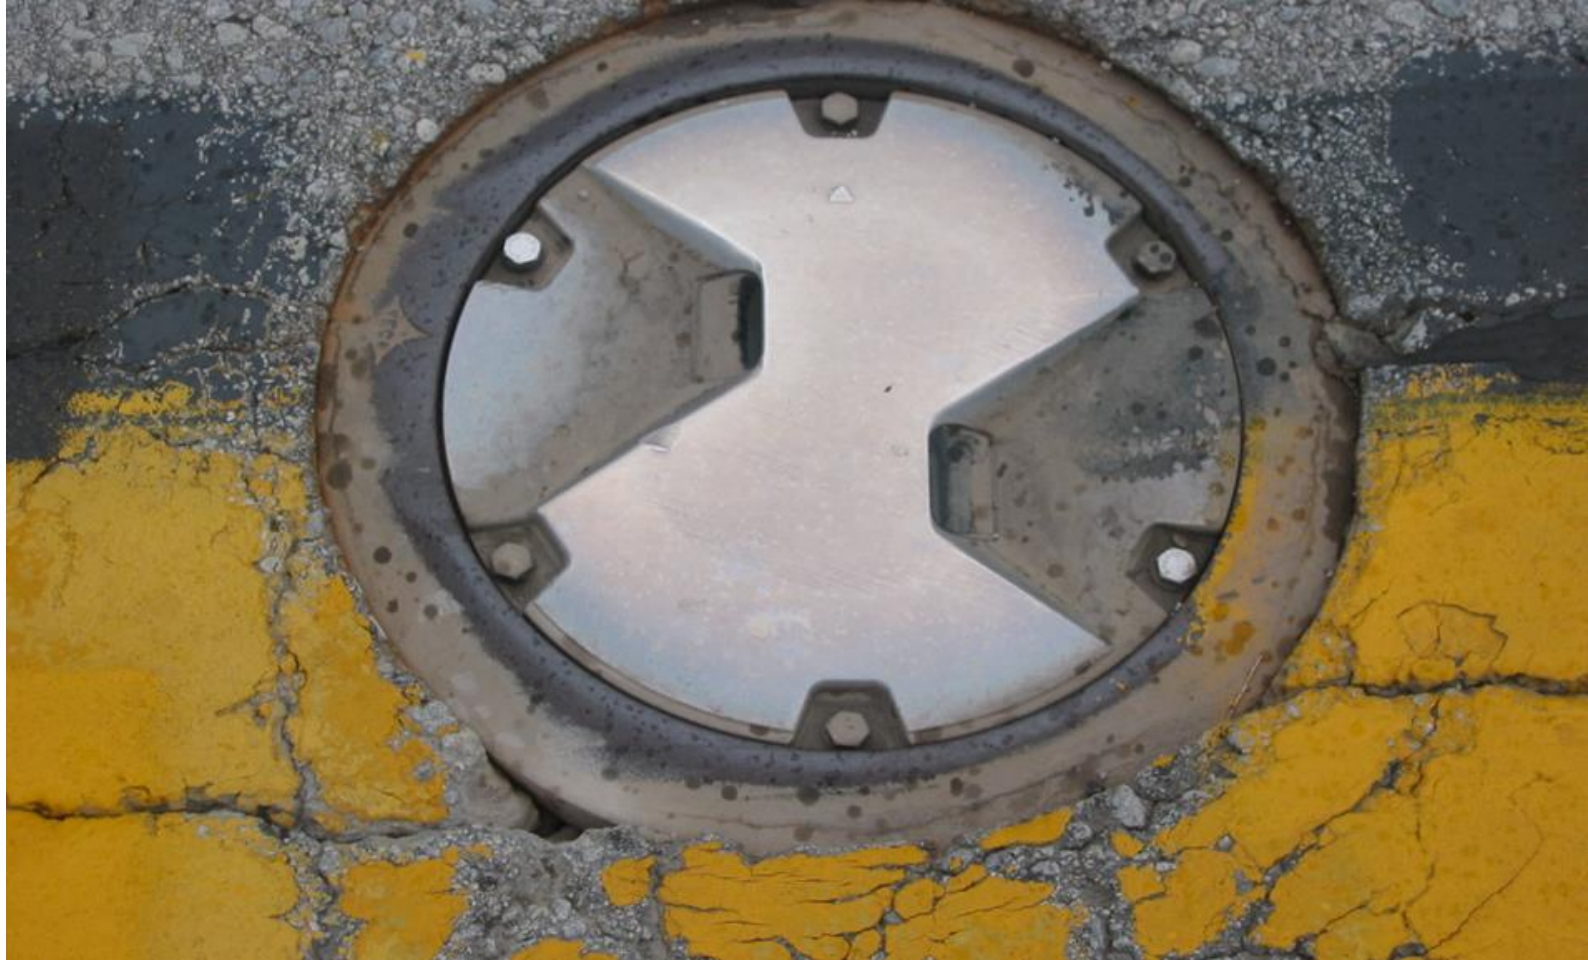
Small pieces of asphalt start missing around can. This will create bigger issues if not addressed early.

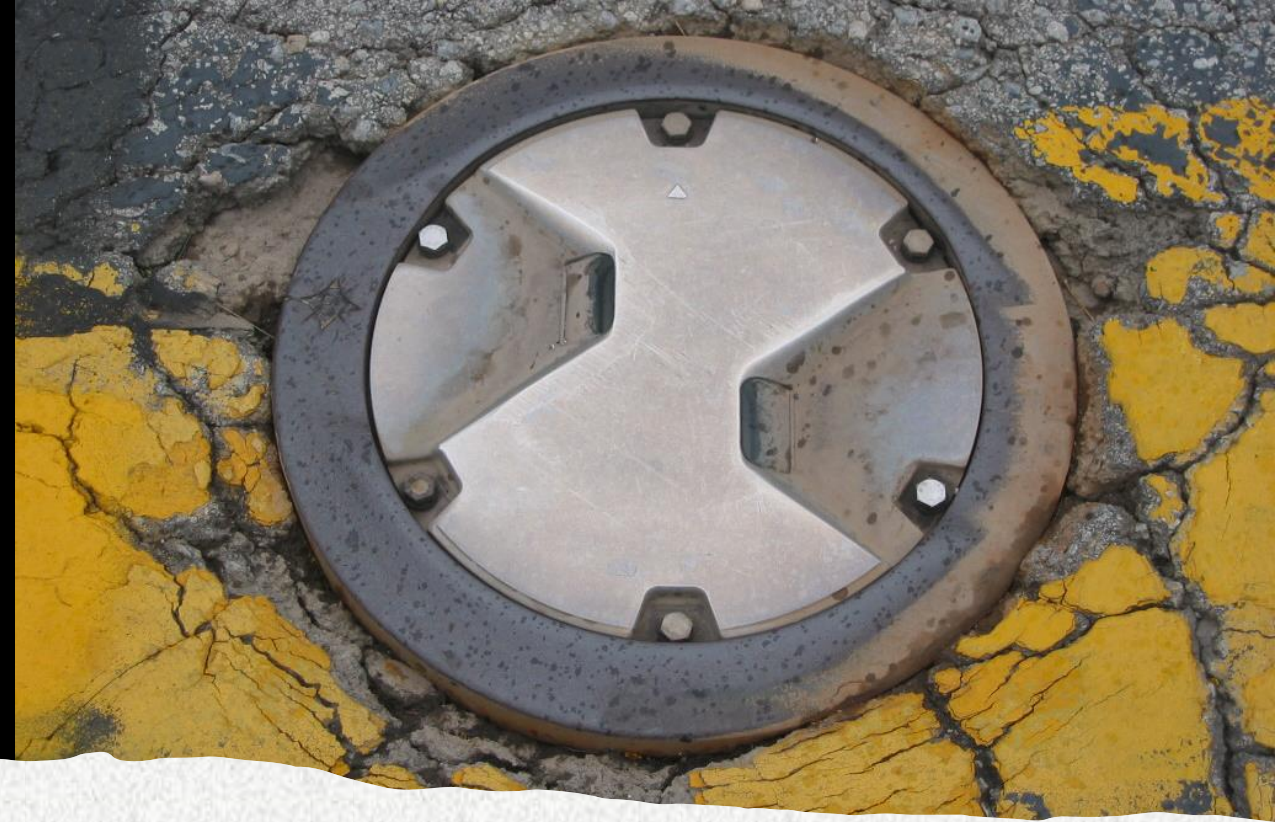
This was likely caused by improper compaction around the inset light when it was initially installed.

**Most likely didn't
have a solid
concrete base
underneath or a
shallow inset can
was installed**

**Inset can Sunken
into asphalt**

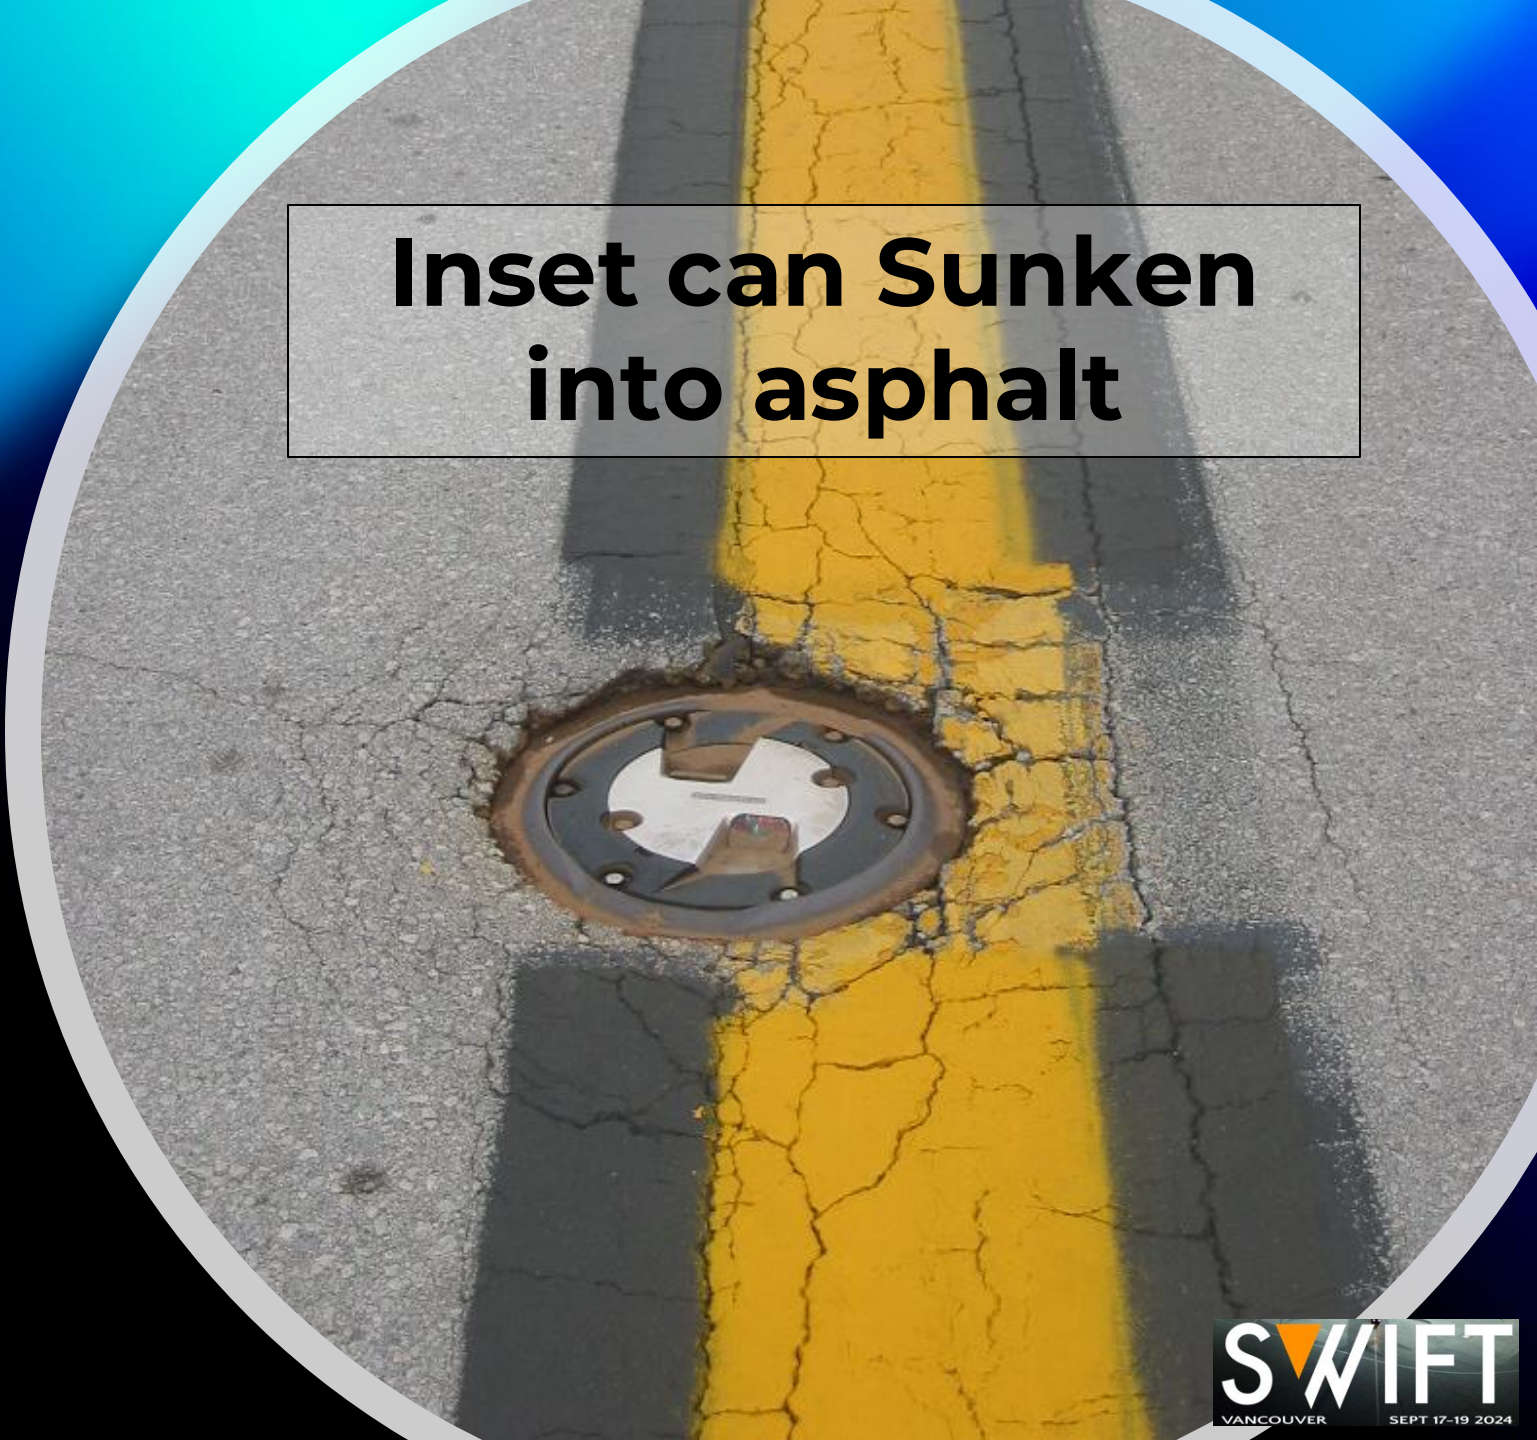
Concrete/Grout around inset can started breaking up

- Can Generate FOD
- Asphalt -> Concrete isn't ideal
or a good match

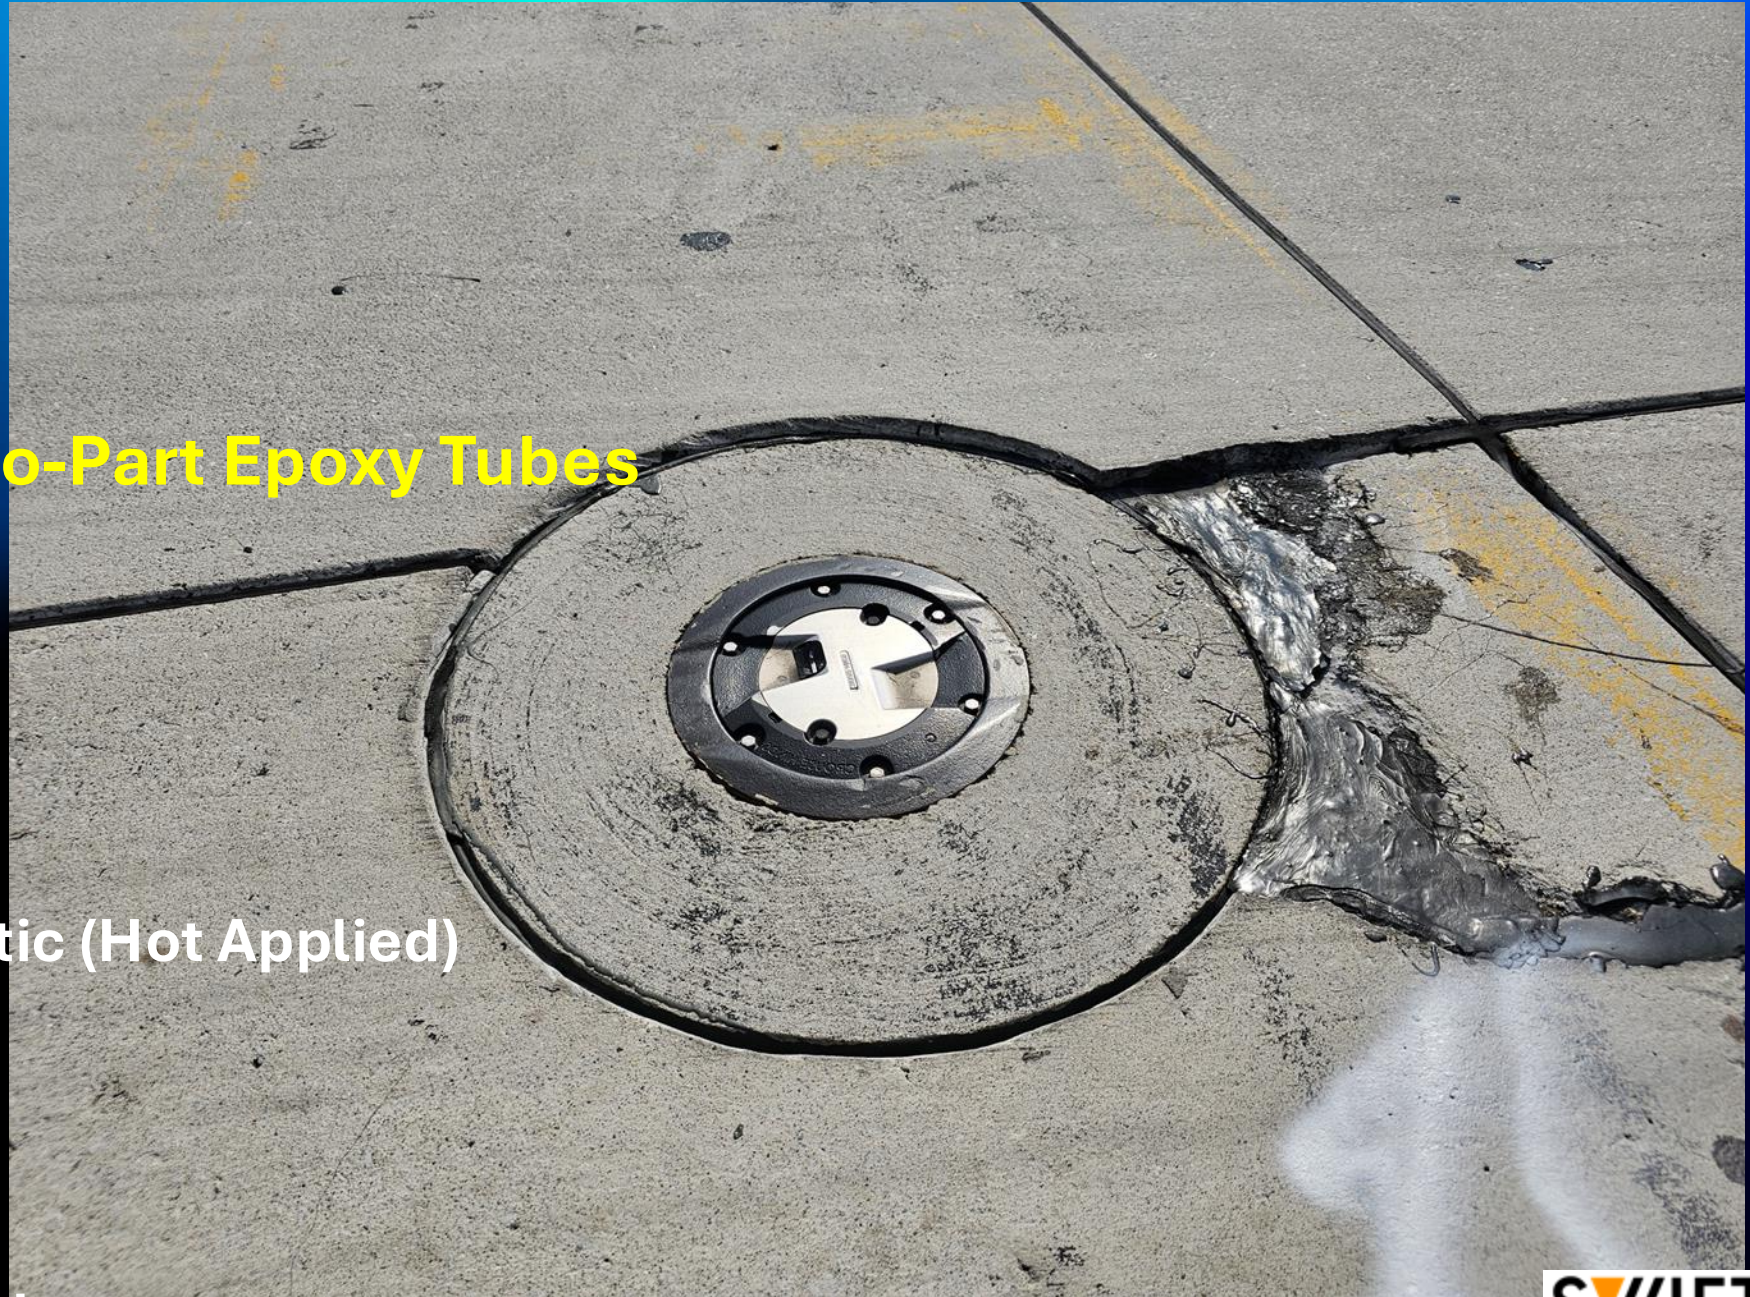
Material Options For Repairs

Delpatch Elastomeric Concrete can accept traffic in as little as one hour after the final pour when installed in normal working temperatures

Delpatch

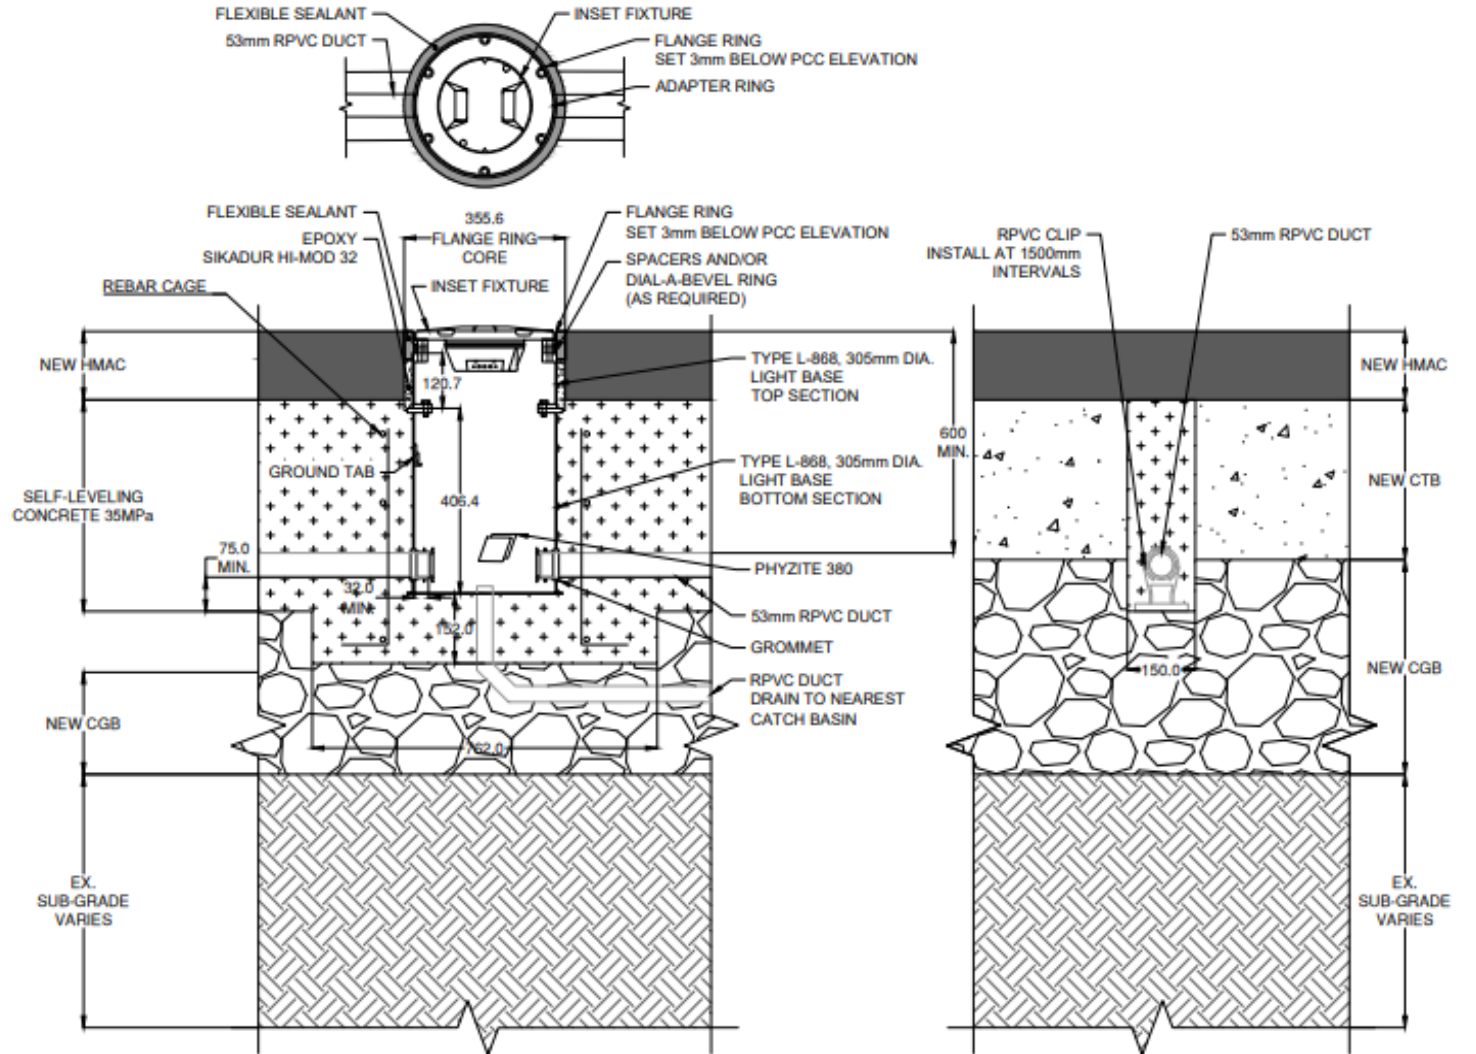
01 TYPICAL INSTALLATION OF NEW INSET LIGHT FIXTURE IN NEW HMAC
 SCALE: 1:10

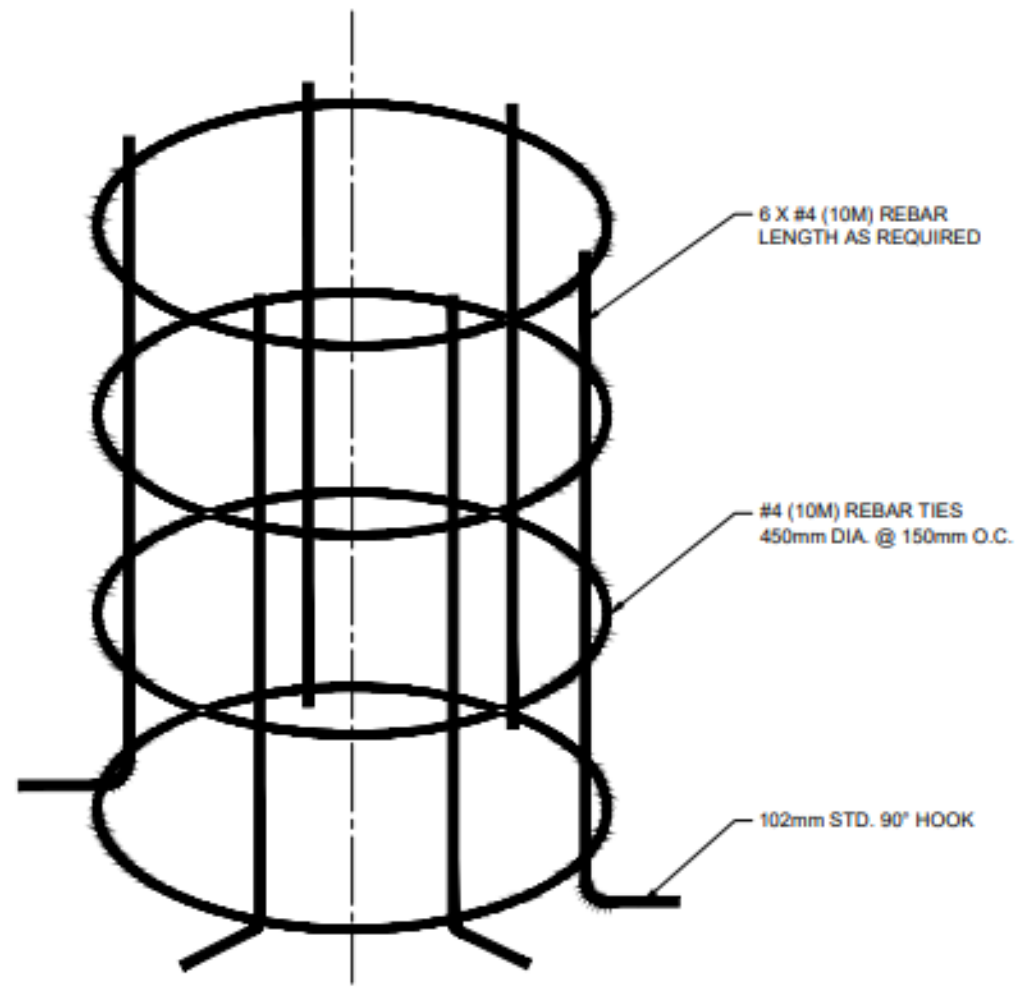
ISOMETRIC VIEW

- MAINTAIN 75mm MIN. COVER ON REBAR.

TYPICAL DETAIL FOR REBAR CAGE

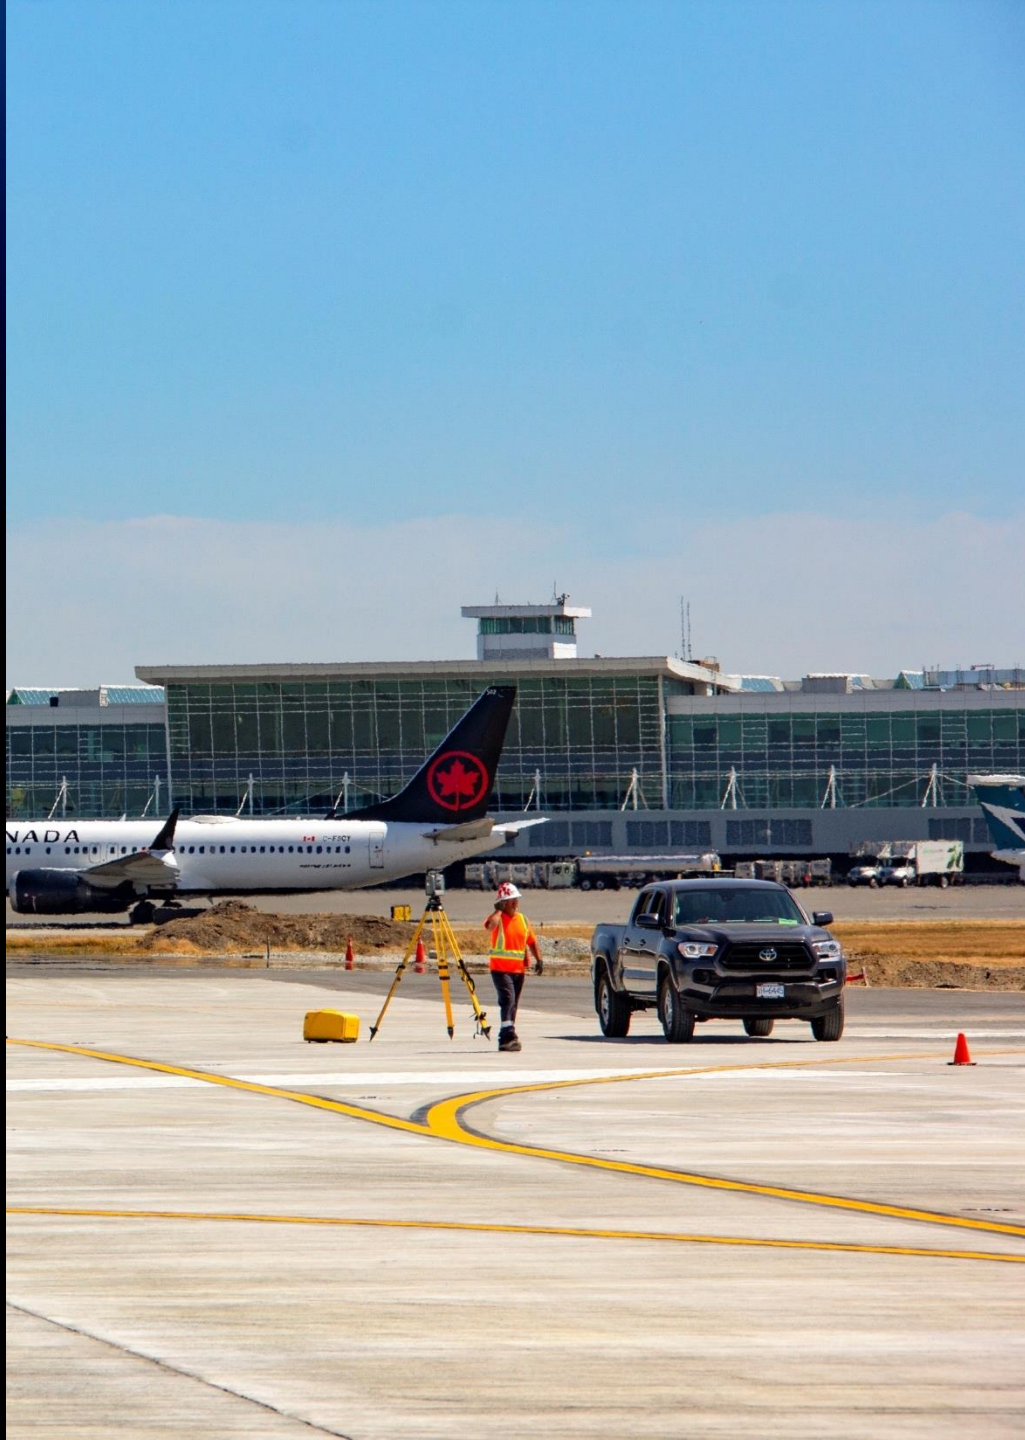
**YVR SOUTH AIRFIELD
PAVEMENT
REHABILITATION**
****2023 (TAXIWAY L, L2,
L4, D3) ****
